Merged Report on In-Depth Case Studies

TU Delft – Chair of Heritage and Technology

Editors: Gabriel Pardo Redondo and Silvia Naldini (TU Delft)

Date: November 19, 2021

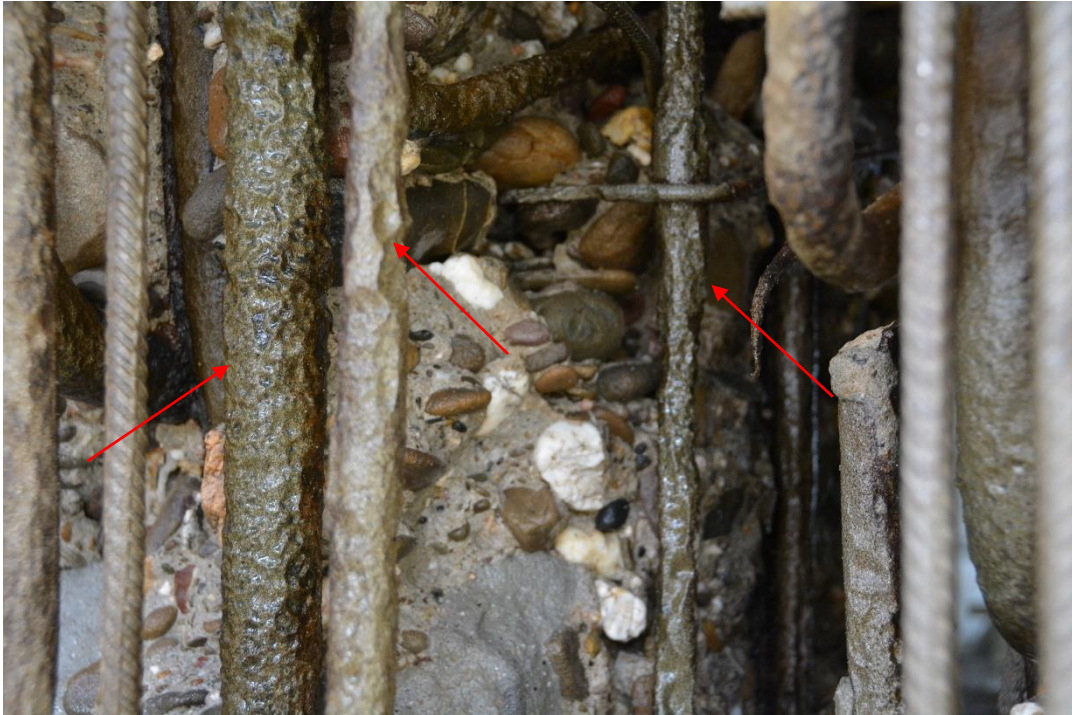
In the exterior face of the south façade the following damage were found: Cracks, spalling, and exposed rebar with rust layers. The damage were located in the majority of the columns and under the eaves, and in a lesser extent in the walls of the first floor. The added render from the 1980s did not seem to add protection to the reinforcement, and the visible corrosion is severe, which can affect the structural integrity of the columns. The spalling often affects substantial sections of the concrete, and the loss of steel section, especially in smaller diameters, is beyond safe standards. In one of the columns under restoration at the time of the inspection, signs of pitting corrosion were visible in the rebar (Figure 6). Although, this damage type was only visible after cleaning the rebar with high-pressure water jets to remove the carbonated concrete. The interior

side of the south exterior columns have scattered, local signs of corrosion induced damage, which is not extensive.

Figure 6. Signs of pitting corrosion in one of the exterior columns of the south facade. This picture was taken after cleaning the concrete around the rebar with high-pressure water jets (2020).

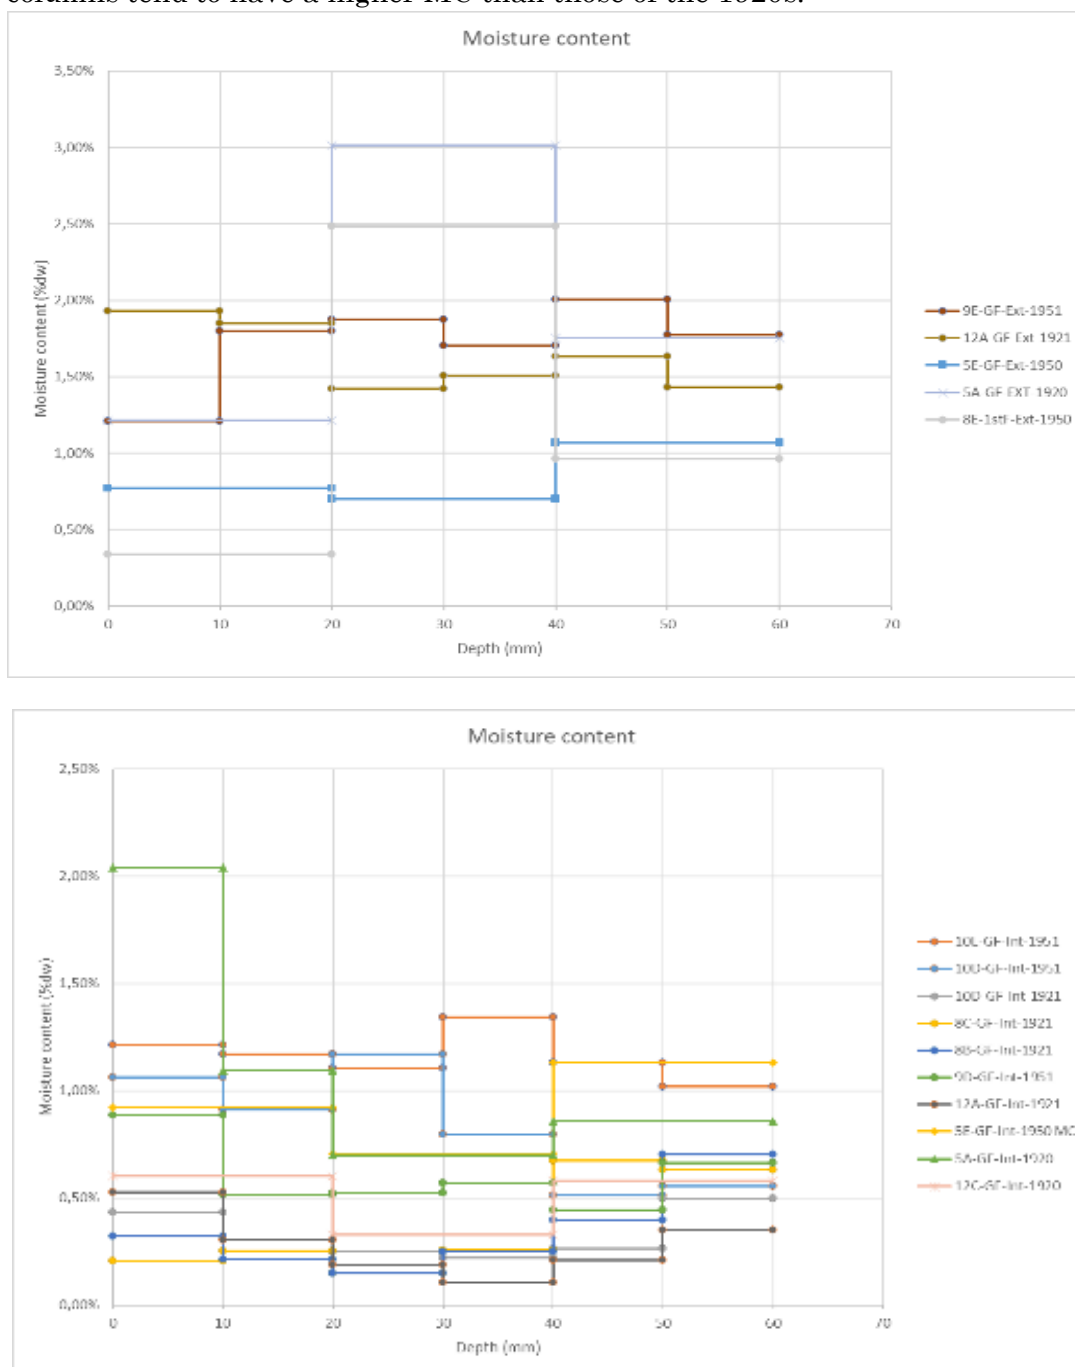
MC is below 2% in all columns with the exception of 3 exterior columns that have MC peaks of 2.5, 3 and 8.5%. Average MC in interior columns is 0.62% (+/- 0.40%) and in exterior columns 2.41 (+/- 1.92%) (see Figure 14). Average MC in 1920s columns is 0.45% ($\pm 0.37\%$) for interior, and 1.75% ($\pm 0.51\%$) for exterior. For 1951s columns the average MC is 0.87% ($\pm 0.28\%$) for interior, and 2.73% ($\pm 2.26\%$) for exterior. One of the exterior 1951's columns was soaked wet due to a water infiltration from a drainpipe. Disregarding this column, the average MC of the 1951s exterior columns is 1.39% ($\pm 0.63\%$), which slightly less than for the 1920's exterior columns.

There is not significant difference between MC in exterior columns from 1920 and 1951. However, under the same interior conditions of temperature and humidity, 1951s interior columns tend to have a higher MC than those of the 1920s.

Figure 14. Moisture content of exterior columns (Top) and interior columns (Bottom).

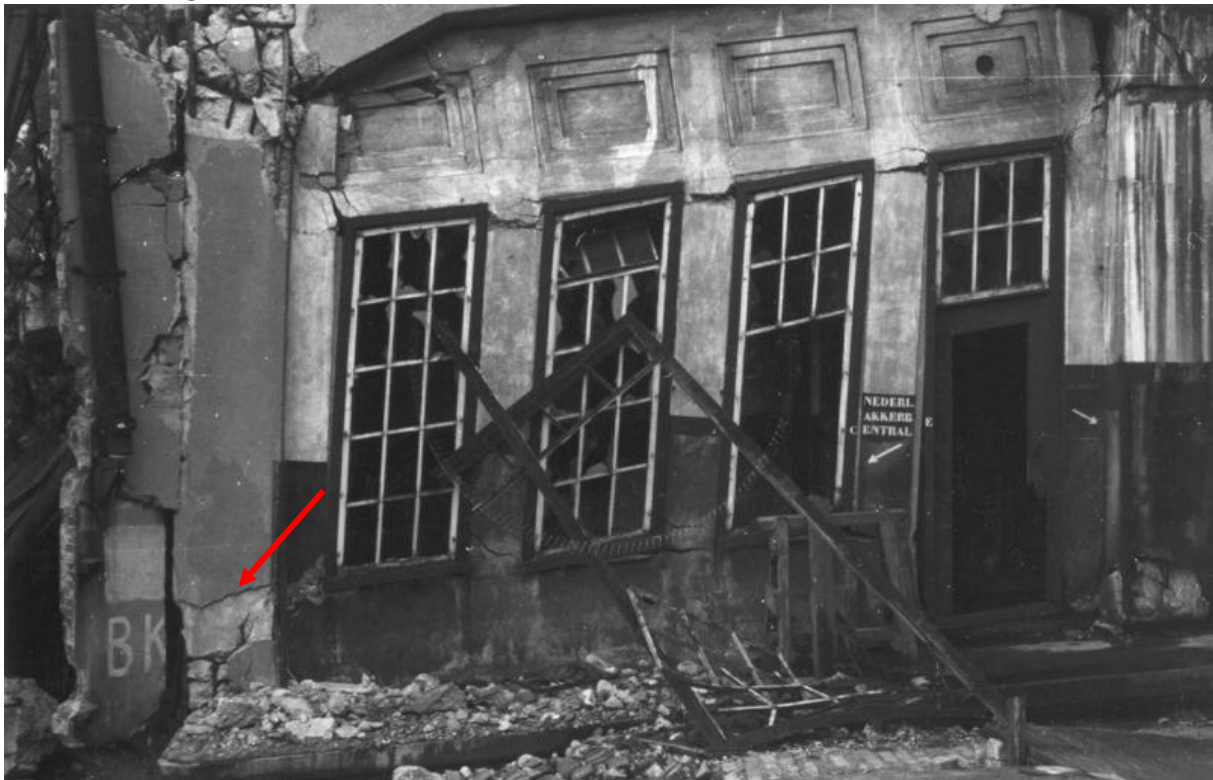
Figure 18. Part of the original 1920's north façade after the bombing in 1944. The red arrow points out the render applied over the exterior concrete columns. Retrieve from: <https://pt.slideshare.net/Consoslide/fenixlofts-presentatie-201113/3?smtNoRedir=1>

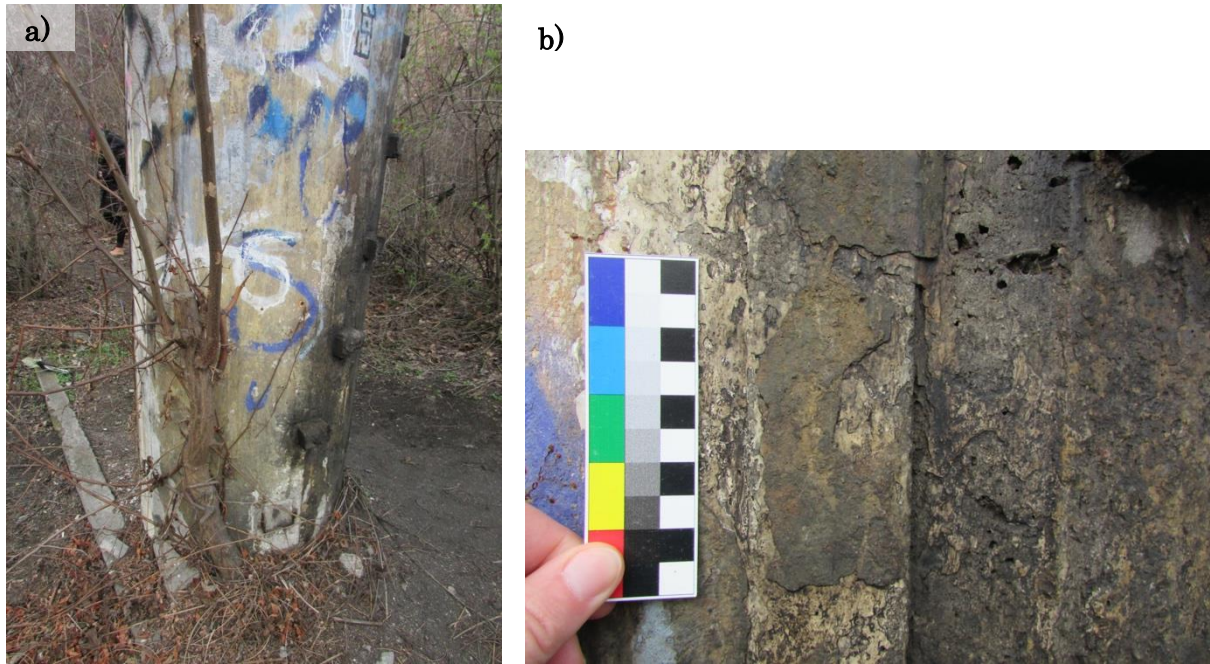
The pillar of the diving tower is the only element that does not show signs of structural damage, though higher plants with roots adjacent to the pillar might grow, affecting its stability (Figure 6.a). Apart from the almost complete loss of the original surface coats that once covered the pillar, the most common deterioration patterns registered on the pillar are surface discoloration due to soiling and graffiti (Figure 6.a,b).

Figure 6. Detail of the pillar at the ground level: a) Graffiti and higher plant growing adjacent to the pillar, b) Reminiscences of finishing coats (blistering) and soiling.

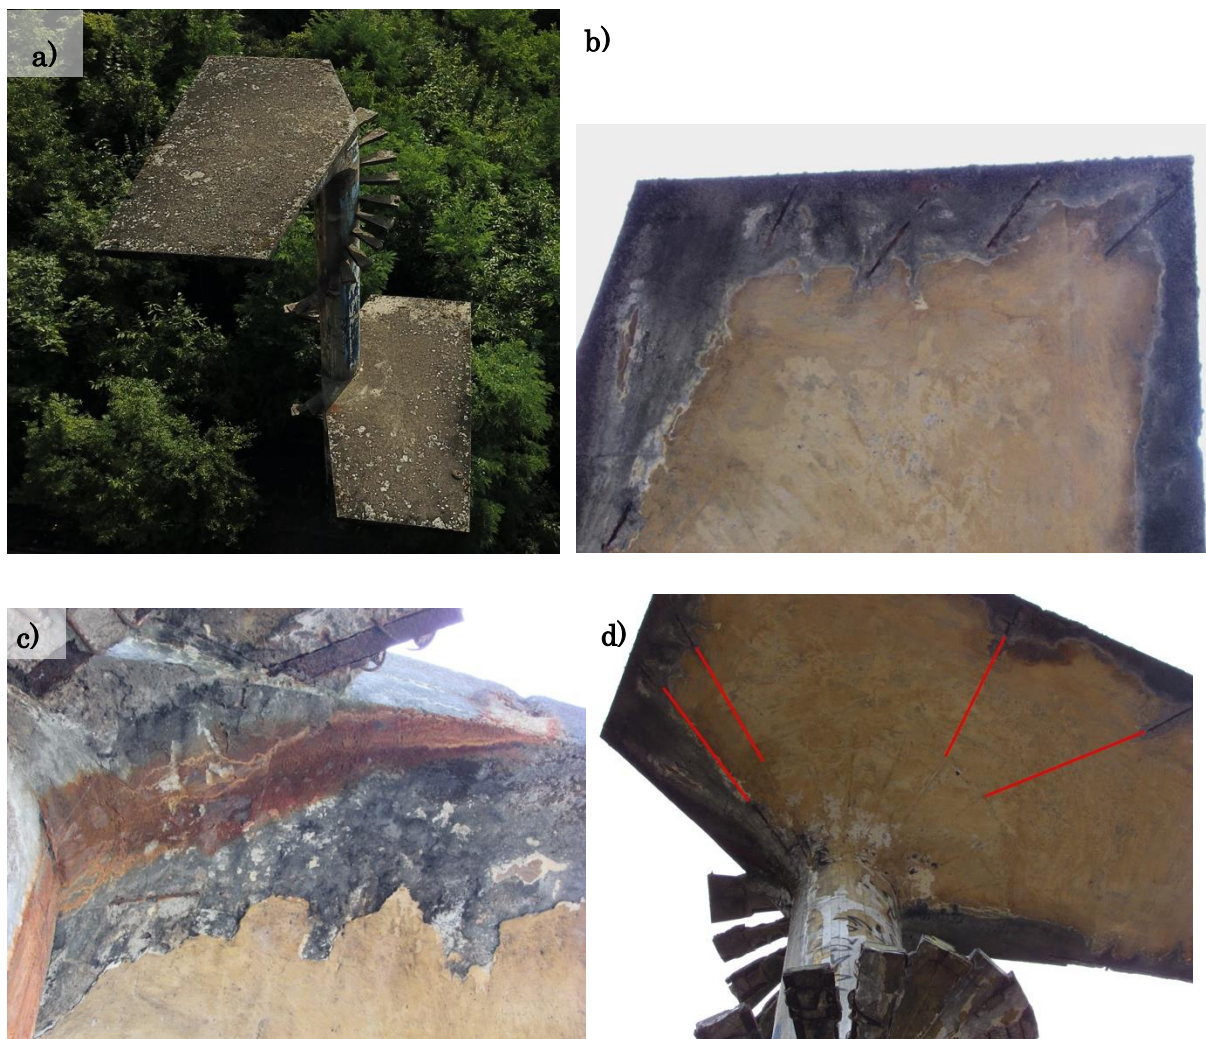
The diving platforms show biological colonization on the top of the concrete cover (e.g., lichens, cyanobacteria, mosses) (Figure 8.a) and corrosion of the reinforcement mostly visible underneath the platforms (Figure 8.b, d), enabling the visualization of its radial structure (Figure 8.c).

Figure 8. Aspects of the platforms: a) Top view of the platforms showing biological colonization, b) Detail of the corrosion of the reinforcement in the highest platform, c) Detail of the staining resulting from the corrosion of the reinforcement in the lower platform, d) Bottom view of the highest platform with the indication of the structure of the reinforcement (red lines).

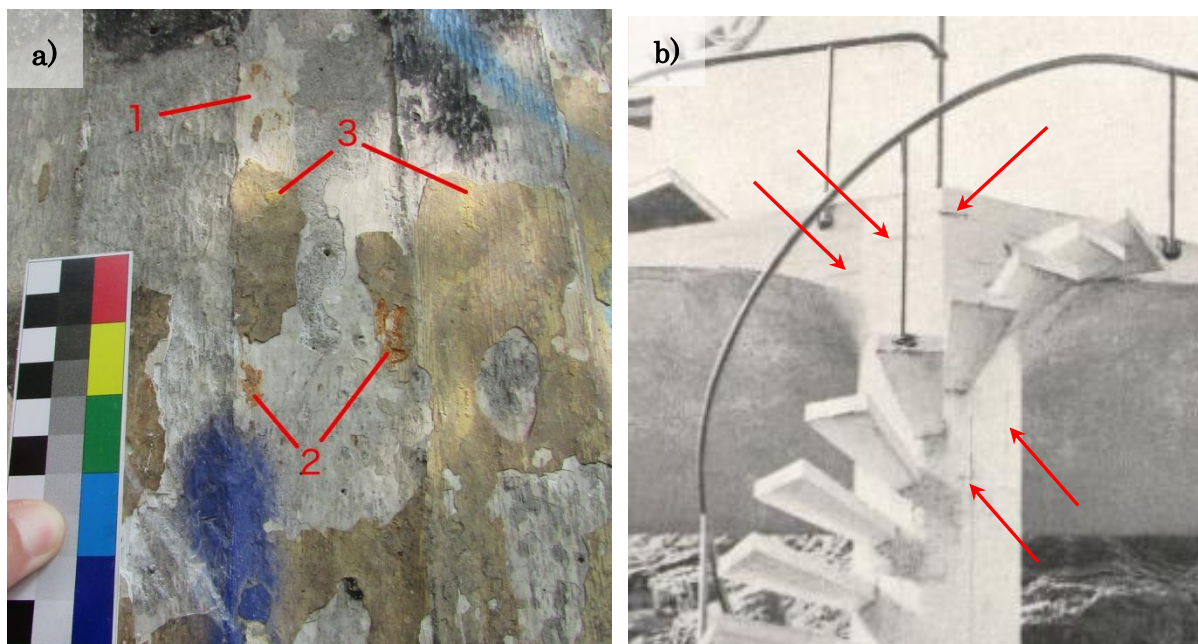
Figure 12. Finishing coats: a) Aspects of the finishing coats on the pillar at the ground level where three layers can be detected (marked in red in a sequence of application), b) Detail of a photo from 1932 where it is possible to see the traces of the texture remaining from the cast-in-place coated constructive system [9].

The characterization of the finishing coat system should be assessed by analysing its stratigraphy, microstructure, and chemical-mineralogical composition using microscopic methods (LM, SEM-EDS, and Raman microscopy) and FTIR. However, sampling of the entire cross-section of the coats might prove complicated. The collection of samples by scratching can be an option. Still, there is a risk of contamination between the different layers, complicating the assessment of the original composition of the already degraded coats. Hence, a larger number of samples should be collected with this sampling method to enable a reliable statistical analysis. In addition, onsite analysis with a portable X-ray fluorescence device could help analyse the composition of the finishing coats.

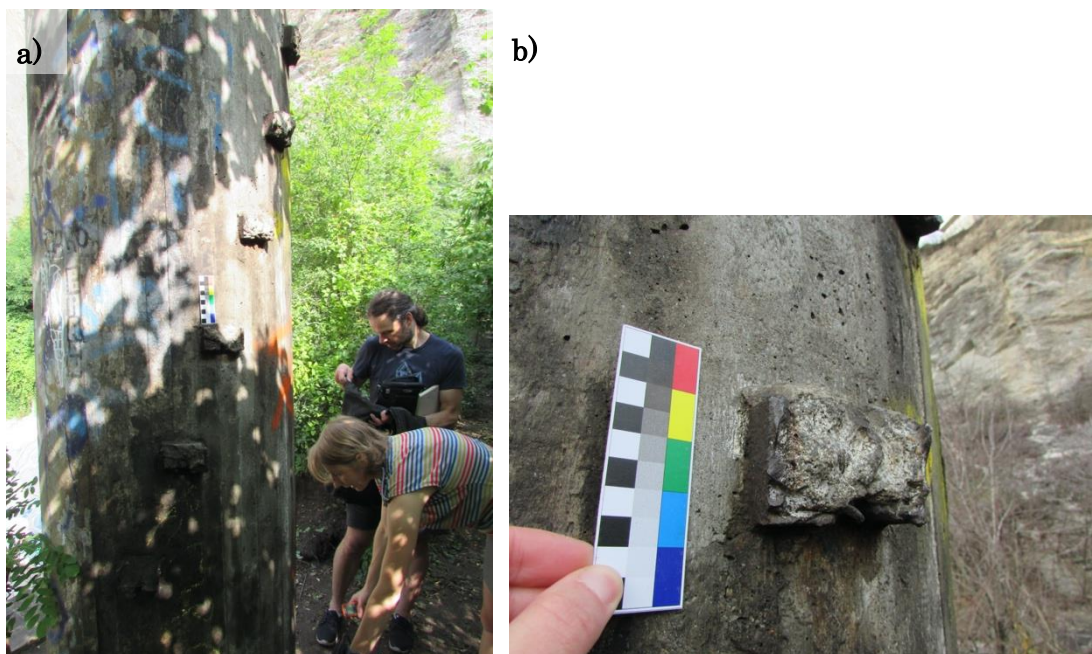
Figure 13. Step "openings" that remained after the removal of the steps for safety reasons: a) View of the pillar at the ground level showing the step "openings," b) Detail of a step "opening."

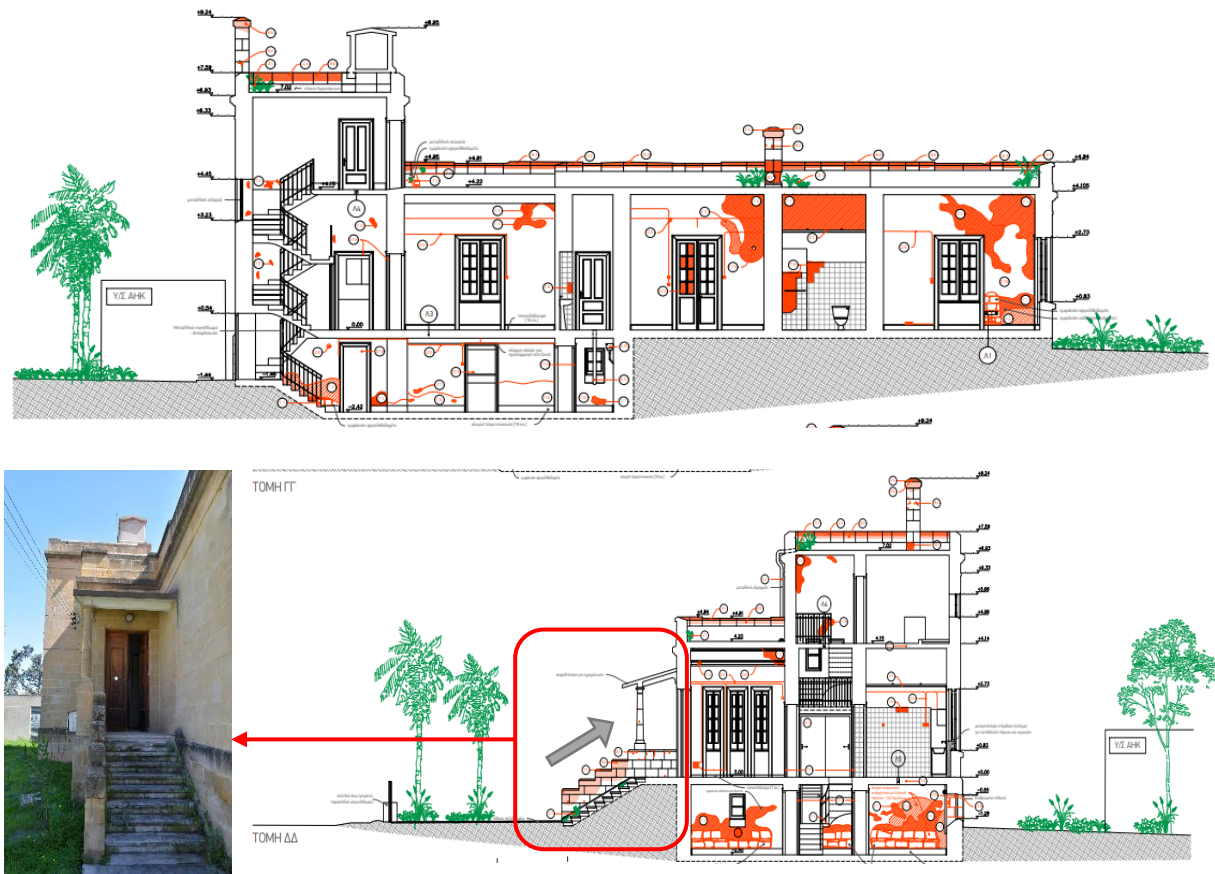
Figure 25. Recorded damages of the Melkonian Residence (2020).

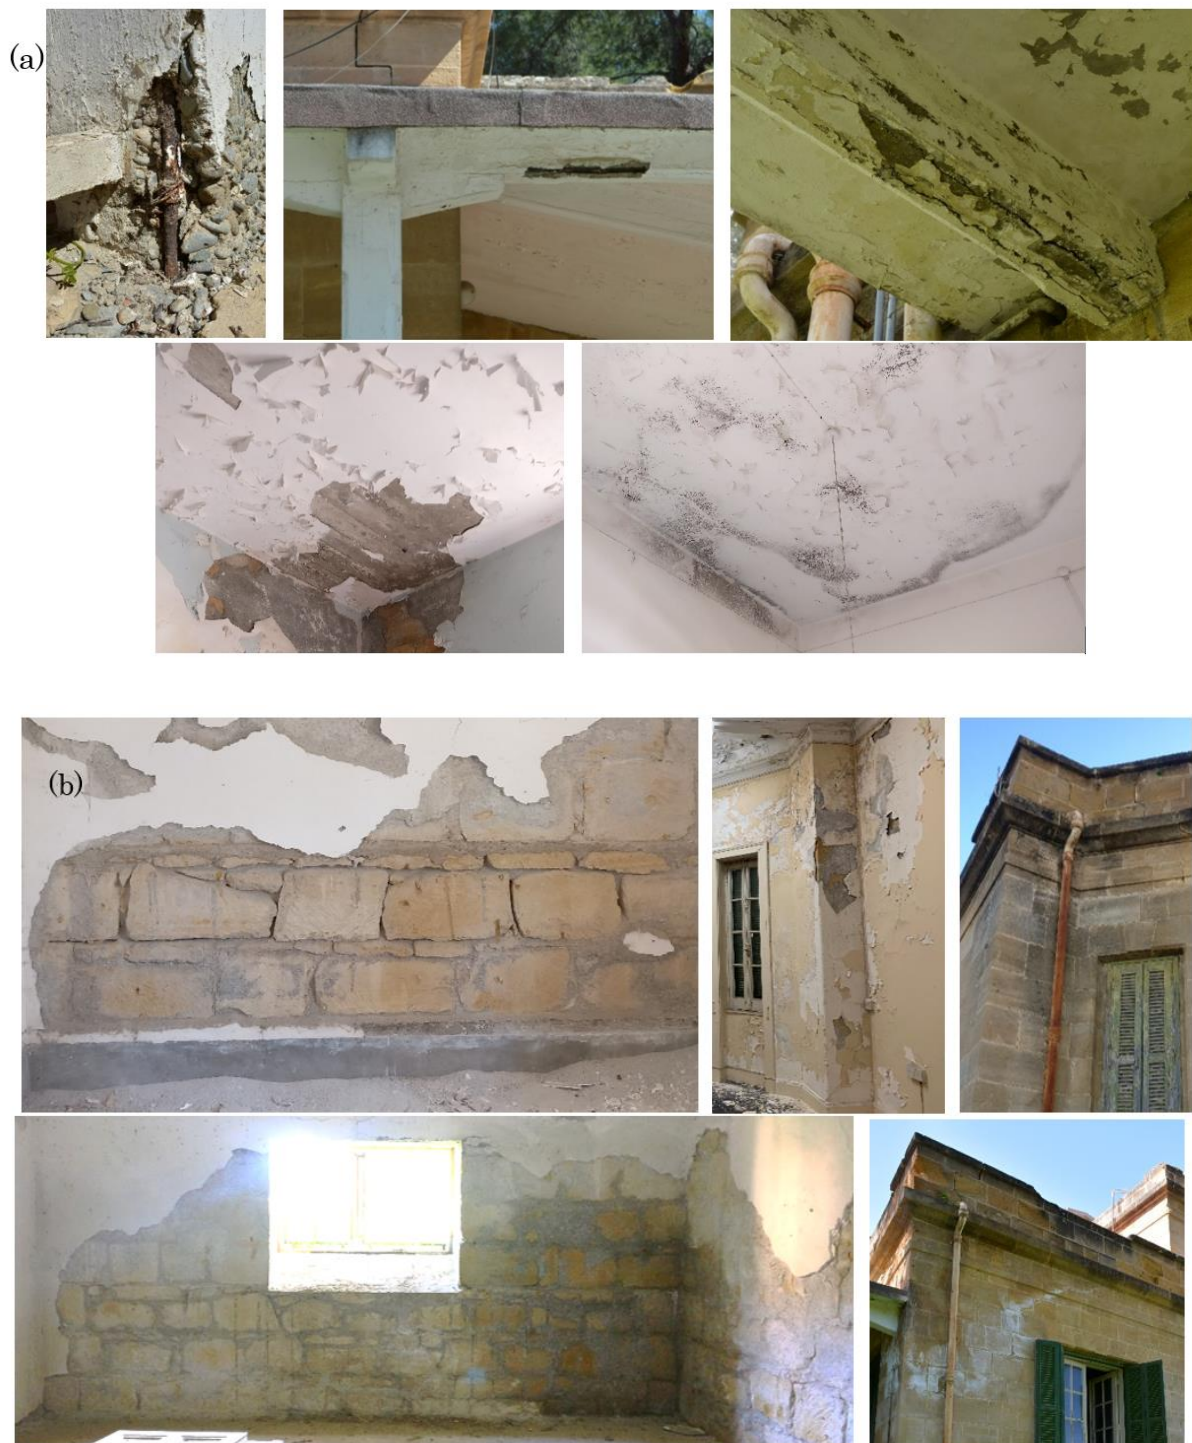
Figure 26. (a) Damage in the reinforced concrete members and (b) Damage of the masonry members.

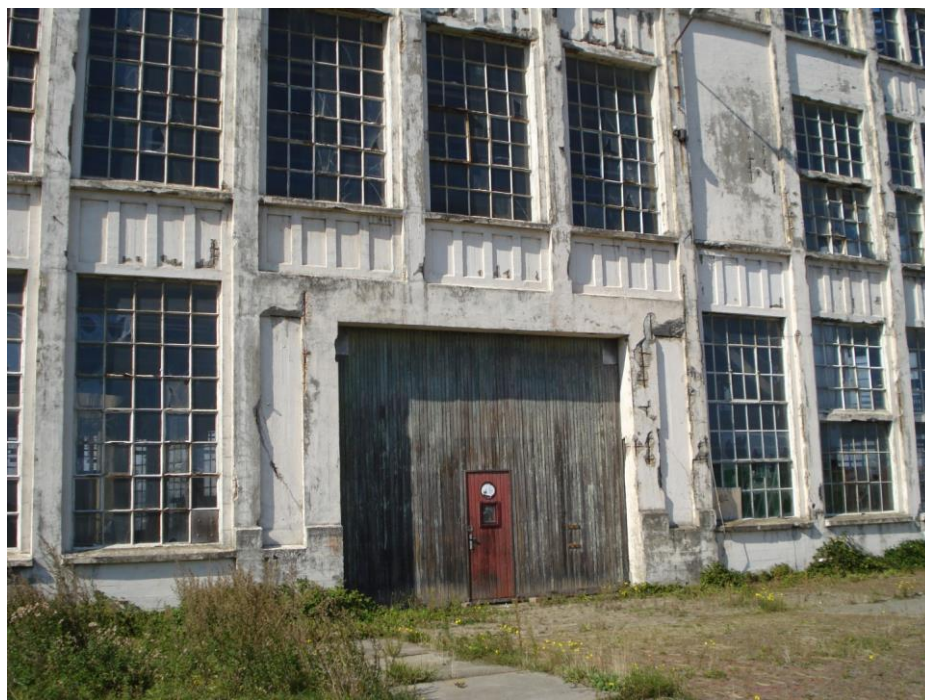
Figure 59. Condition of the building in 2010. Source: TNO.

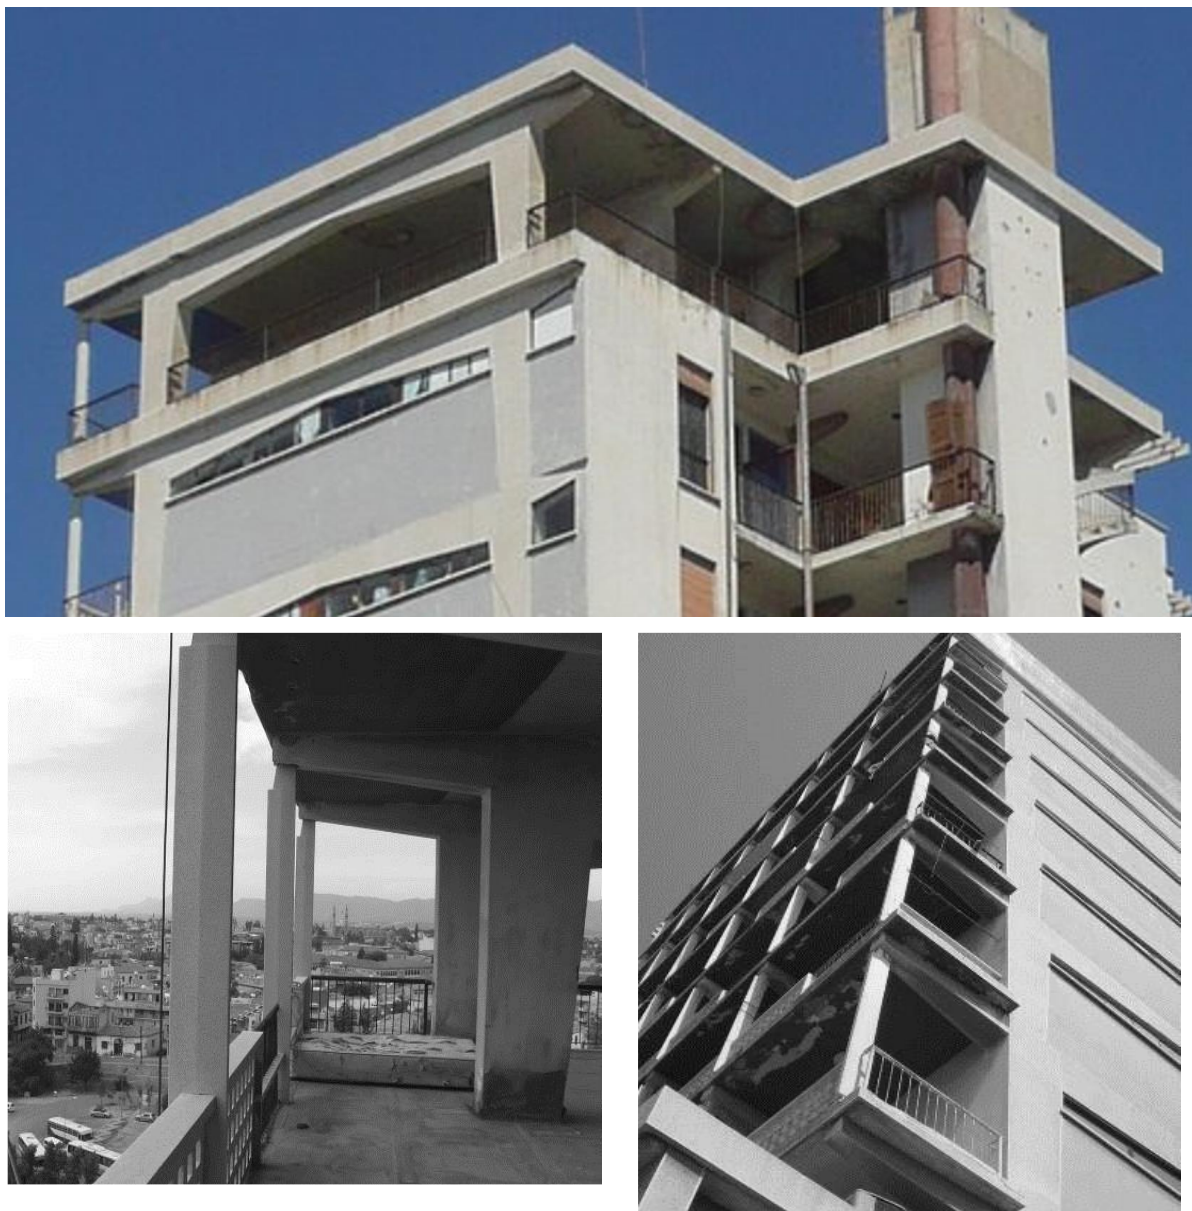
Figure 78. Defects identified prior to the retrofit works

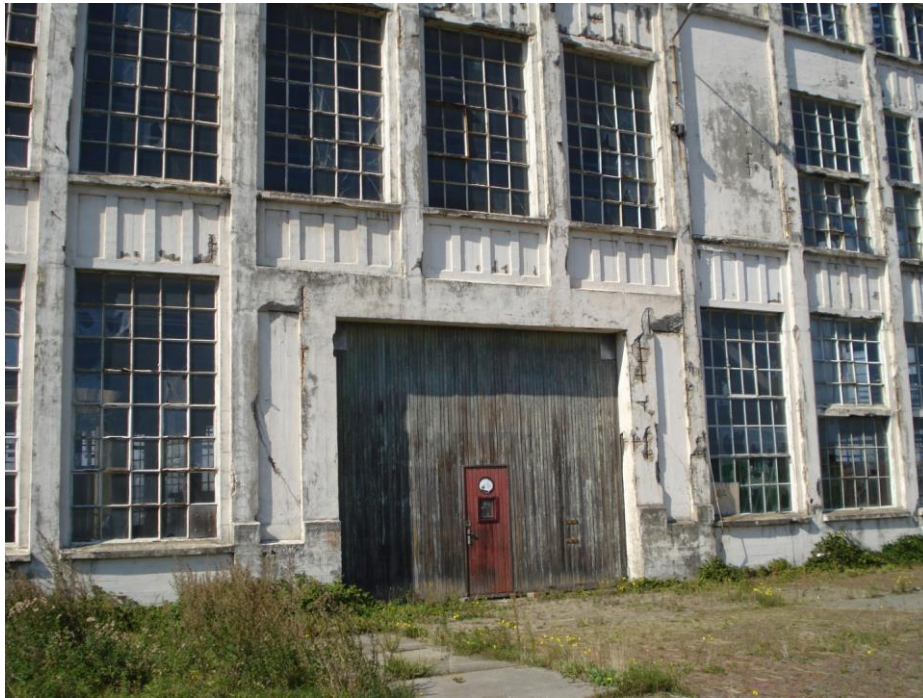
Figure 59. Condition of the building in 2010. Source: TNO.

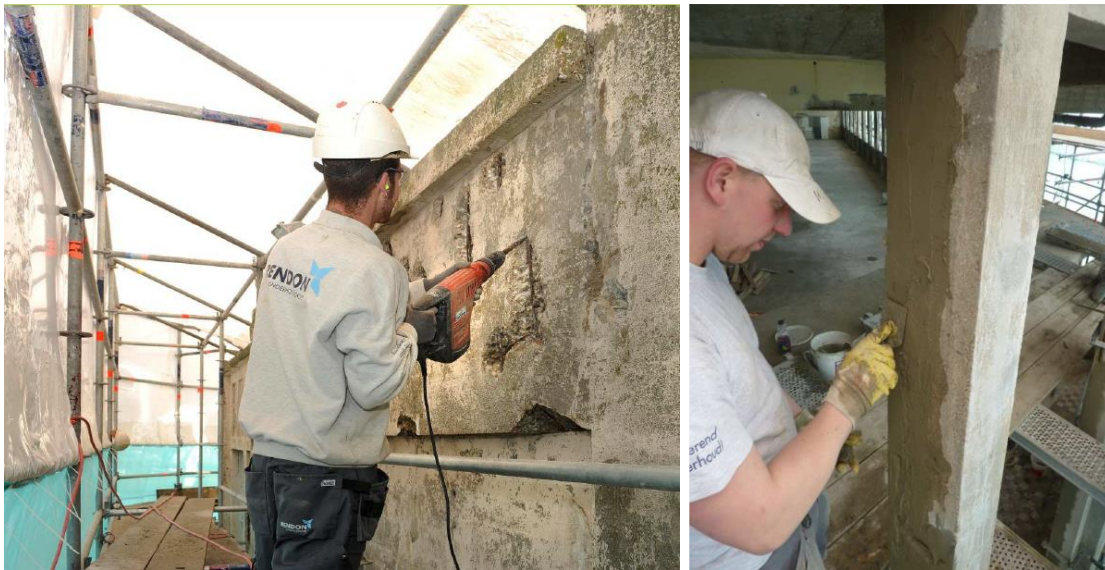
Figure 62. Repair works in 2010. Removing loose concrete (left) and applying mortar repair (right). Source: Bouwgroep Peters B.V.

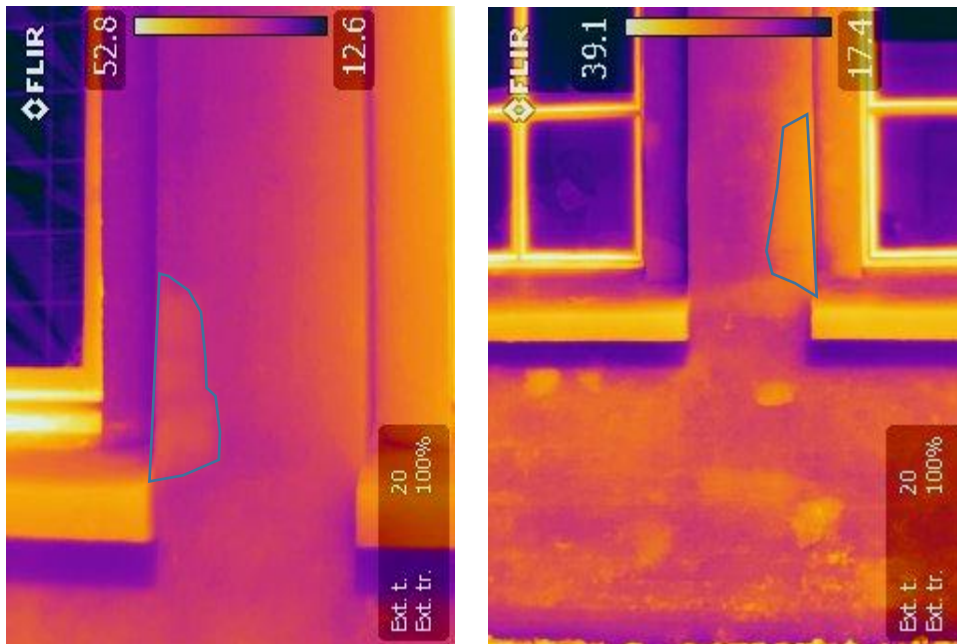
Figure 67. Thermal pictures of hollow-sound patch repairs showing thermal differences. The contour of the patches performed in 2010 are drawn.

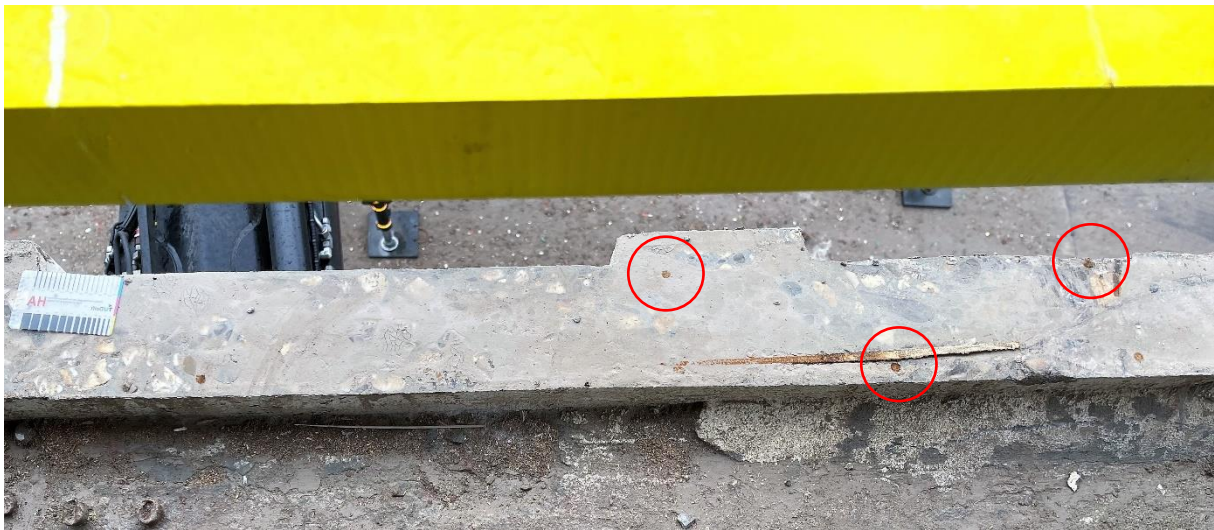
Figure 68. Location of vertical reinforcement in existing exterior walls (circled). Note the difference of concrete cover between the most left rebar and the most right rebar.

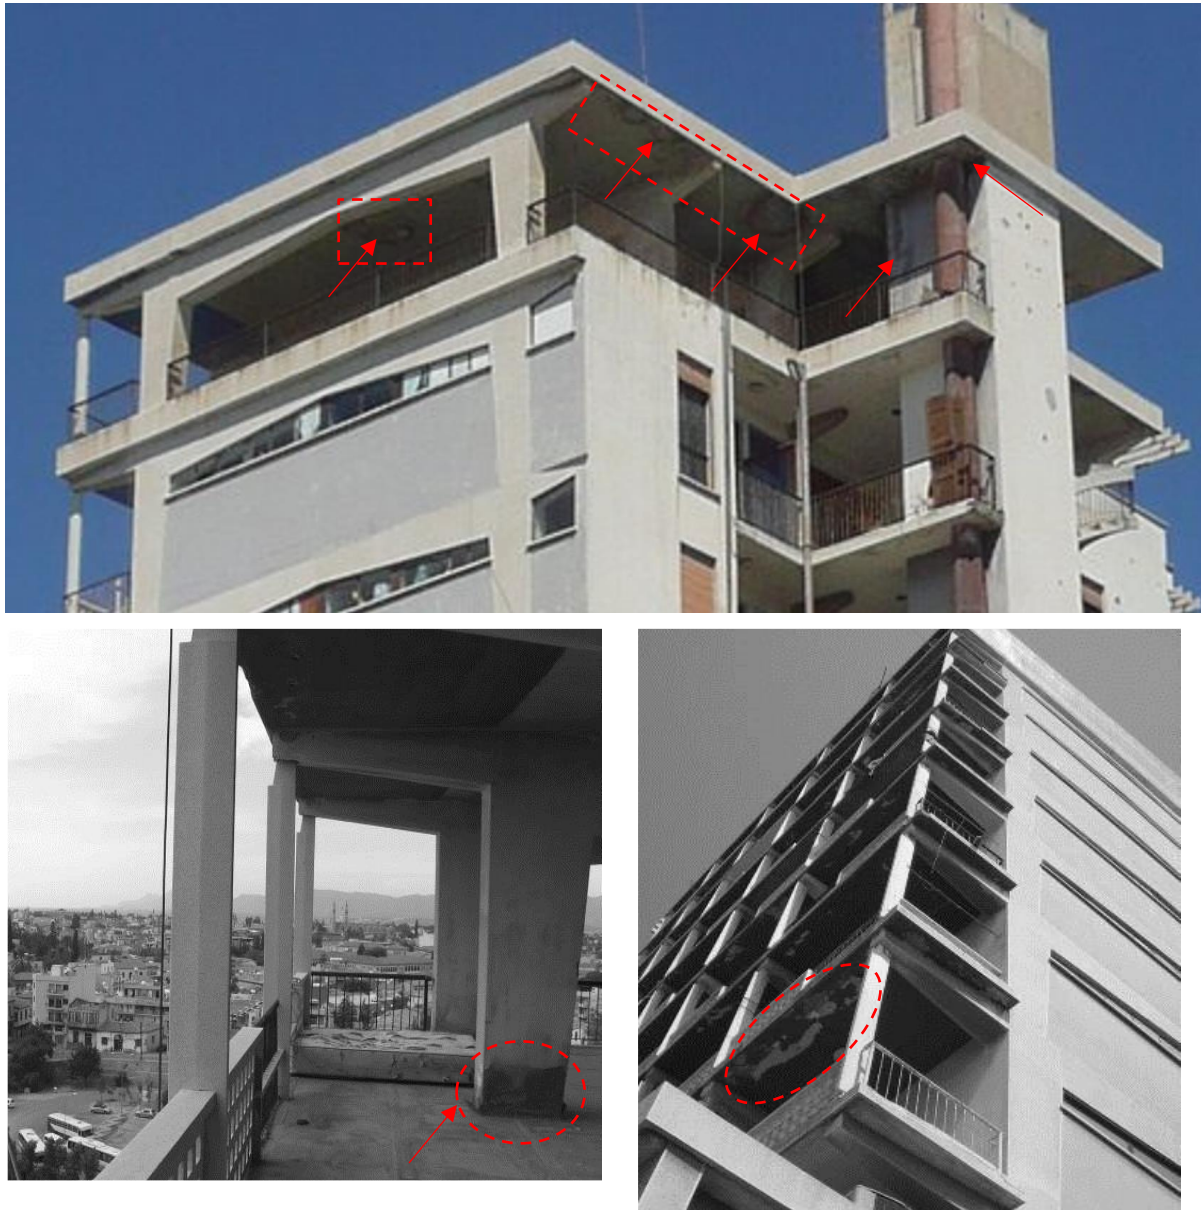
Figure 78. Defects identified prior to the retrofit works
