Report on Conservation Proposals

Project: CONSECH 20

Working Package 4 – Task (iii)

Date: 30 June, 2022

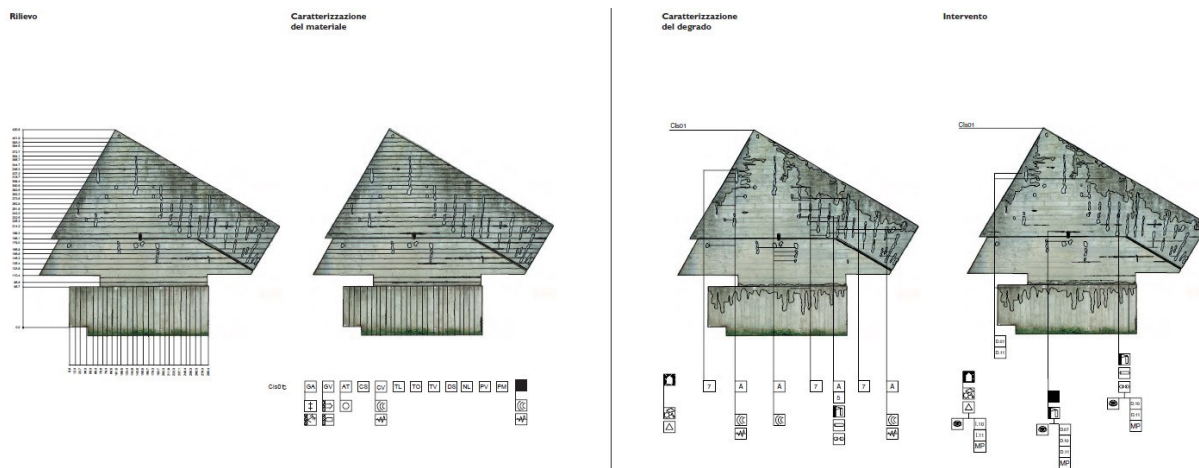
Figure A.3-2. Map of external surfaces: Surveying, material characterization, decay characterization and intervention. Tomba Brion, Altivole, Treviso.

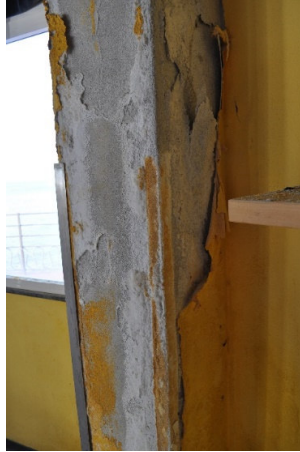
Figure A.3-4. Salt efflorescence on the surface of a reinforced concrete structure. Ex hotel Marinella, Genova.

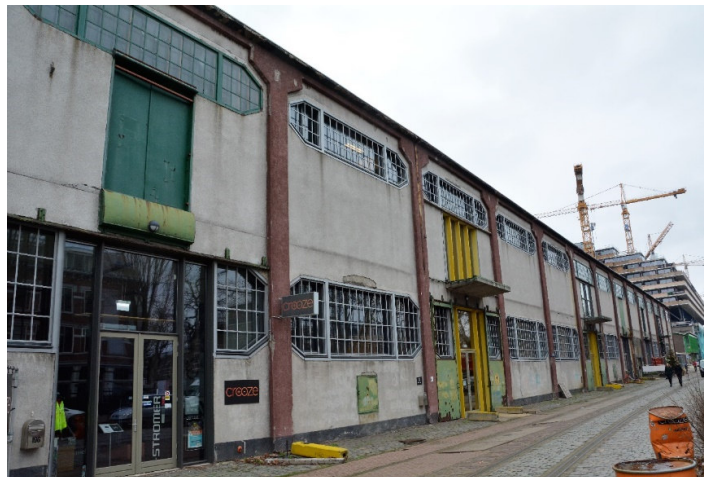
Figure B.1-1. View of the south wall of the Fenix II (2019)

The focus of the intervention plan is the south façade. The rest of the structure does not show relevant damages. For details of the damage and its causes refer to the in-depth report prepared in WP2 [2].

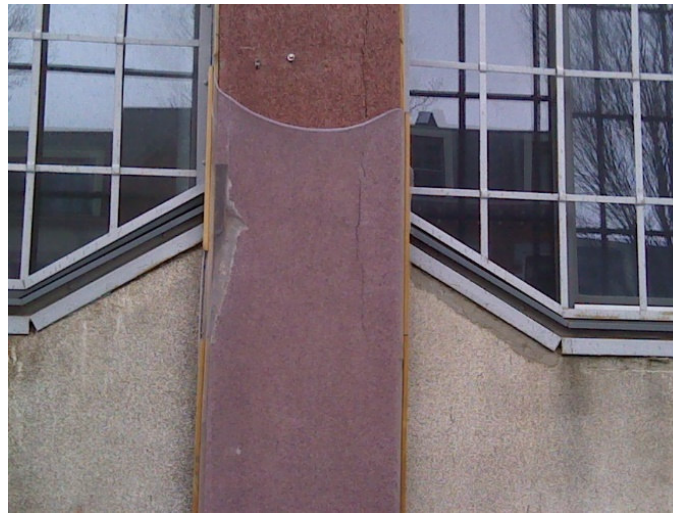
The south façade is affected by heavy corrosion damage caused by carbonation. The existing render applied in the 1980s is cracked and spalled, as well as the original concrete cover. The cause of the corrosion seems related to the fact that the carbonated concrete was not properly removed when applying the render. This is confirmed with the carbonation tests carried out on these columns (Fig.

B.1-2). Consequently, the corrosion has proceeded, likely due to the high relative humidity due to the rainy weather in the Netherland and the close proximity of the building to the waterfront. In addition, the early cracks in the render eased moisture ingress into the concrete. The low permeability of the render may have further caused a barrier effect to drying, thus trapping moisture in the concrete surrounding the reinforcement. This effect has likely increased the corrosion rate of the reinforcement.

Figure B.1-2. Close up picture of the south facade columns in the Fenix II.

Based on the above reported considerations, as the 1980s render must be removed in any of the scenarios, the most feasible option is to use concrete recasting. For recasting, the following procedure is recommended:

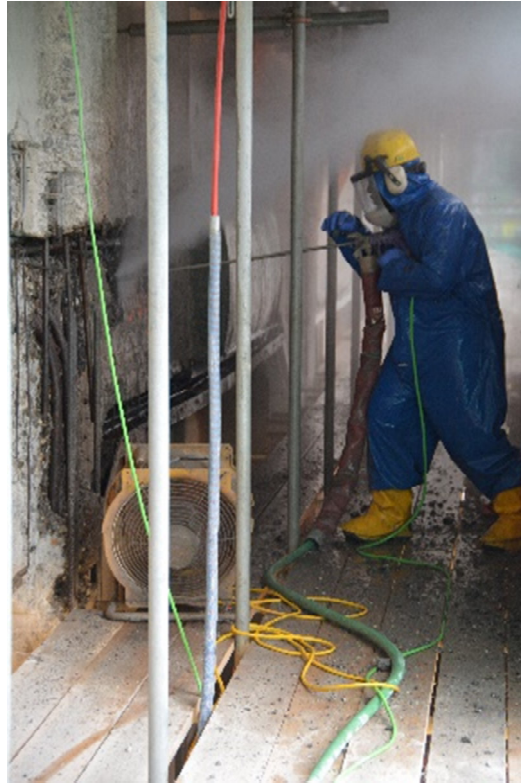
Figure B.1-3. Jet blasting to remove carbonated concrete in the Fenix II.

- The existing plaster and the contaminated concrete must first be removed, as recommended per CUR Recommendations 53 “Sprayed Concrete” and CUR 54 “Concrete repair with polymer-modified repair mortars”. This can be done with pressured water-jets (Fig. B.1-3).

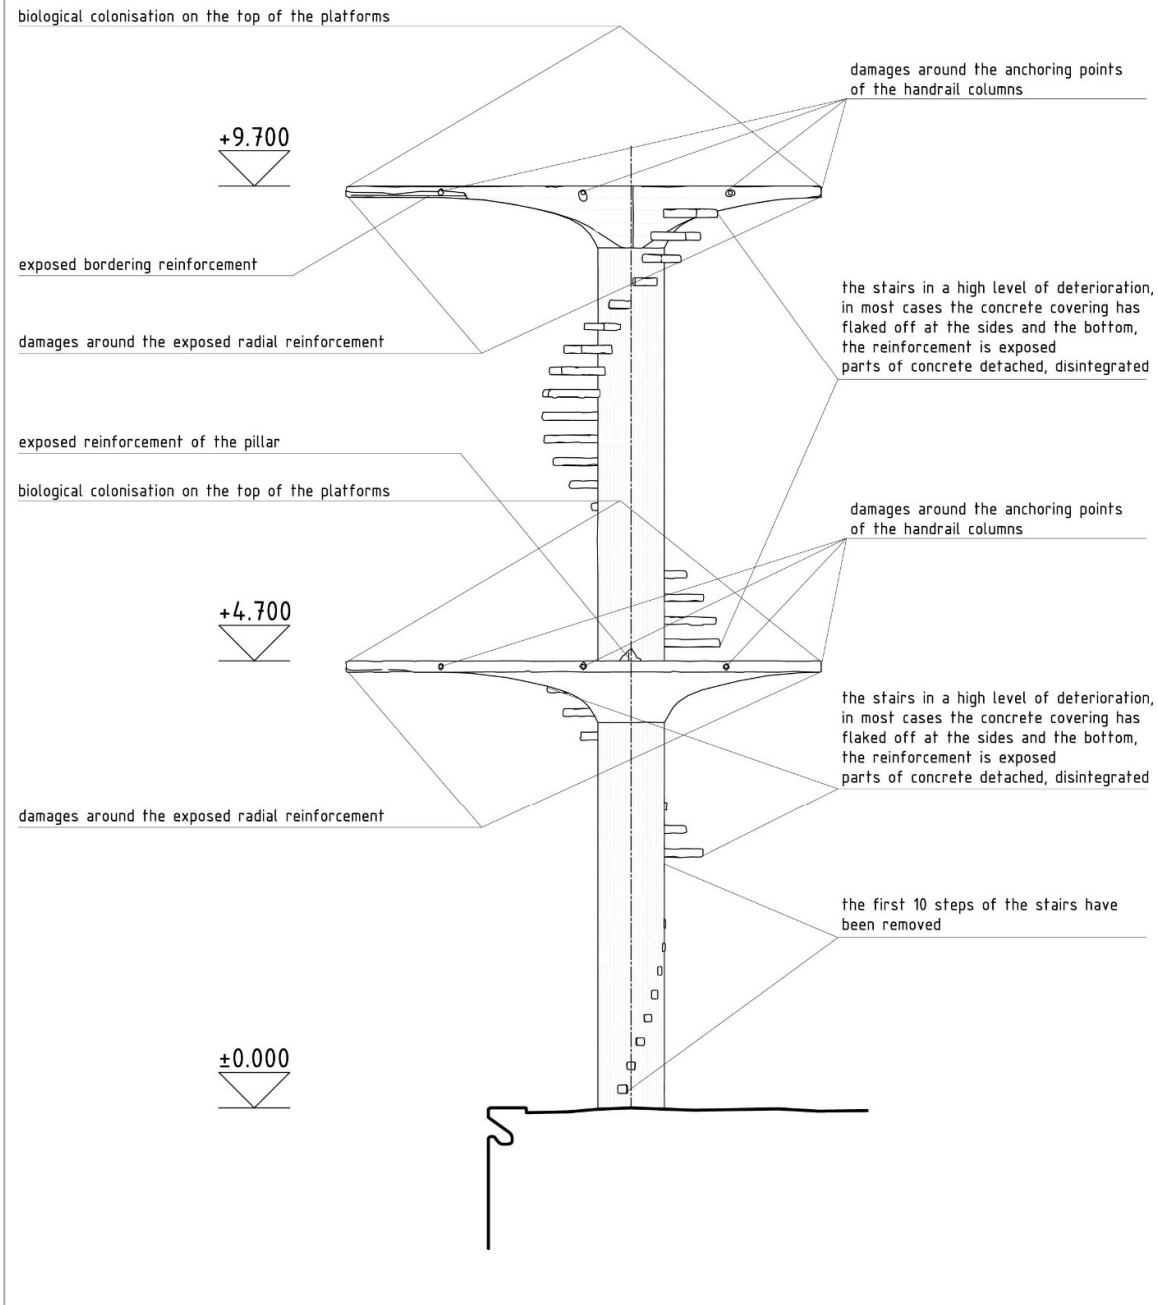
Figure B.2-16. South elevation with the indication of the most important damages.

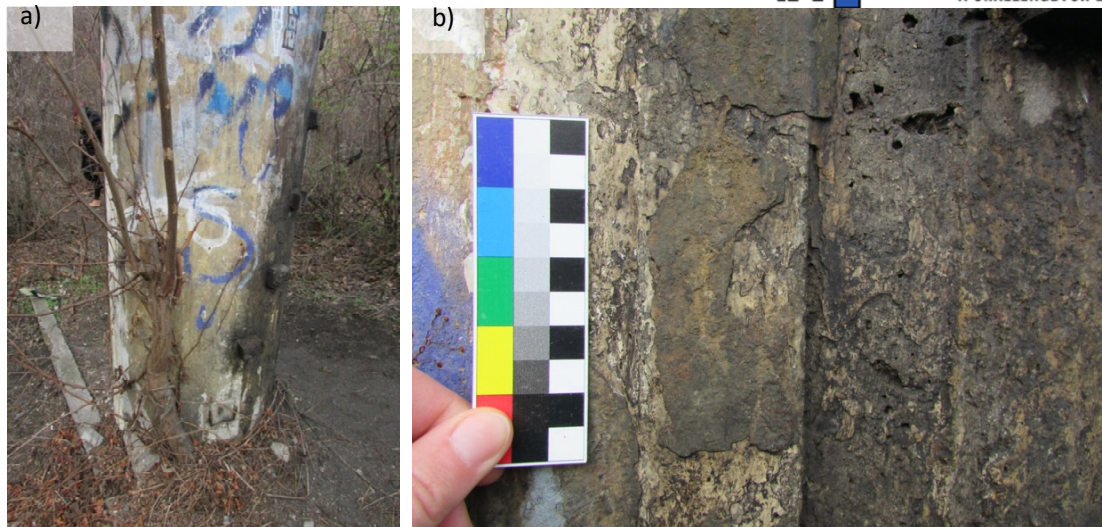
Figure B.2-17. Detail of the pillar at the ground level: a) Graffiti and higher plant growing adjacent to the pillar, b) Reminiscences of finishing coats (blistering) and soiling.

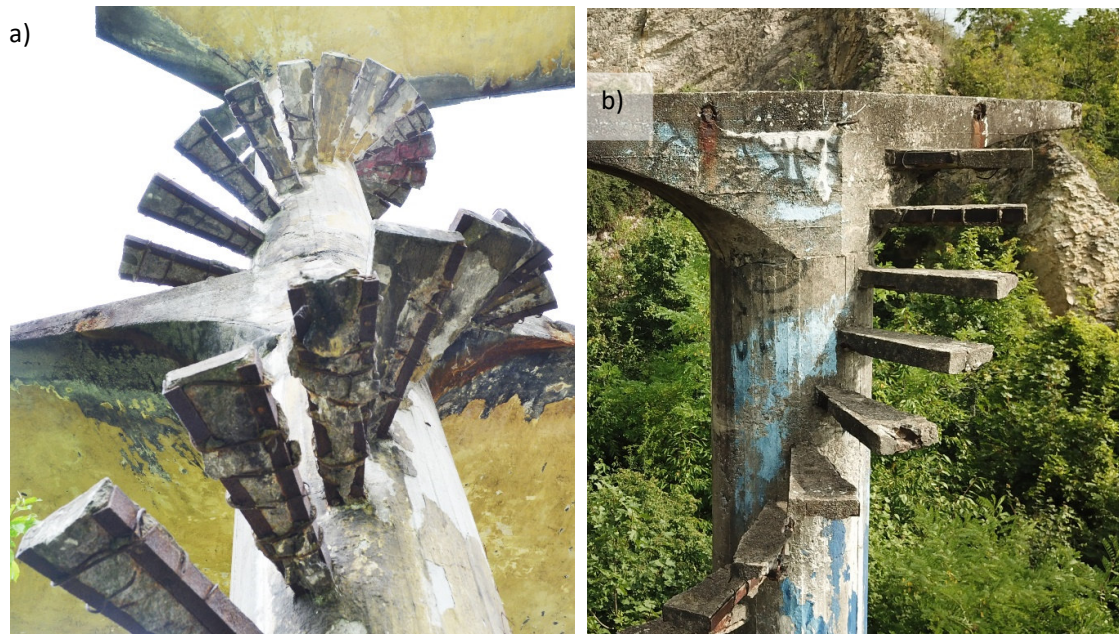
Figure B.2-18. Details of the stair steps: a) View below the steps to the lower platform, b) Top view of the steps to the highest platform.

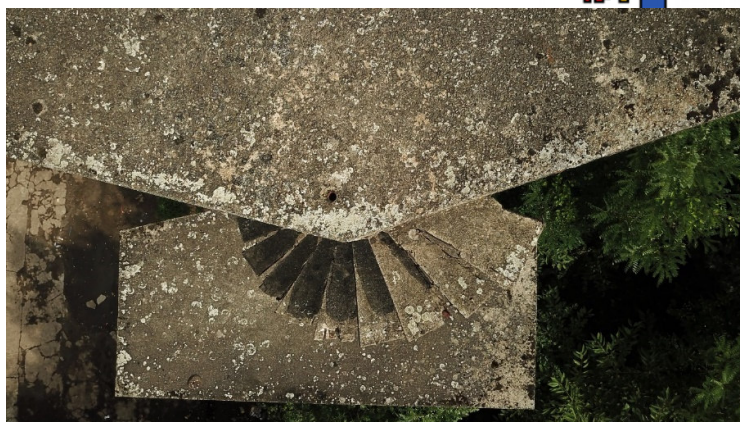
Figure B.2-19. Top view of the platforms showing biological colonization.

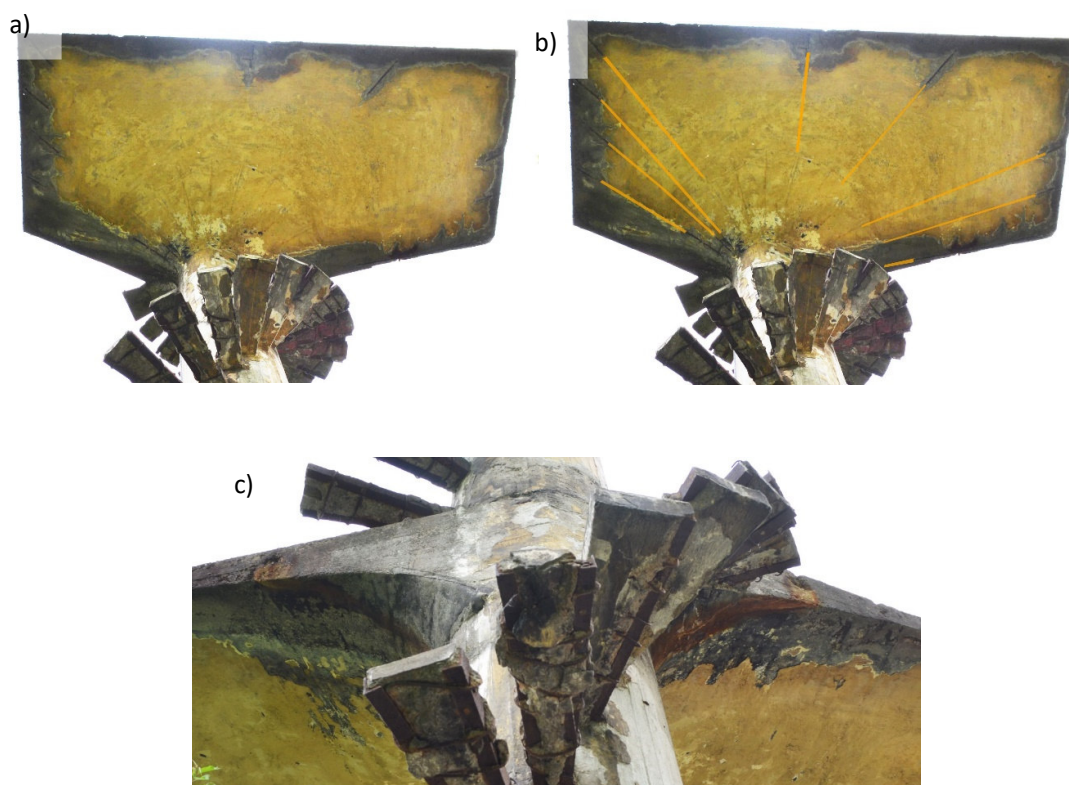
Figure B.2-20. View of the platforms: a) Bottom view of the highest platform showing corrosion of the reinforcement; b) Indication of the layout of the reinforcement in the highest platform (orange lines); c) Detail of the staining resulting from the corrosion of the exposed anchoring points of the removed handrail on the lower platform (both on the right and left side of the pillar).

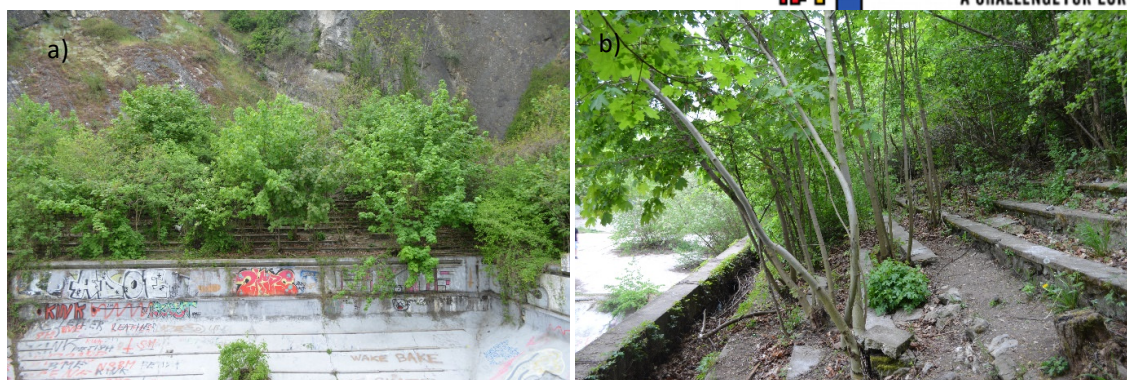
Figure B.2-24. Aspect of the current state of the tribunes of the swimming stadium: a) General view from the diving tower; b) Detail of higher plants growing in the tribunes. Photos taken on 29.4.2020.
