Newsletter no. 2

CONSErvation of 20th century concrete

Cultural **Heritage** in urban changing environments

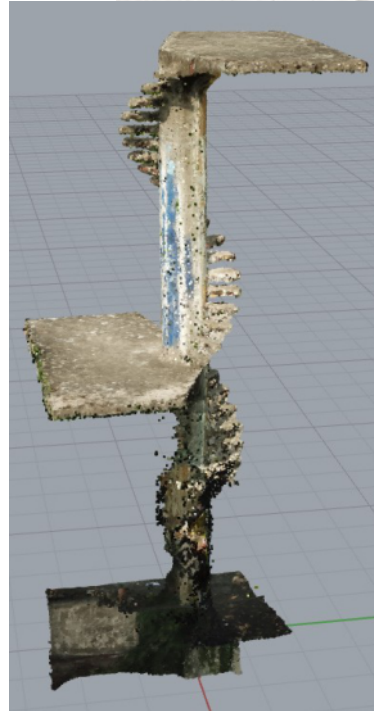
Point cloud 3D image of the Barrandov diving tower.

The lack of drawing documentation of the Barrandov tower asked for a new survey. Close-range photogrammetry was chosen to overcome accessibility limitations. A drone was used to shoot over 600 photos to document the state of the inaccessible parts of the structure and used for constructing the photogrammetric 3D image.

The executive-project drawings and the photogrammetric survey were the primary sources for reconstructing the original geometry.

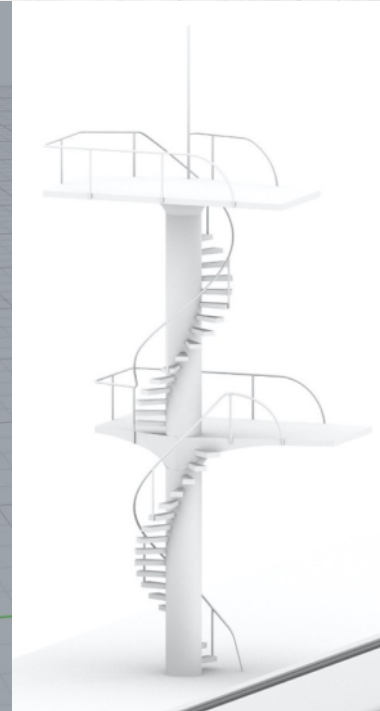
3D reconstruction of the original state of the Barrandov diving tower.

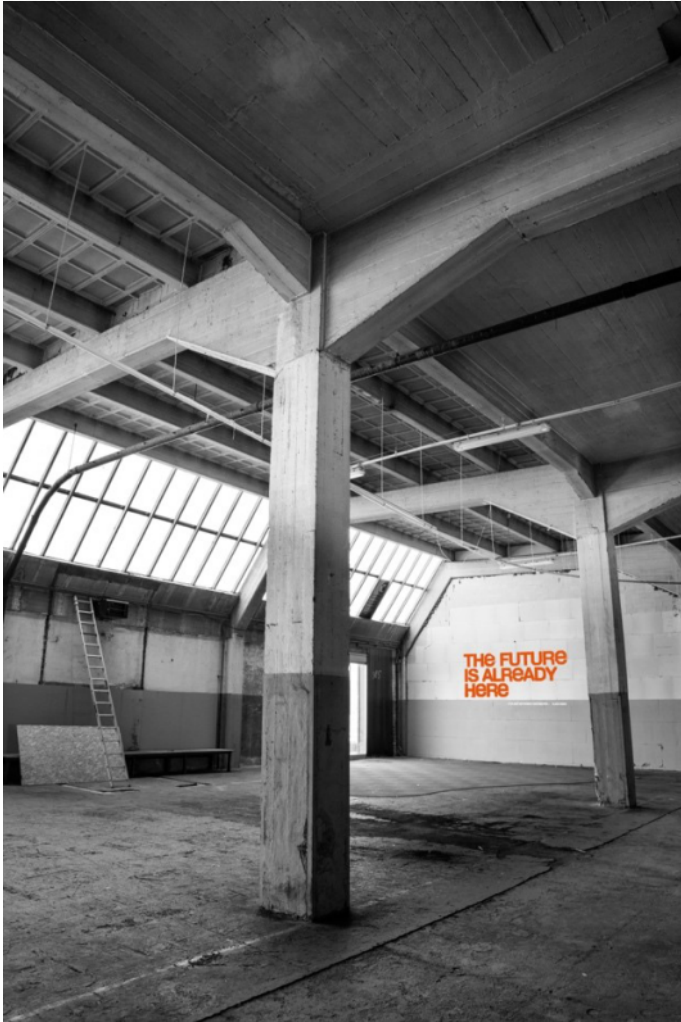
Fenix, former storage place for the North America Line, Rotterdam, The Netherlands (Photo M. Olmeda)

The columns supporting the structure showed local spalling, cracks and corrosion of the reinforcement, especially on the South side. The South façade had been furnished with a render layer in 1980 and a finishing layer of Kristal Cement Granite.

NDTs (e.g. profoscop, rebound hammer, etc.) were used in the investigation, next to powder drilling - sampling. The results showed that the cover layer of the exposed 1920's columns was originally too thin; as expected, the carbonation depth found in the old columns was higher than the depth reached in the 1950's columns. The reinforcement used in the two periods is comparable (only the spacing of the ties differs). The compressive strength values of the 1951's columns are only slightly higher than the 1920's.

Summarizing, it has been concluded that the quality of the concrete (Portland cement used) exceeded the quality standards of the times. The carbonation induced corrosion on the exposed columns is the main cause of spalling and cracks in the building. The higher carbonation depth of the external South columns is probably due to the old construction techniques (e.g. less compaction). Together with the cover layer being originally too thin, this induced the corrosion of the reinforcement, leading to damage.

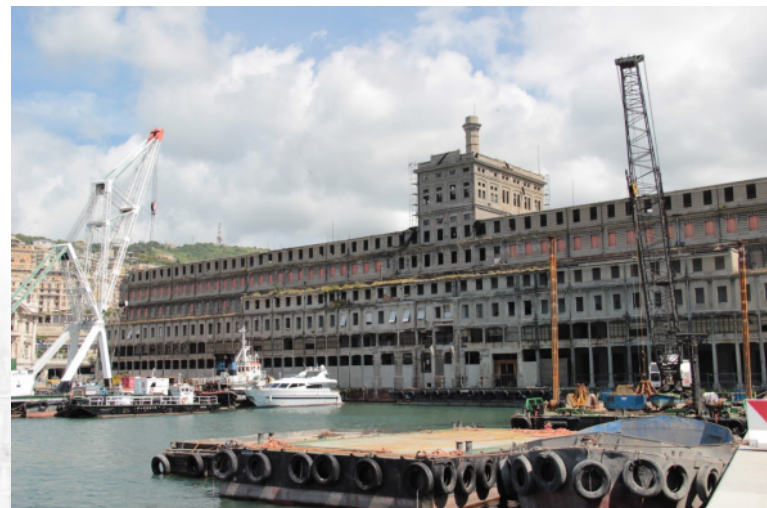
Hennebique grain silos in Genoa, Italy (Foto: L. Pedrazzi, 2018)

Operational until the end of the 20th century, the building is now in a state of neglect, even if structurally it does not show any significant signs of fragility. The deterioration of concrete structures can be attributed to two factors: intrinsic

characteristics of the material and environmental conditions. At that time construction techniques in reinforced concrete were still underdeveloped; the mixture used contains round and large aggregates that give the material physical characteristics that favour degradation phenomena.

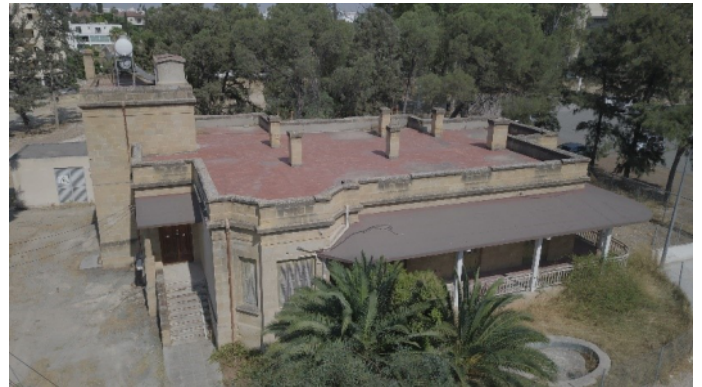
Melkonian Educational Institute - Headmaster's Mansion, Nicosia, Cyprus

The overall state of the three buildings, including the Headmaster's Mansion, is rather good, despite the fact that these have been abandoned since 2005. In general, in the Mansion there are no visible cracks on the reinforced concrete elements from either service or seismic loads. The pathology of the building was recorded during several site visits, while for its seismic assessment, the following procedure was adopted:

The analysis performed showed that the reinforced concrete elements are not properly detailed, as they lack stirrup detailing. This may potentially lead to shear brittle failures in a future seismic event. They therefore need careful retrofitting and strengthening to withstand future seismic actions, while maintaining the original fabric, dimensions, detailing and materials, and serving their loadbearing function according to the original proprietary design.

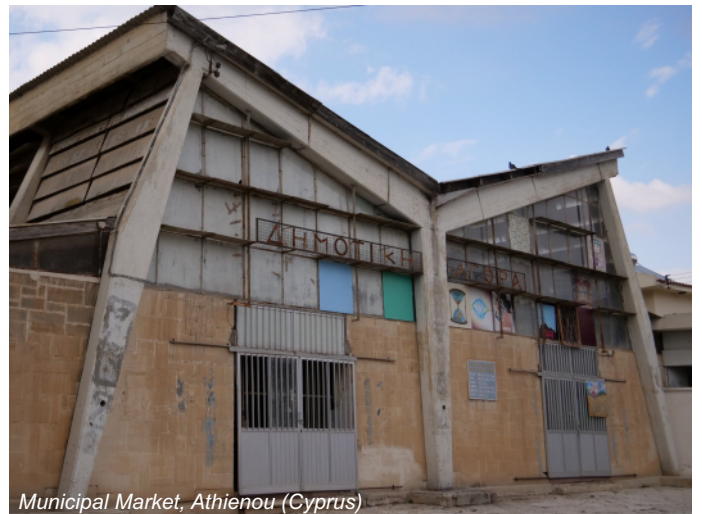
Municipal Market, Athienou (Cyprus)

century are rarely listed as monuments, despite reflecting the past and usually displaying a multitude of values. The main problem with historic concrete structures is their lack of seismic detailing and design, which renders them dangerous for public use, and prone to collapse and permanent loss, especially in countries located in seismic zones. This paper examines one of the culturally significant historic concrete structures of Cyprus, the Pedieos Post Office, located in Nicosia. The building is not currently listed; yet, it continues to serve the community since its construction in 1964. The paper assesses the seismic capacity of the structure by means of comparing various assessment analysis methods.
