Selection of suitable materials and techniques for the conservation of buildings in need of restoration

Project: CONSECH 20

Working Package 4 – Task (ii)

Abstract

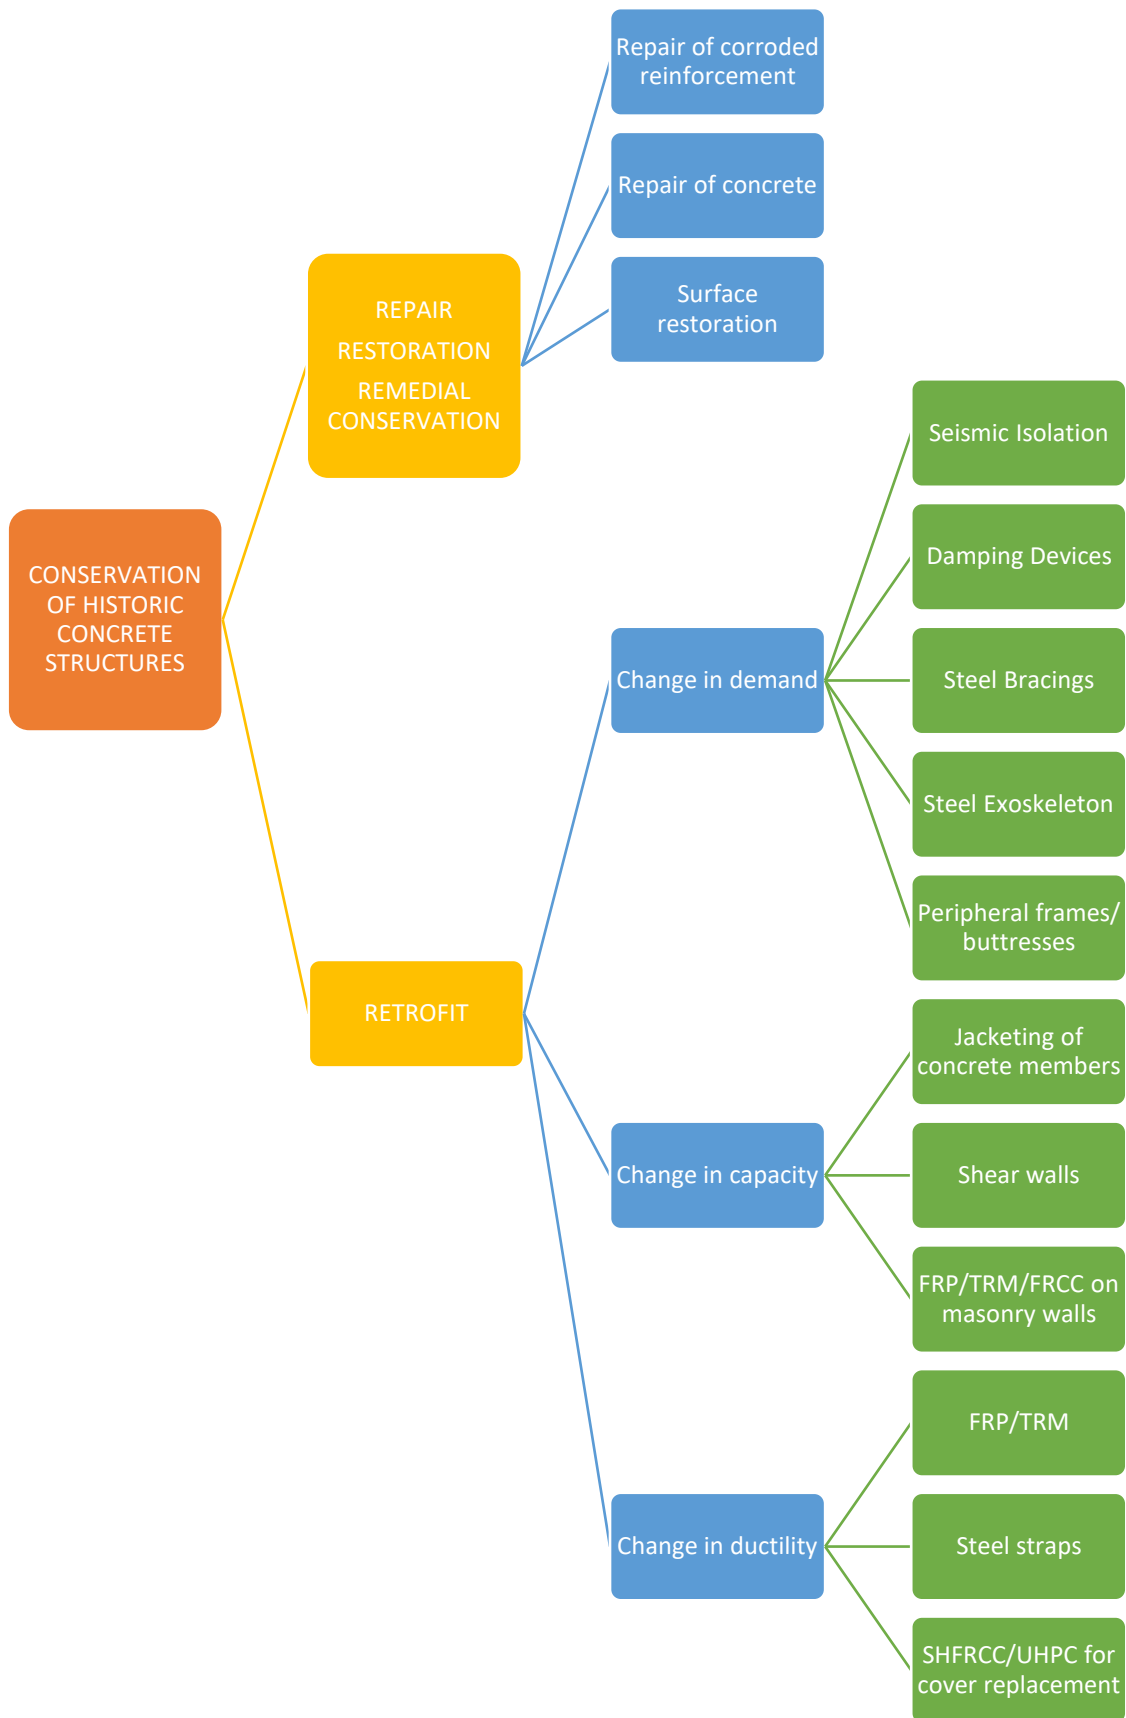
Classification of the intervention practices used for RC structures, based on the modification of frequency characteristics

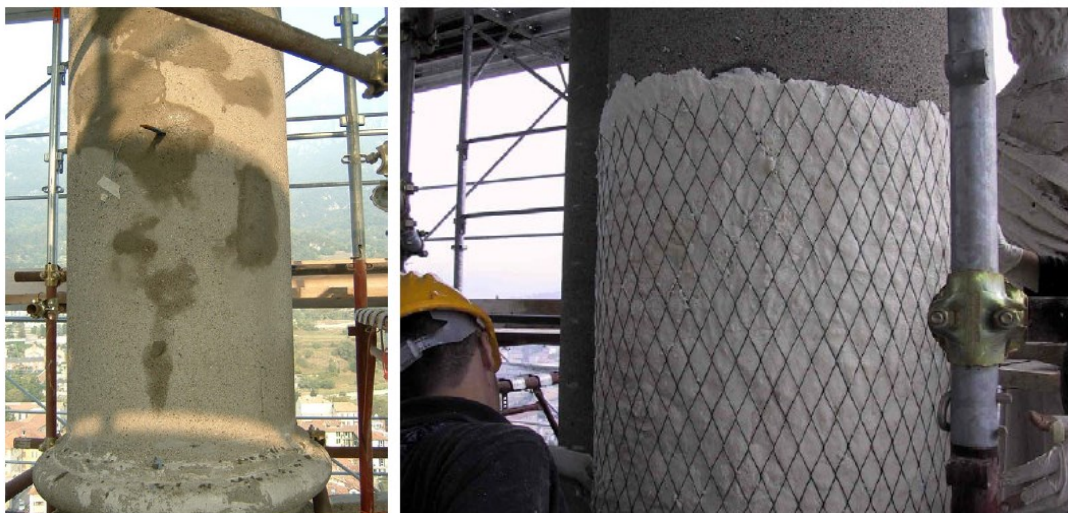
Figure A.1-1 Concrete repair and electrical connections with reinforcement and activated titanium electrode on a column (left).
Application of the anodic system on column (right) [5]

The use of preventive treatments is also crucial in order to slow the deterioration process that is taking place on structural elements. Types of such treatments may include the **application of film-forming or water-repellant materials** on the surface of the structure, or the use of electrochemical methods, such as **re-alkalization of concrete** or **cathodic protection of reinforcement** (Figure A.1-) [4].

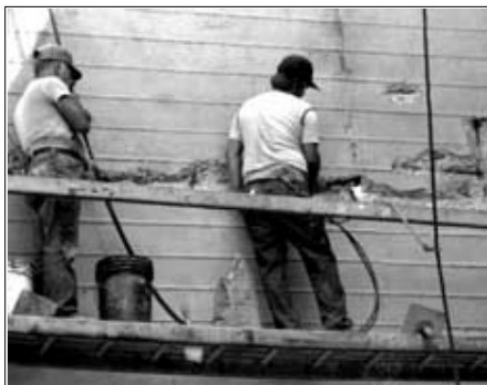
Figure A.1-2 Deteriorated or redundant reinforcing bars are removed after evaluation by a structural engineer. An acetylene torch is being used to cut out the bars. Photo: NPS files [54]

When adding new reinforcement for the **replacement of corroded rebars** (Figure A.1-), tying of the old and new reinforcement together is more preferable, rather than tack welding, since the possible difference in carbon content between the old and new materials may result to corrosion [6]. The same principle is applied to the electrical continuity in the case of installing a cathodic protection system, where mechanical forms of bonding should be preferred to welded connections [6].

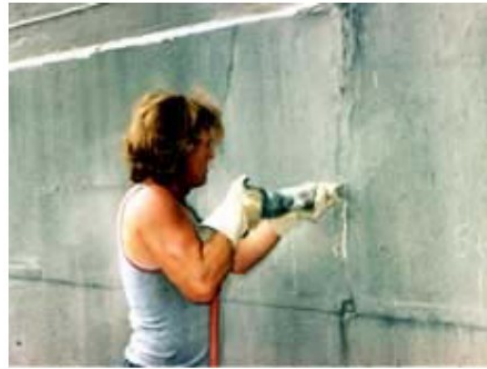
Figure A.1-1 At the Virginia Heating Plant, Arlington, Virginia (1941), narrow cracks needed to be widened to receive concrete patches. Photo: NPS files [54]

The procedure of **repairing cracks** in structural members is related to the width and length of those cracks (Figure A.1-1), whether these are still active, or whether they are related to reinforcement corrosion. Crack repair practices include **epoxy injections** or **epoxy repair cementitious mortars**.

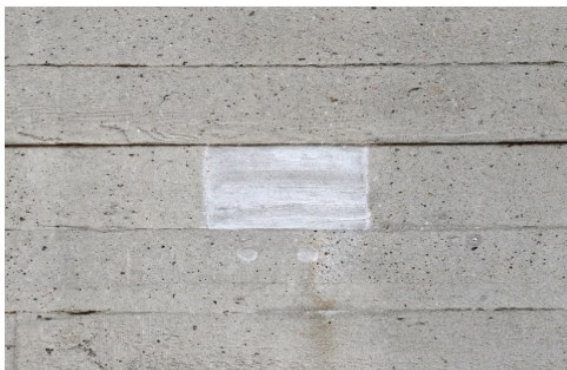
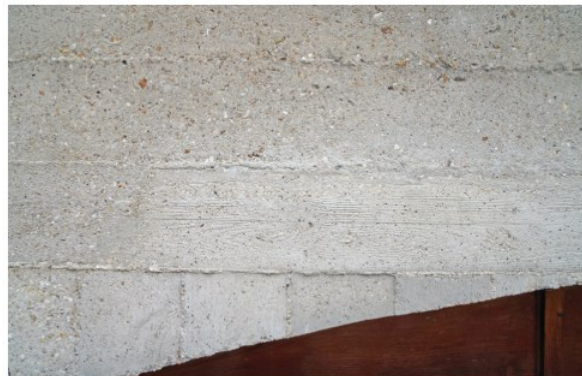
Figure A.1-2 (a) Example of poor aesthetic match; (b) Example of good aesthetic match. Photos: Ana Paula Arato Gonçalves, 2019, © J. Paul Getty Trust. [4]

The repair material should be no stronger than the base material, as this can cause damage to the original concrete. In particular, repairs incorporating modern Portland cement should be carefully designed to match the lower strength of an older material [9]. Additionally, if the repair material will not carry loads, it should have a lower modulus of elasticity than the substrate, while if it will carry loads, the modulus of elasticity should be similar for the repair material and the parent concrete [10]. When the modulus of elasticity of the repair material is higher than that of the original concrete, there is the risk of damage to the latter [10]. Especially in historic concrete, where the aesthetic value is of significance, the patch repairs must be such so as to match the original fabric (Figure A.1-2).

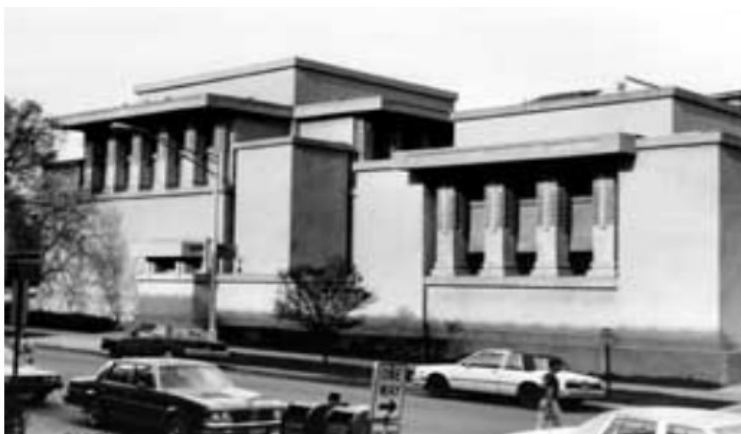
Figure A.1-5 Unity Temple, Oak Park, Illinois (1906). Photo: NPS files [54]

The **surface restoration** process may include various procedures that take place after the repair work is completed. In Unity Temple (Figure A.1-), the entire building was **sprayed with a concrete mixture** consisting of pea-gravel and sand, which was then **hand-troweled**. Finally, the building was **grit-blasted** to remove the cement paste and reproduce the exposed aggregate finish.

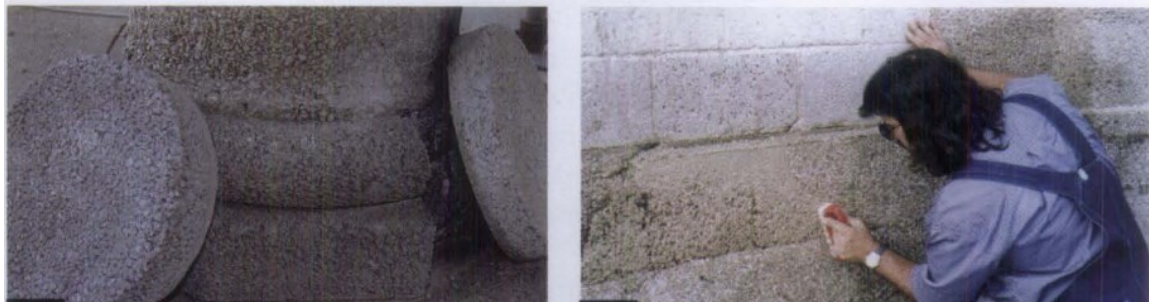
Figure A.1-3 Mock-ups of the concrete repair mix and craftsman finishing the repair with a nylon bristle brush to remove loose paste and expose the aggregate [11]

The concrete members may be sounded with a hammer to detect all areas of deterioration, while, prior to the placement of the concrete, a **retarding agent** can be brush-applied to the inside face of the formwork to slow curing at the surface. Usually the sizes and types of aggregates used for surface restoration must be carefully selected to match the original concrete materials, while **mock-ups** of the repair concrete mix must be prepared and compared to the original concrete prior to its use. Other parameters that may influence the aesthetic result are the cement color, proportions of the mixing materials, aggregate exposure after the application and surface finish [11]. After the concrete is partially cured, the forms are removed and the surface of the **concrete is rubbed** to remove some of the paste and expose the aggregate (Figure A.1-3).

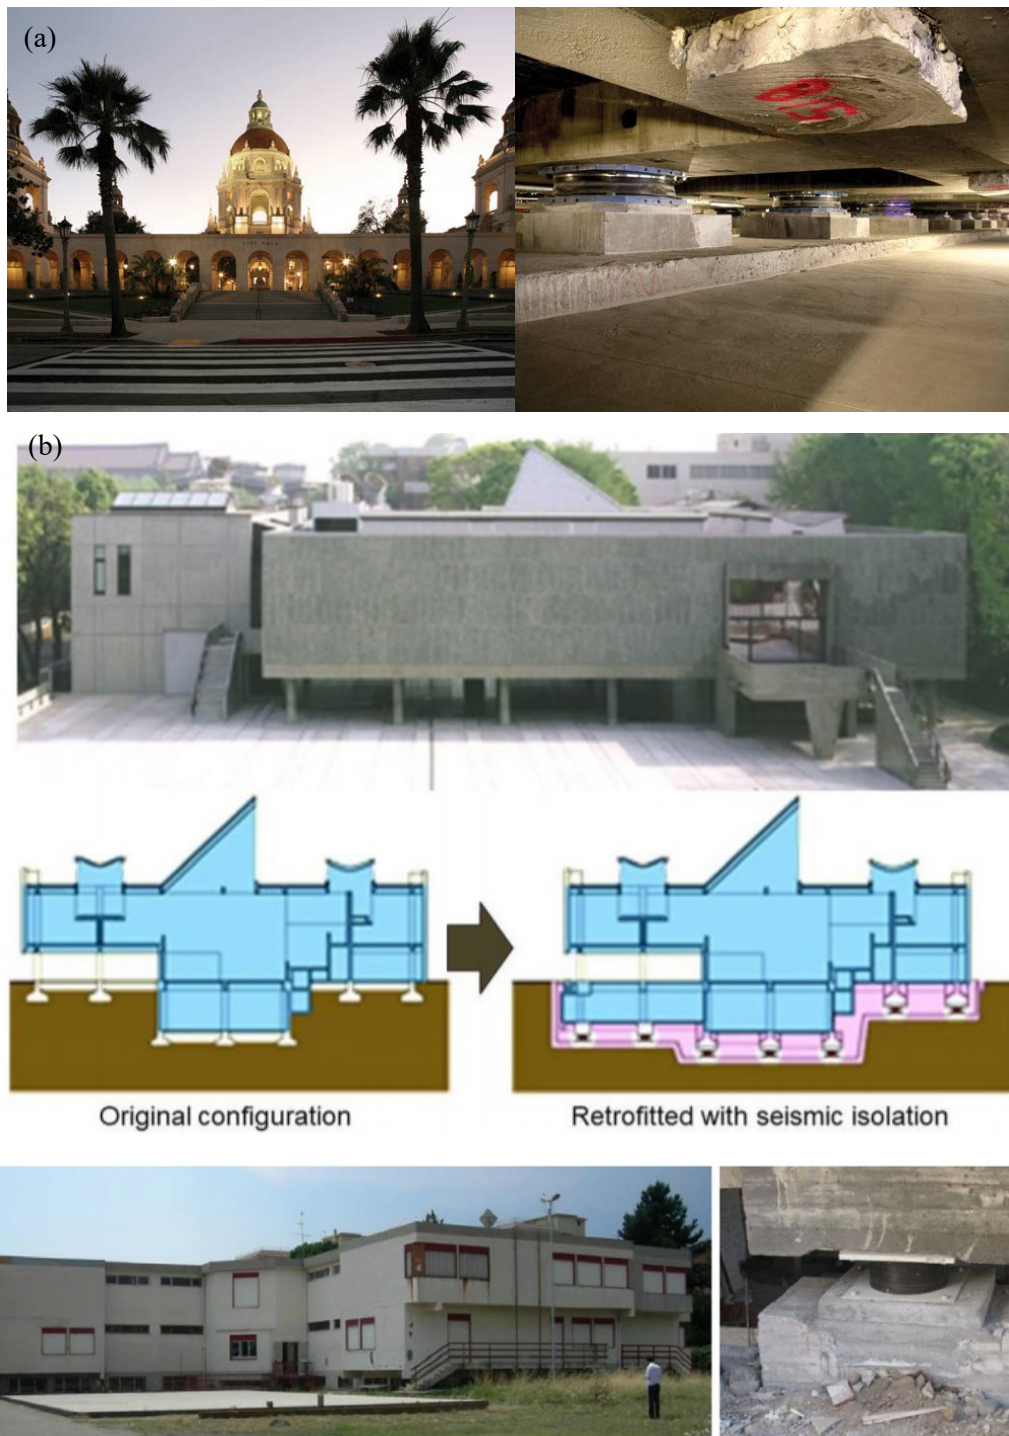
Figure A.2-2: (a) Pasadena Historic City Hall base isolation [14], (b) Seismic isolation retrofit of the National Museum of Western Art [15] and (c) The school of Riposto, Catania [16]

This passive structural control technique is used to reduce the response of a building by partially isolating it from the ground excitation, and can be established by **base isolation units, such as lead-rubber bearings**. Base isolation is designed to allow movement or absorb energy and induce damping to the system. Base isolation cannot be used in tall high-rise buildings, or on buildings on very soft soil [13]. There are two types of base isolation systems, **elastomeric bearings and sliding systems**. A series of examples of base isolation on historic concrete structures are depicted in Figure A.2-2 a-c.

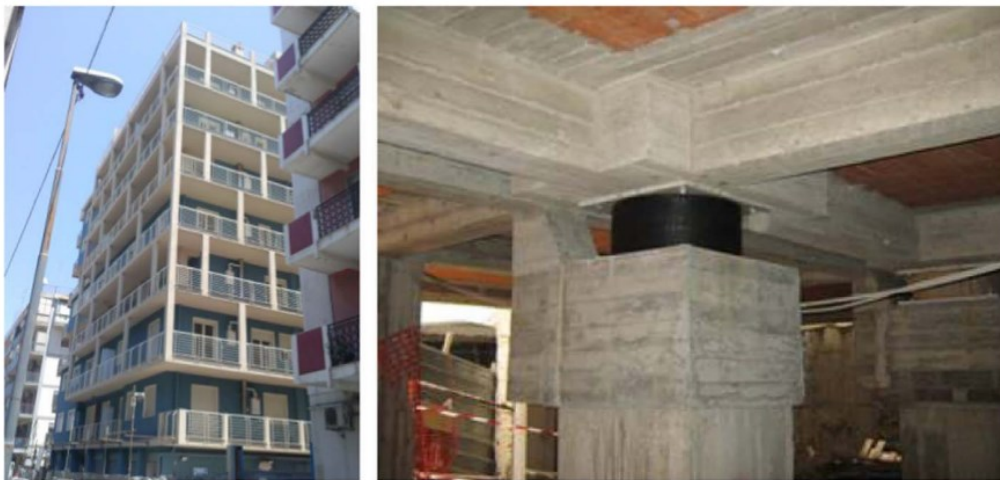
Figure A.2-3 The residential building on Spatafora Street in Messina, which is the tallest seismic isolated building (LRB) in Italy [16].

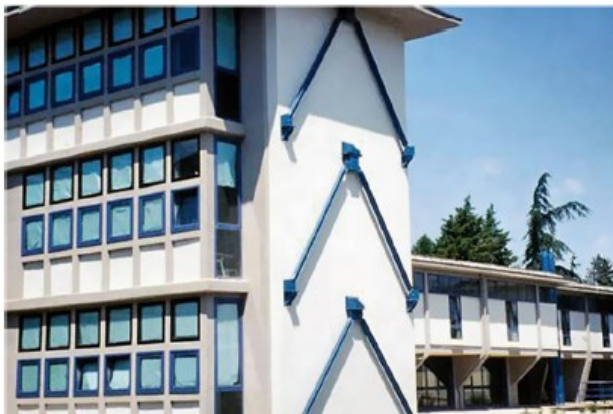
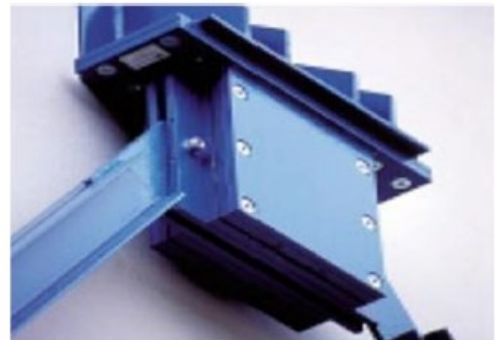
Figure A.2-5 Retrofit intervention by means of viscoelastic dampers in the school Gentile-Fermi in Fabriano (Ancona) [18]

They consist of friction pads, visco-elastic polymer pads and steel plates. An elastomer is stretched in combination with metal parts, with energy absorbed by the controlled shearing of solids.

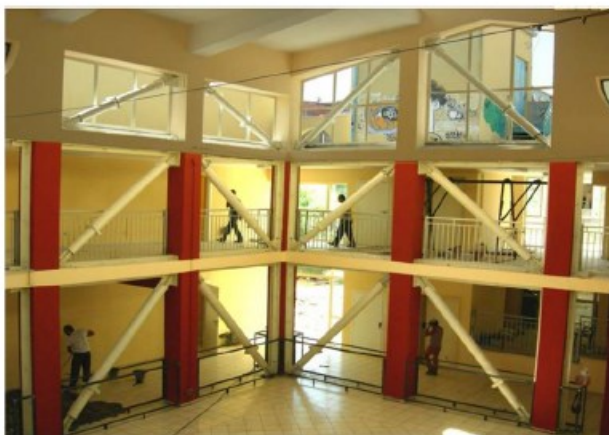
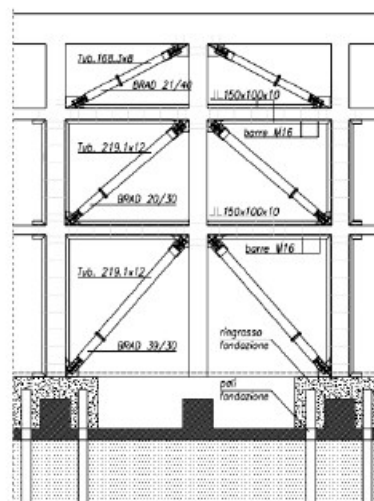
Figure A.2-3 Retrofit intervention by means of BRB frames in the school Cappuccini in Ramacca (Catania) [18]

Energy dissipation is performed by a tension-compression brace, with yielding in both tension and compression. The buckling must be restrained when the member is in compression. Strains are kept to low values by increasing the yielding zone length [13].

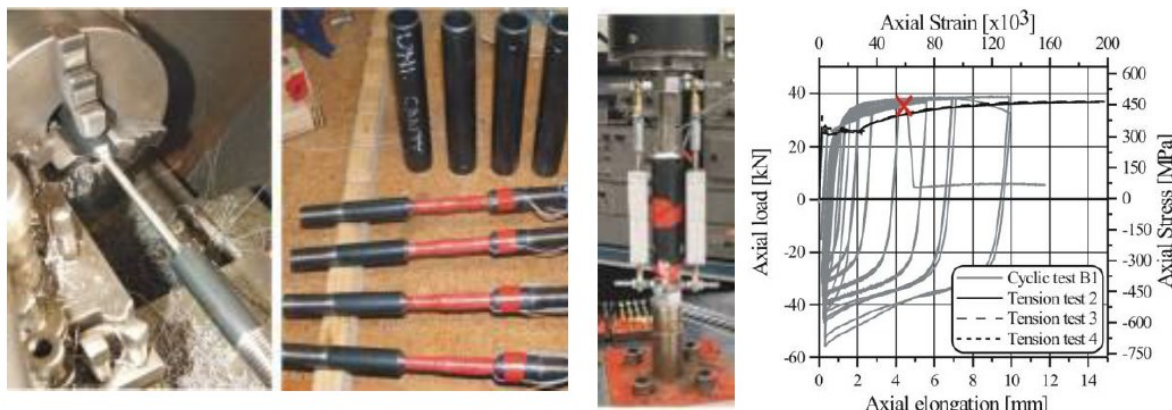
Figure A.2-7 Manufacturing process and testing of “Plug & Play” dissipaters [19]

Plug & play dissipaters consist of axial, tension-compression yielding, mild steel elements, inserted and grouted in a steel tube, externally applied on the sides of members, at the location of hinge formation.

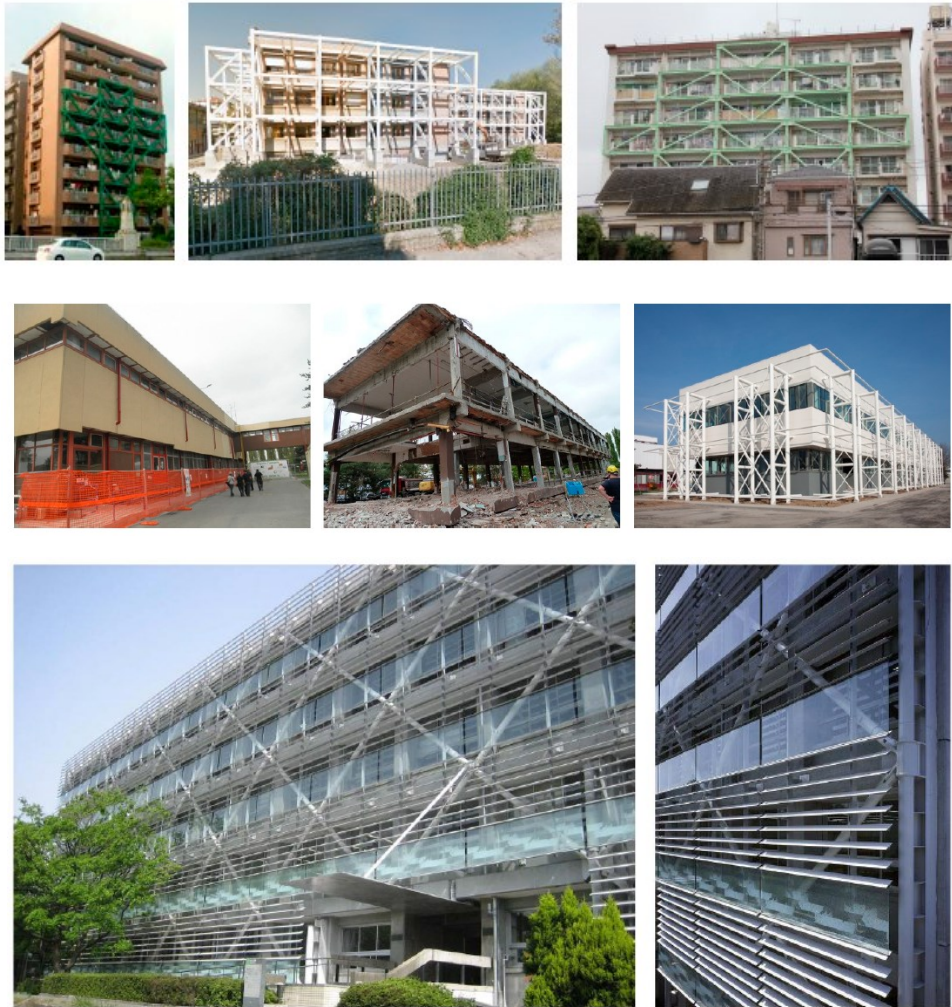
Figure A.2-4 (Top) Examples of seismic retrofitting with steel exoskeletons [20] (Middle) Steps of the seismic retrofit of the Magneti Marelli headquarters in Crevalcore, Italy [20], (Bottom) Midorigaoka-1st building after retrofit [18]

A **steel exoskeleton** is placed outside the building in order to attract and transfer seismic loads to the foundation and provide lateral stiffness to the structure. Although this method is convenient in the case where interruption of use is not an option, and waste materials are minimized, it requires free external spaces in front of the facades, while local intervention in the beam-column joints is required, at places where the exoskeleton will be connected. While in some cases the aesthetics of the buildings are compromised (Figure A.2-4 Top), or most of the building has to be demolished and then rebuilt (Figure A.2-4 Middle), in some cases, such as in the Midorigaoka 1st building of the Tokyo Institute of Technology, a more holistic approach is adopted, including seismic resilience and energy upgrading by the use of glasses, louvers and a steel BRB frame -exoskeleton (Figure A.2-4 Bottom).

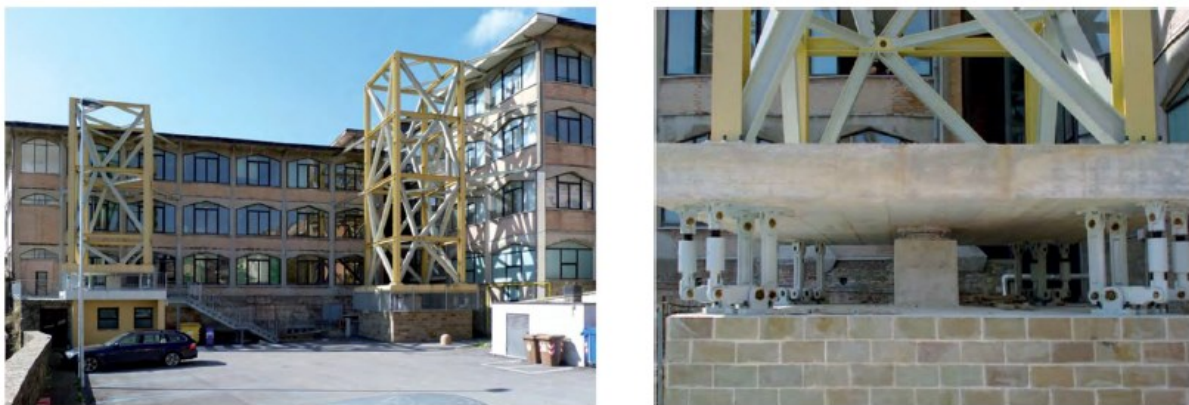
Figure A.2-5 Retrofit intervention by means of dissipative towers and viscous dampers in Camerino (Macerata) [18,21]

Peripheral frame buttresses can be used alone or in combination with viscous dampers to increase lateral stiffness. This method of intervention is externally applied in limited time, without interrupting the activities of the building. If viscous dampers are also used, then a large amount of energy is dissipated. The buttresses reduce the lateral sway, intending to leave the existing structural system to behave elastically. Figure A.2-5 shows a RC frame school in Camerino, built in the 1960s, that was retrofitted with the use of two steel braced towers connected to the floor slabs by steel trusses.

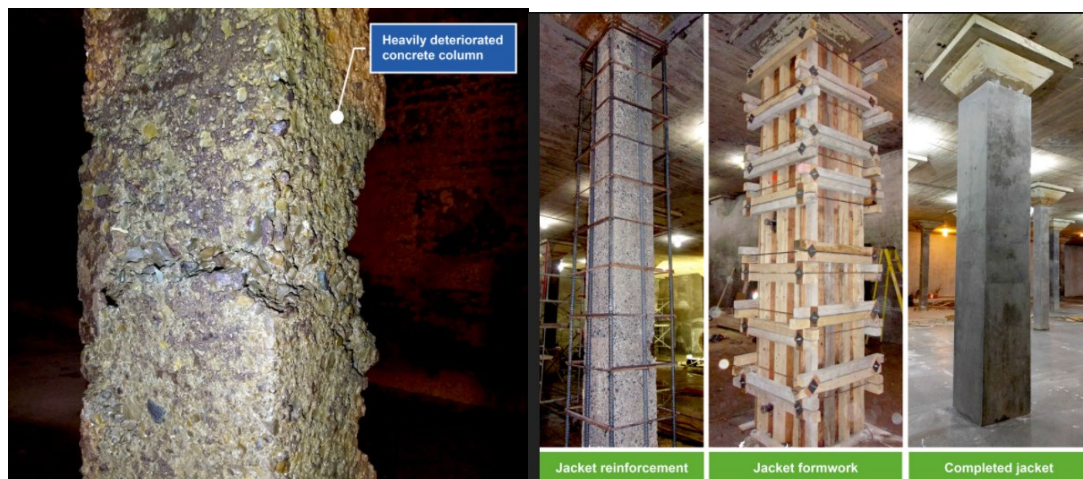
Figure A.2-6 Peterborough's 90-year-old reservoir and long-term rehabilitation project with self-compacting concrete jacketing [22]

Concrete jacketing is one of the most common techniques for the seismic upgrading of RC structures. This technique is used in vertical slender members, with high axial load, that are most likely to fail in brittle manner, due to high compressive stresses, or beams and slabs. Additionally, it is used when an increase in stiffness is required, due to possible soft-storey formation during seismic excitation, for changing the shape mode of the lateral sway. Furthermore, it can alter the “weak column-strong beam” behavior, typical of old substandard structures, to the more ductile “strong column-weak beam” behavior. Jacketing usually results in change of the members’ cross-section, especially in the cases where additional reinforcement is placed around the members. The jacket material may vary based on the depth of the jacket, the necessary increase of strength, or the alignment of the member. Yet, in any case, the material must have good bonding properties with the substrate and non-shrinking properties. The jacketing is performed on the sides of existing members, with the addition of longitudinal and transverse reinforcement (Figure A.2-10). The new reinforcement has to be extended to the adjacent floors, or properly anchored, in order to be able to sustain stresses at the critical sections of the plastic hinge formation. Due to the increase of the axial and flexural strength, this type of intervention requires strengthening of the foundations of the columns.

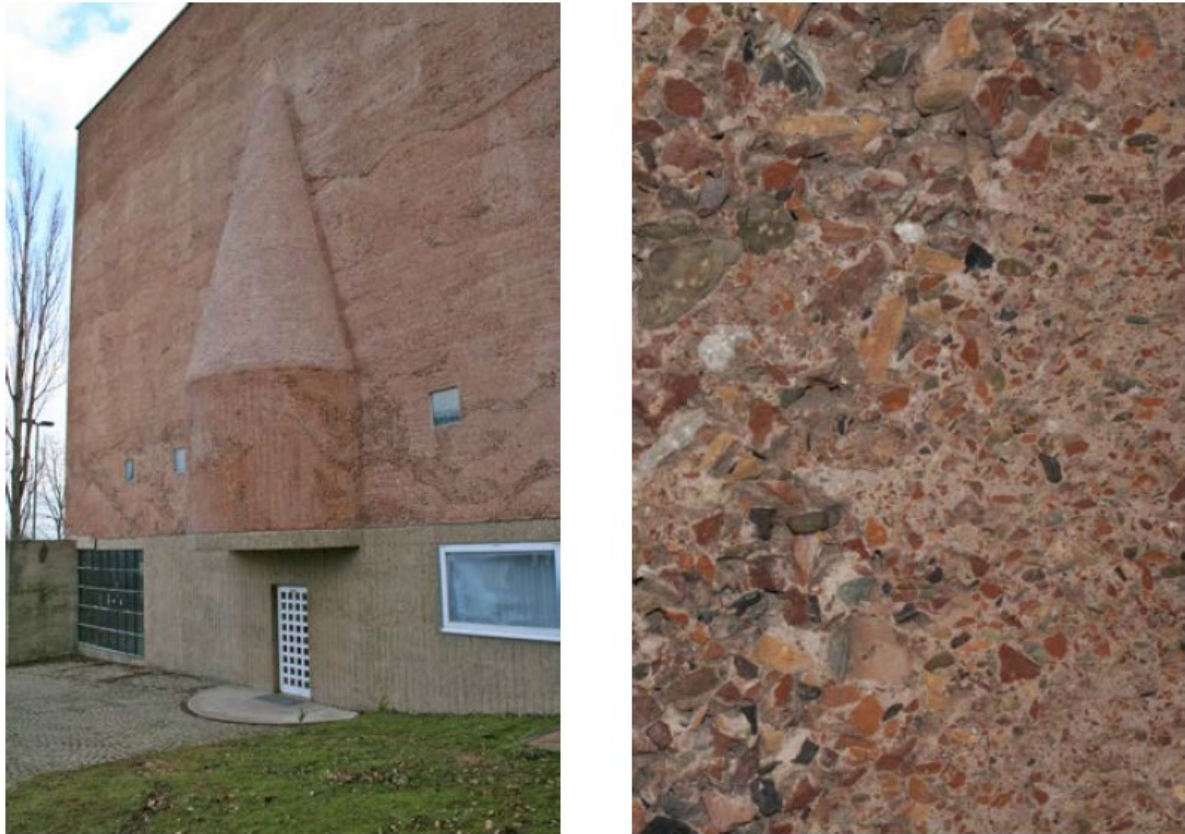
Figure A.2-7 Example of using sprayed concrete with a specially adapted repair concrete [12]

Shotcrete, contrary to normal concrete that requires formwork to be poured in, is sprayed on the existing substrate, with pressure (Figure A.2-11). The water is mixed with the rest of the raw materials during the pressuring procedure by experienced personnel, at a low content, leading to a high strength, pressure applied material to fill the gaps, improving adhesion and compaction at the same time. This type of concrete can be applied to inclined or horizontal surfaces, such as slabs.

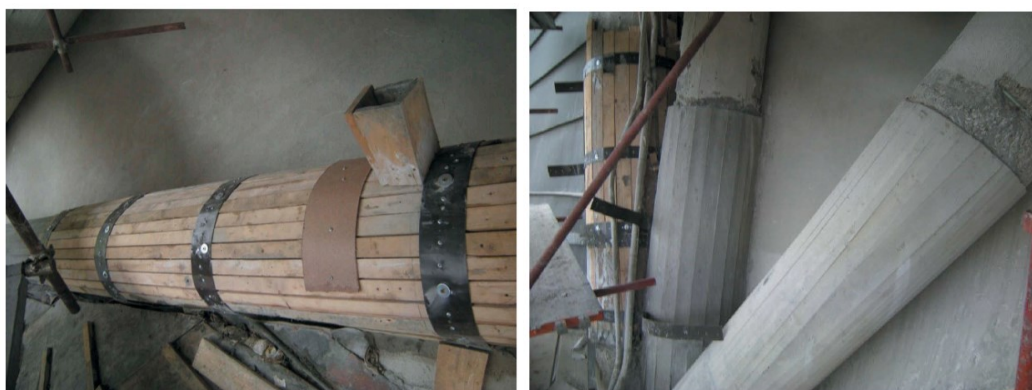
Figure A.2-8 Formwork manufactured with wooden boards and finished product

- Self-consolidating or self-compacting concrete may be used where compaction of the concrete is not feasible due to the geometry of the reinforcement, or the thickness of the layer. In this case, coarse aggregates are of a maximum diameter of no more than 10 mm, allowing for thinner widths of jackets to be applied [23,24]. In the case of the Peterborough's 90-year-old reservoir (Figure A.2-110) [22], concrete was pumped in the formworks from the bottom and the middle of the height of the columns. The use of this technique allows elements with a texture similar to the original surface to be obtained (Figure A.2-112) [25].

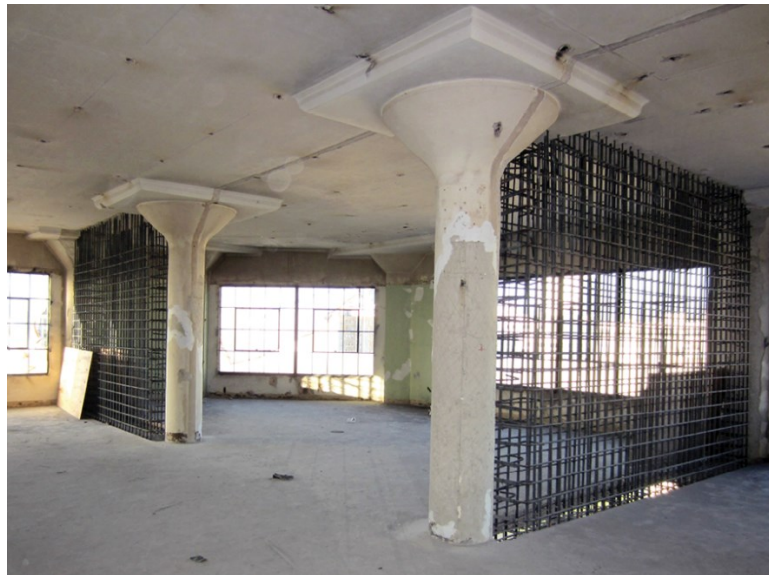
Figure A.2-9 Steel reinforcement for the new shear walls, perpendicular to the windows, is being installed in this concrete-frame building [26]

Reinforced concrete shear walls may be placed in structures that have a significant lack of lateral stiffness, due to high mass and very slender column members. The shear walls are usually placed in areas of secondary importance to the historic context and are preferably hidden in spaces of previous masonry walls (Figure A.2-13). The RC walls must extend to the ground level and should be properly supported on new foundation systems, that are able to transfer their moment and shear to the ground. At the same time, proper connection must be made with the existing structural system, while the slab zones around the shear wall must be adequately retrofitted in order to support the transfer of loads when plastic hinges are formed.

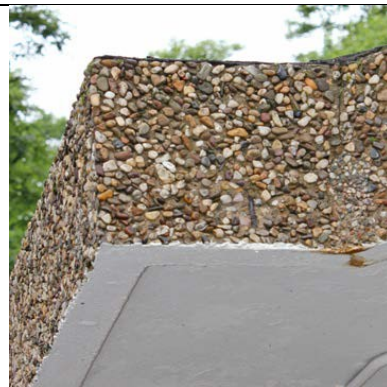
Figure B.1-7 Washing out concrete (Heinemann, 2013)

Once the technical assessment of the concrete has been done and the material has been valued considering its present state and past aspect, the question arises on how far to go with the cleaning process. Even though, other than in the case of traditional materials like stone and brick, the so called ‘patina of time’ may be less evident and wanted, yet some effects of the environment (rain) could be foreseen/intended and thus need to be kept. This is for example the case of the Bijenkorf store building in Rotterdam by M. Breuer, who designed the geometry of the façade foreseeing the effect of the dirt deposition (Figure B.1-). Similarly, Brutalism urged designers to keep the signs of the formwork, as proof of the concrete being a genuine material (see the case of the TU Delft Aula Broek and Bakema, Figure 0.05). Other examples of concrete textures are the decorative use of the traces of the formwork (Figure B.1-6.), and the various ways of giving concrete a lively aspect (polishing, washing...) (Figure B.1-7).

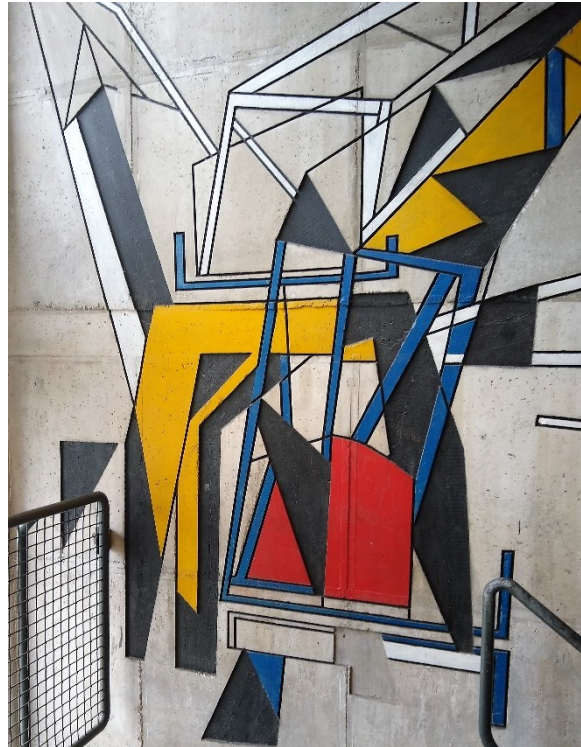
Figure B.1-10. Coloured bass-relief.

In the interior, there were bass-reliefs that required the use of more careful cleaning methods. The bass-reliefs were the work of artist Harry op de Laak's (Figure B.1-10). The main art-work measured 8 by 28 m and it was located in the main staircase. It was originally unpainted concrete but later painted. It was not clear if the original artist participated in the painting. It was decided to preserve the colors in the grooves of the bass-relief, but to remove the orange paint covering the rest of the wall. The use of a peeling agent followed by steam blasting, used on the rest of the interior concrete surfaces, was not used in this area, as it could affect the polychrome in the grooves. With the help of specialized conservators, a trial with an innovative dry-cleaning process was performed, using dry ice and dry snow blast cleaning. These methods make use of carbon dioxide crystals that evaporate after the impact with the concrete surface. After various tests, dry snow blasting with fine ice crystals was chosen, as it appeared that the original concrete surface was not affected. The fine nozzles allowed to work within millimeters away of the paint of the bass reliefs, which was protected with rubber strings. The dry-snow cleaning process had the advantage of removing the risk of water damage. The main downside of this process was the slow pace and high cost, and the noise created, that limited the access to the stairs for weeks.

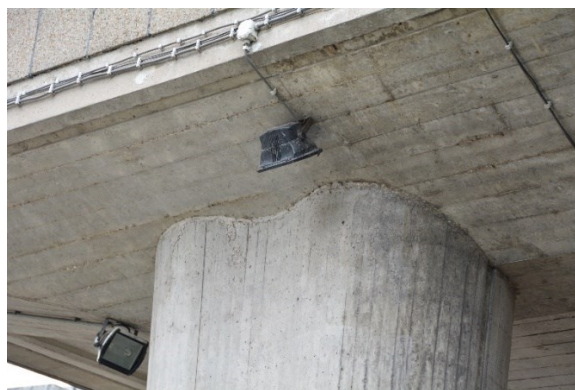
Figure B.1-11. Detail of the intersection between ground floor columns and first floor slab.

At the exterior, cleaning of the exposed concrete aimed at removing grime and dirt from pigeons dropping, stains of the anti-pigeon system glued in the window sills of the facades in 1999, and urban pollution. Based on the architect's experience and trials on site, low-pressure steam cleaning method was chosen. This technique minimized the impact on the concrete surfaces, and avoided an increase of surface porosity that could make the concrete more sensitive to further carbonation, water penetration and damage (Figure B.1-11).

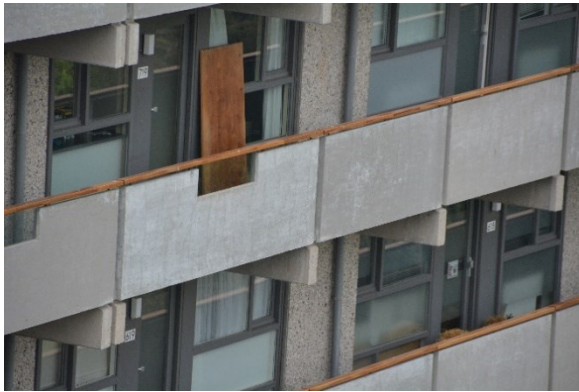
Figure B.1-13. Prefab concrete balusters of the Kleiburg.

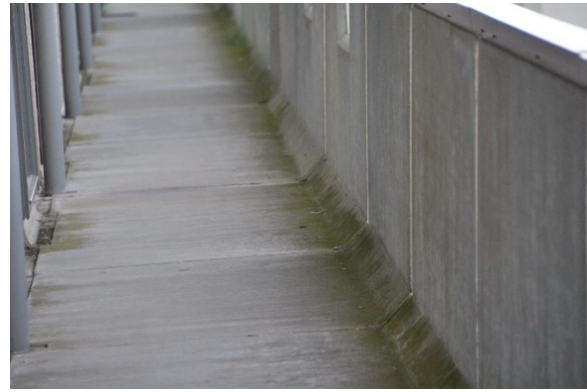
Figure B.1-14. Inside of the concrete balusters in the Kleiburg.

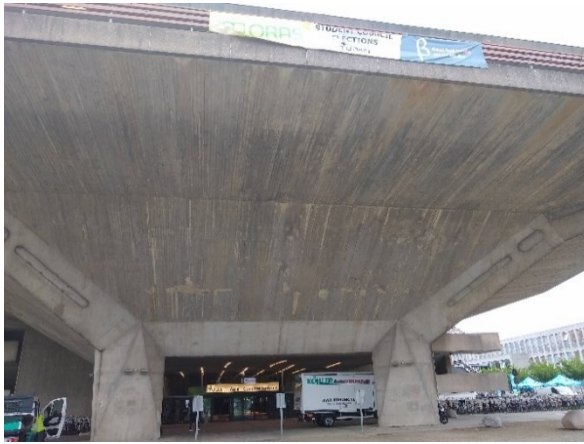
Figure B.1-16. Concrete texture at the underside of the building front.

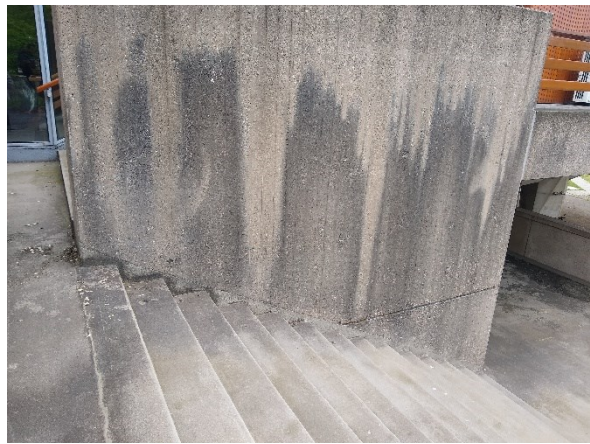
Figure B.1-17. Concrete stains at the exterior stairs.

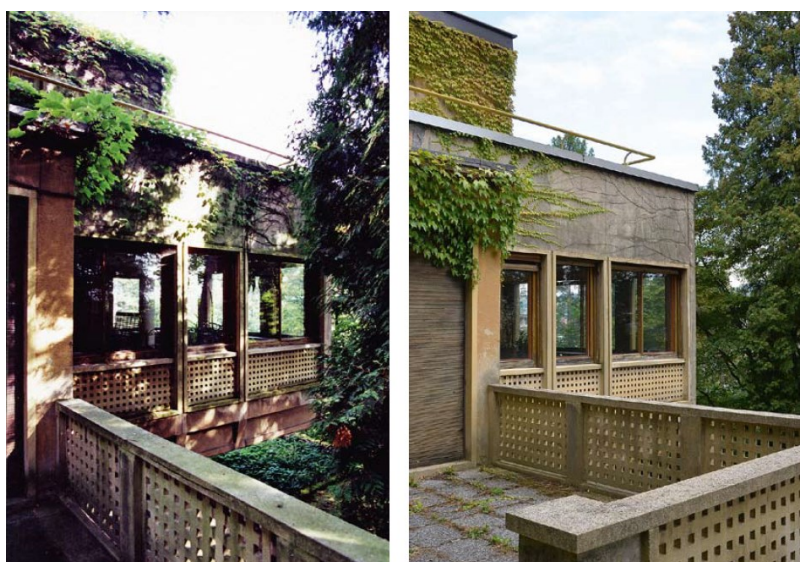
Figure B.2-1. Restoration of vila Zikmund in Zlín [35,36]

For these reasons, repair of the original concrete elements was chosen instead of their complete substitution. The intention was to preserve the patina of the original material. The patch repairs were left visible (Figure B.2-1). The restoration of the building was designed by an architecture studio specialised on restorations, atelier TRANSAT led by Petr Všecká [35,36].

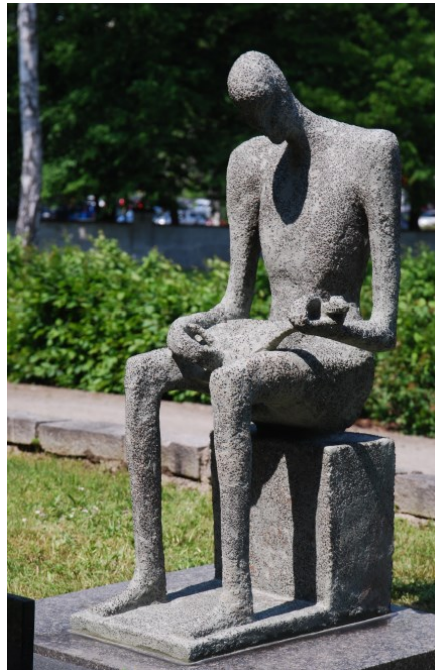
Figure B.2-2. Restoration of the statue of a musician by Alois Šutera [37]

The statue is situated on the Přerov cemetery. Its restoration was carried out in collaboration with the Conservation Faculty of the Pardubice University. Analyses of the original material were first carried out and an identical basaltic aggregate was found. The surface was cleaned from moisture-induced elements, the exposed parts of the reinforcement were cleaned from corrosion, and the cracked parts of

the statue were repaired. In contrast to the previous case, this one is an example of an “invisible” restoration, trying to hide the differences between the old and the new (Figure B.2-2). The statue was restored by Josef Červinka and Vladislava Říhová in 2019 [37].

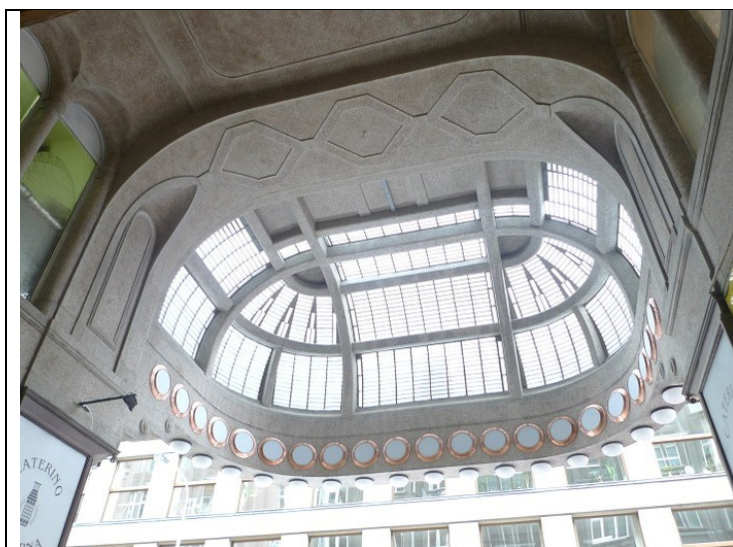
Figure B.2-3. Restored structure of the Lucerna Palace.

A special case of restoration of a glass brick shelter with a reinforced concrete frame was executed and described by sculptor and conservator Jiří Fiala [38,39]. In his report about the restoration of concrete sculptures and other architectural elements, Mr. Fiala underlines the importance of cleaning of the reinforcement from corrosion [40]. Another principal task is to find repair material identical or similar to the original one. In the case of the shelter at Lucerna Palace, special forms have been made to get the right shapes of the ribs (Figure B.2-3-6).

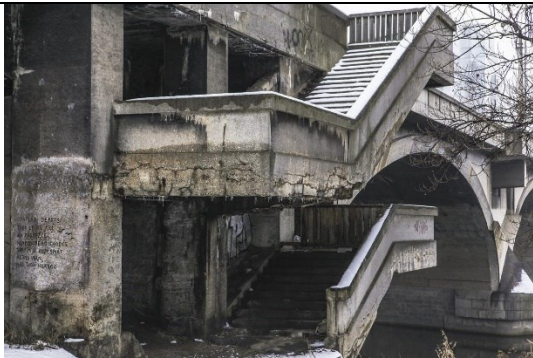
Figure B.2-8. State of the structure in 2018

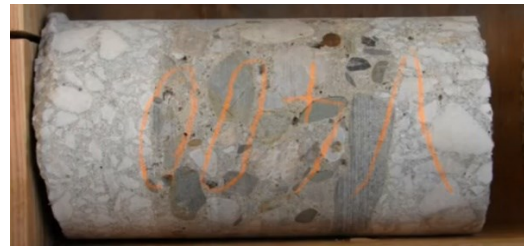
Figure B.2-9 Sample (about 50 mm diameter) from the precast elements of the sidewalls

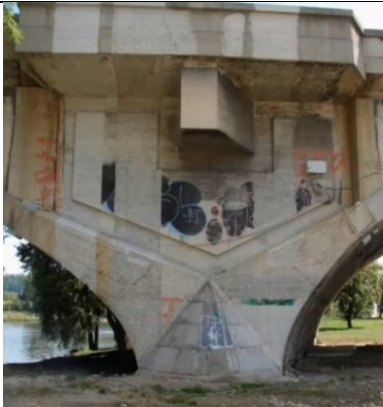
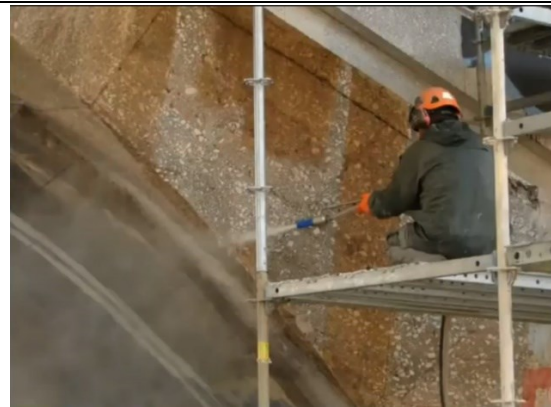
Figure B.2-10. Different cleaning methods were applied (vertical stripes)

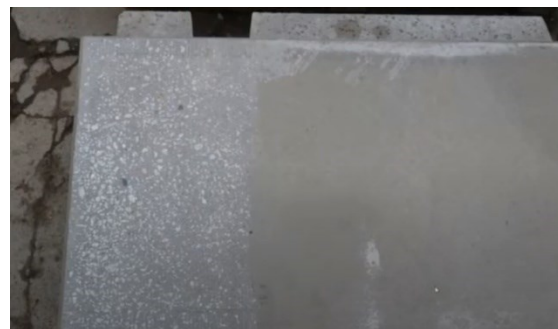
Figure B.2-12. Experiments with fine aggregate have been made to reach a surface similar to the original one.

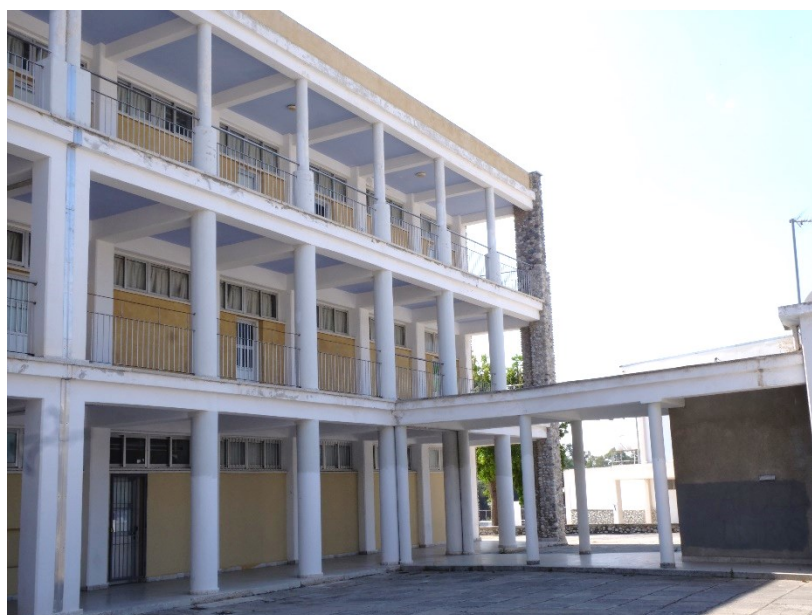
Figure B.3-1. Concrete jacket in the Technical School of Nicosia, Cyprus. Intervention performed in the general framework of seismic strengthening of educational facilities on the island.

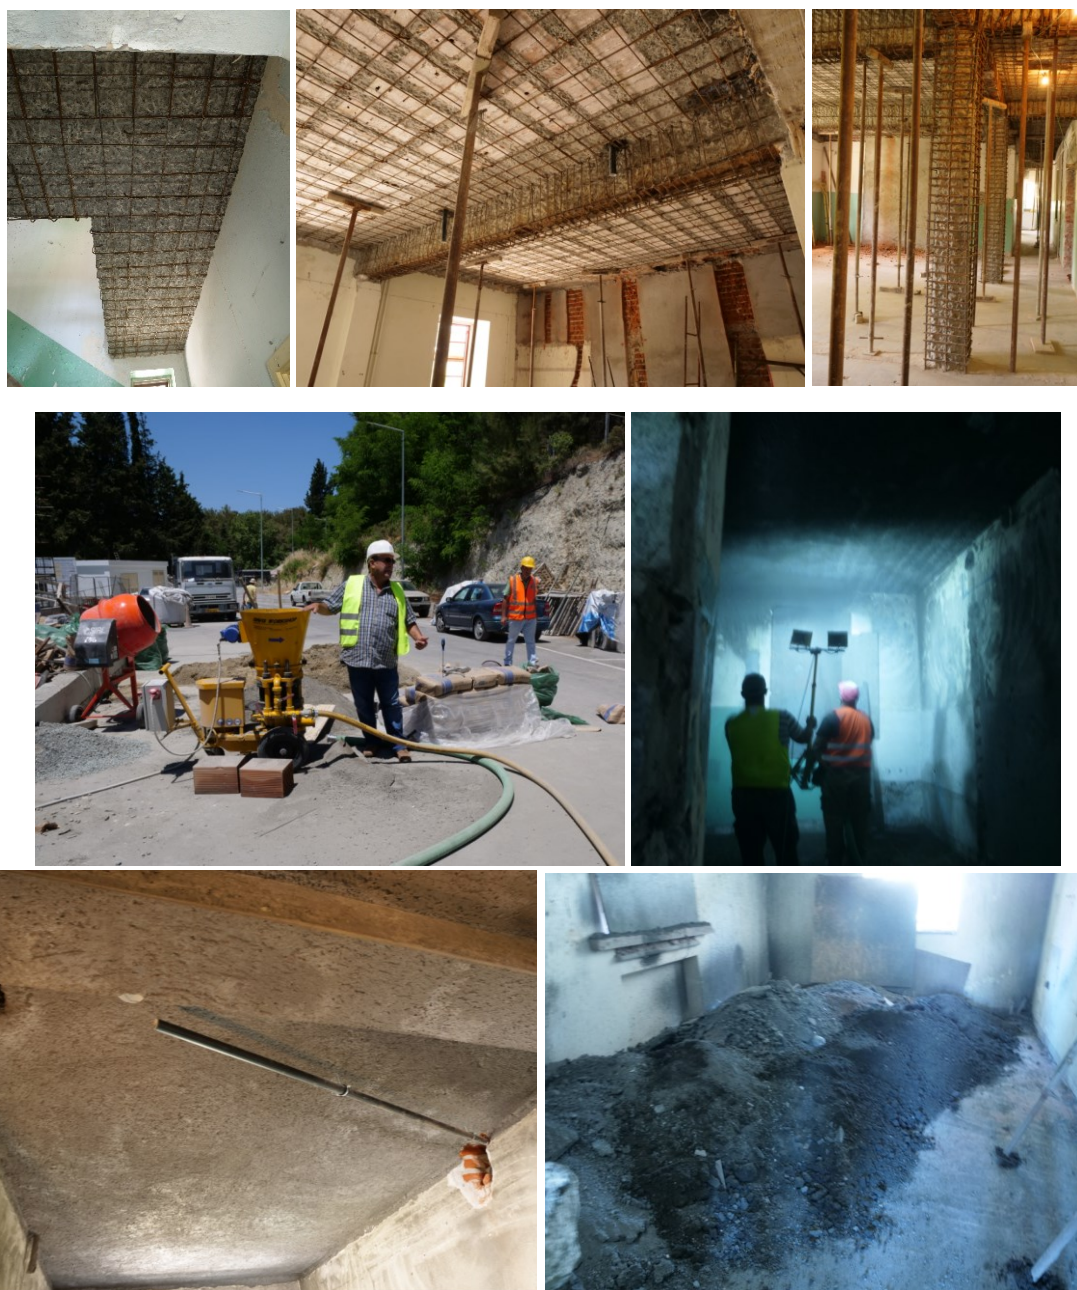
Figure B.3-2. Top: Preparation for shotcrete jackets on slabs, beams and columns. Middle: Shotcrete mixing equipment (left) and application of shotcrete (right). Bottom: Slab after shotcrete jacket (left) and waste material produced during the procedure (right)

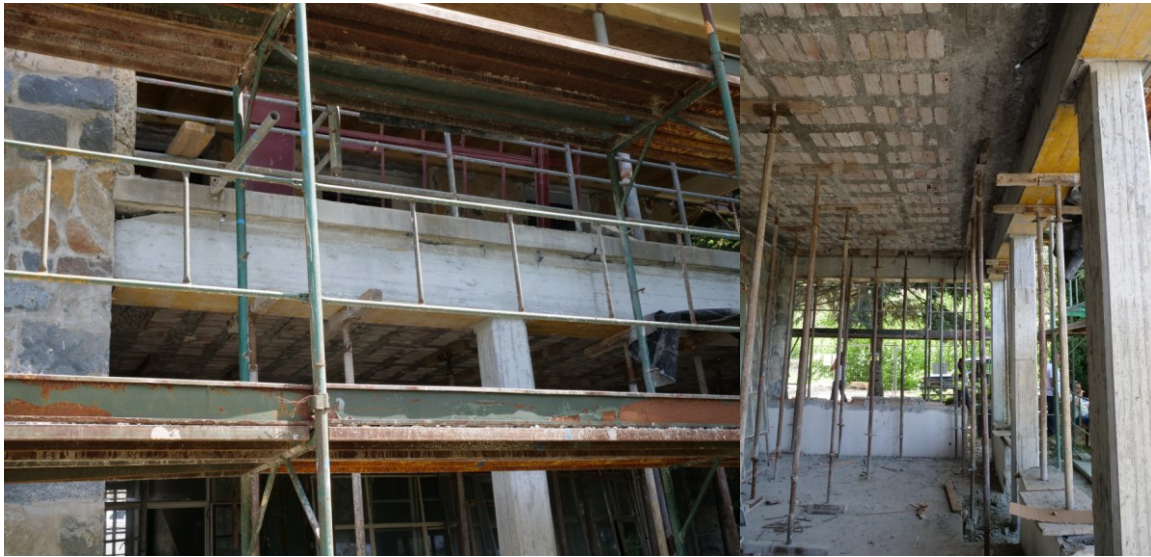
Figure B.3-3. Replacement of the beams and columns in the external porch of Kyperounta Sanatorium Nurses and Doctors Residence Building by contemporary R/C members
