Selection of suitable materials and techniques for the conservation of buildings in need of restoration

Project: CONSECH 20

Working Package 4 – Task (ii)

Abstract

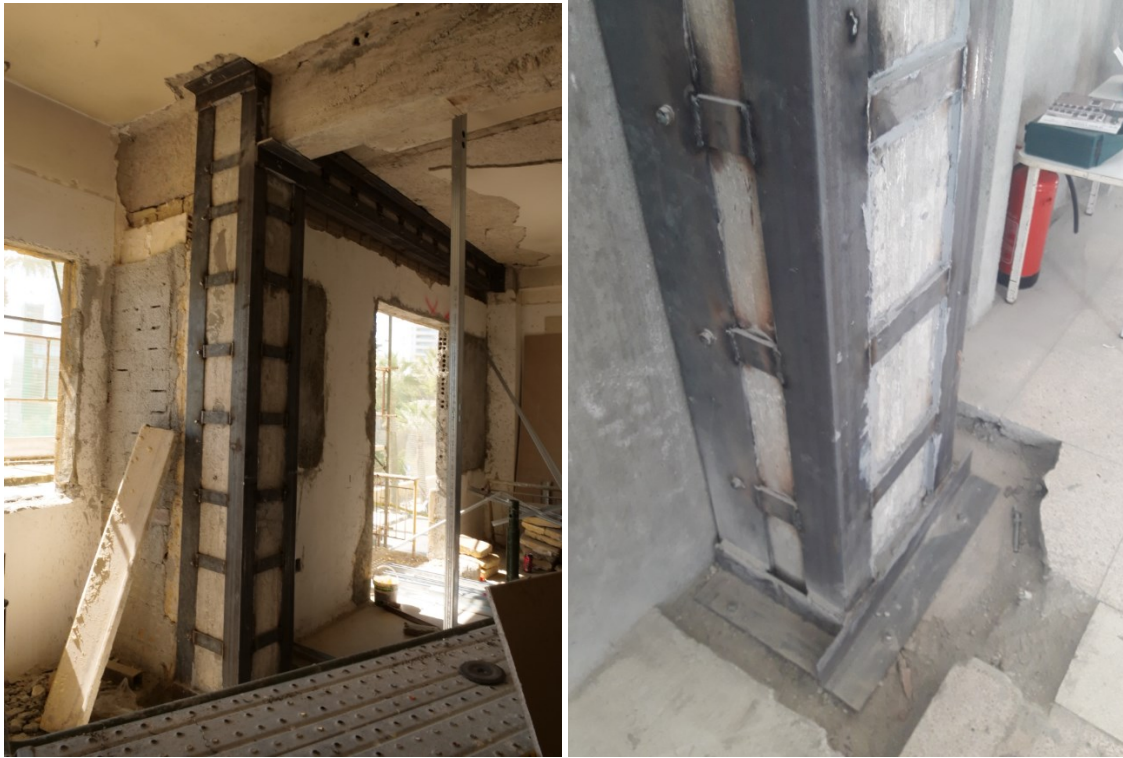
Figure B.3-4. Steel encasement of R/C columns (and beam) in Lyssarides Tower, Nicosia

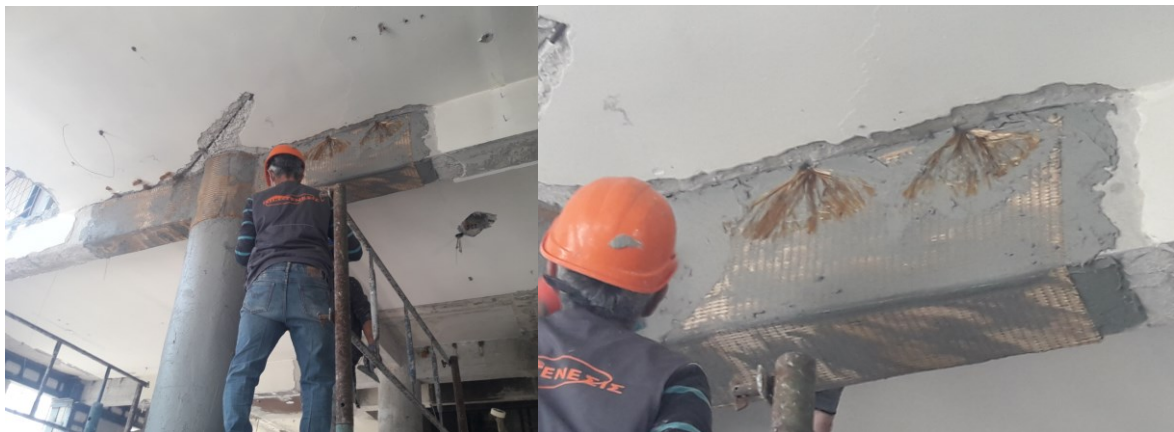
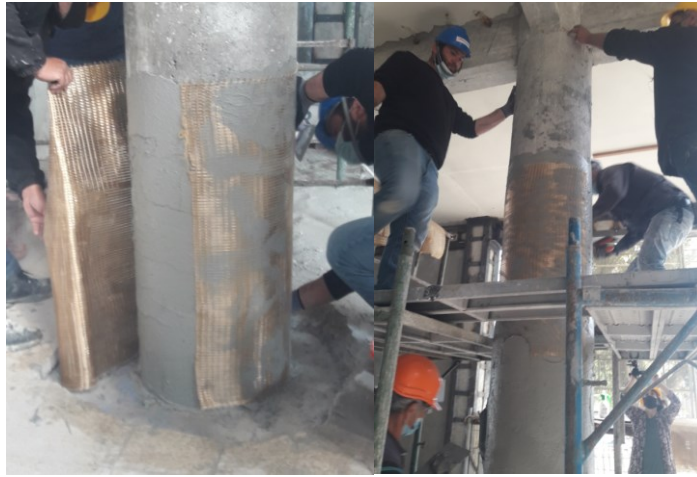
Figure B.3-5. PBO TRM confinement of beams, internal joints and circular columns in Lyssarides Tower, Nicosia

Recommended solution for: Shear and Lap splice brittle failure prevention, Increase of ductility due to confinement, Reversibility, Minimum changes in cross section

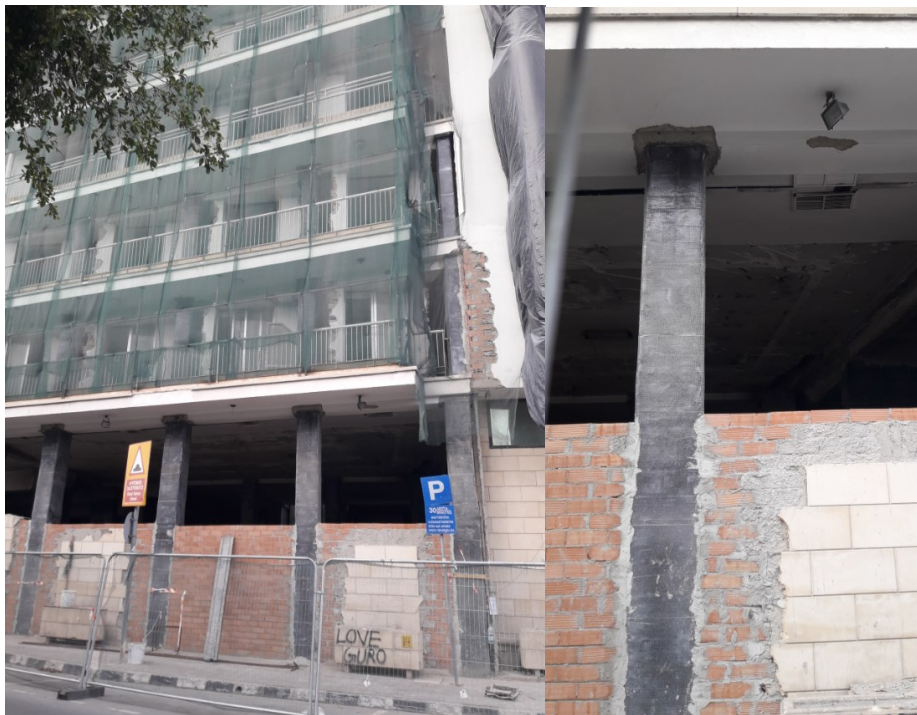
Figure B.3-6. Carbon FRP confinement of rectangular columns in a historic multi-storey hotel, Nicosia

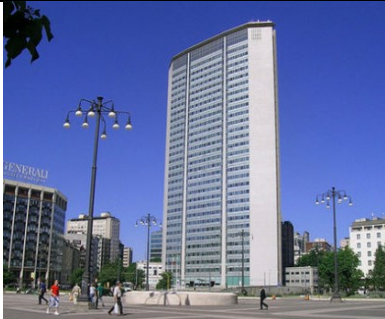
<p>Forced realignment of reinforced concrete floor, with the use of hydraulic jacks.</p> <p>Reinforcement of the reinforced concrete beams by the application of external post-tensioned cables and carbon fibres to the lower surface.</p> <p>Cladding with ceramic tiles.</p> <p>Aluminum structure that makes up the curtain wall and the glass.</p>

<p>Building: Grattacielo Pirelli [42]</p> <p>Architect: Gio Ponti - Pierluigi Nervi</p> <p>Year of Construction: 1956-1960</p> <p>Location: Milano</p> <p>Designer: Scientific technical commission</p>
<p>Repair of expelled concrete covers, by the use of cement mortar with single-component resin addition, trying to imprint the sign of the wooden boards of the formwork to make the reintegration homogeneous with respect to the original surface.</p> <p>Cleaning of surfaces performed at different levels to preserve the material as much as possible and maintain the existing “patina”.</p>

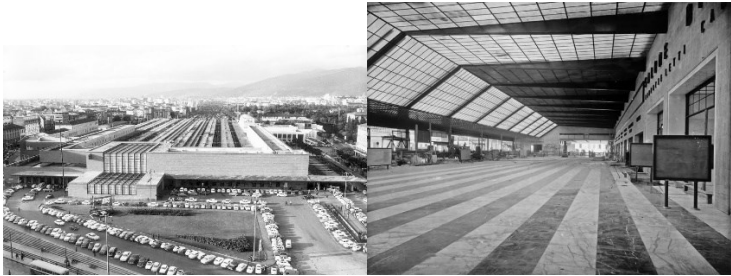
<p>Building: Palazzina Reale and train station of Santa Maria Novella [45]</p> <p>Architect: Gruppo Toscano, Giovanni Michelucci</p> <p>Year of Construction: 1935</p> <p>Location: Firenze</p> <p>Designer: Marco Dezzi Baldeschi</p>
<p>1999: Removal of stained concrete from the porch. Cleaning of steel reinforcement and protection with passive treatment. Restoration of the resistant conglomerate section.</p>

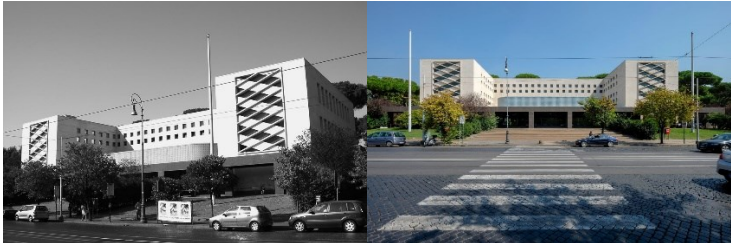
<p>Building: Ostiense Post office [46]</p> <p>Architect: Arch. Alberto Libera - Arch. Mario De Renzi</p> <p>Year of Construction: 1933-1935</p> <p>Location: Roma</p> <p>Designer: Sergio Poretti, Rinaldo Capomolla, Tullia Iori, Stefania Mornati, Rosalia Vittorini</p>
<p>Integration of metal reinforcement where damaged or missing. Finishing with neoplastic plywood shrinking mortar. Reinforcement of pillars by applying carbon fibre fabric.</p>

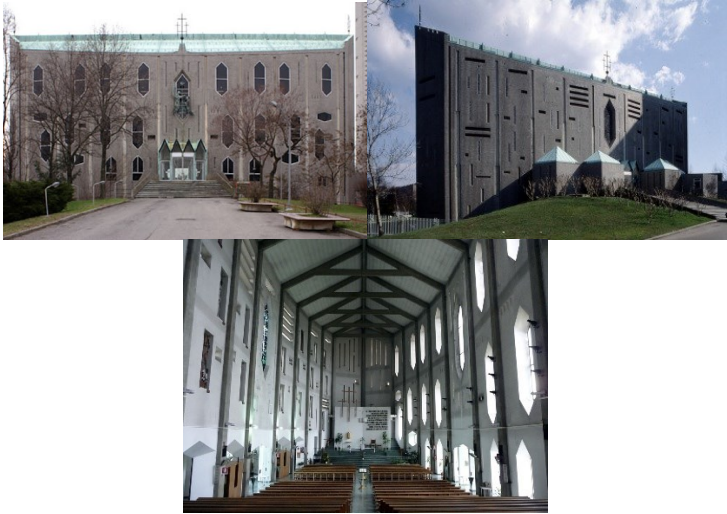
<p>early 2000s: Electrochemical re-alkalization with current density of 1 A/m² (compared to the reinforcement surface) for a period of three weeks. An activated titanium mesh and cellulose pulp soaked in sodium carbonate solution were used as an anode system. Water-repellent treatment carried out on the pillars of the church, using a commercial product based on silicone resins.</p>

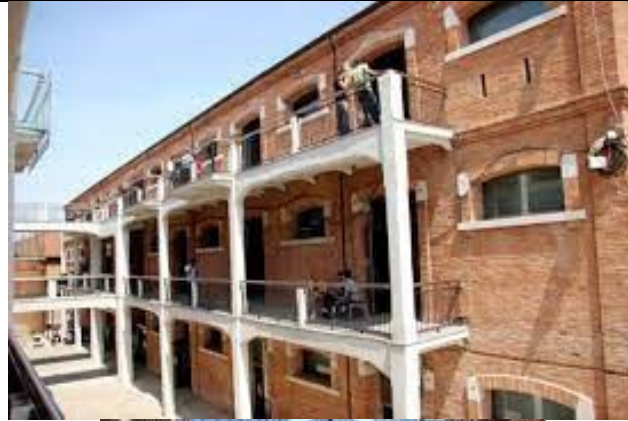
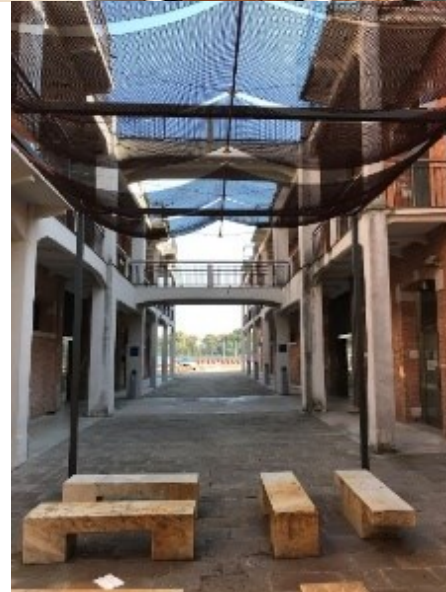
Intervention on the reinforced concrete columns-slabs: preparation of surfaces with removal of degraded material; restoration and reconstruction of the re-bar cover layer and integral protection of the reinforcement through the application of a migrant corrosion inhibitor. Subsequently, when the restoration mortar had matured, structural reinforcement intervention was carried out through the application of epoxy resin and carbon fibre fabric. Surface finish through the application of plaster on all treated surfaces.

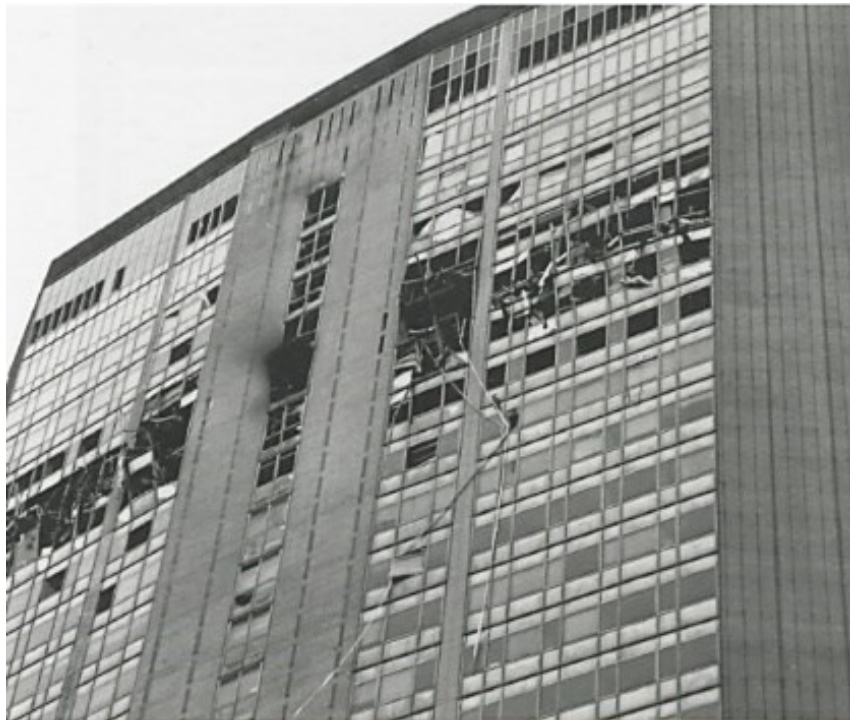
Figure B.4-1 Damage caused by the accident [42]

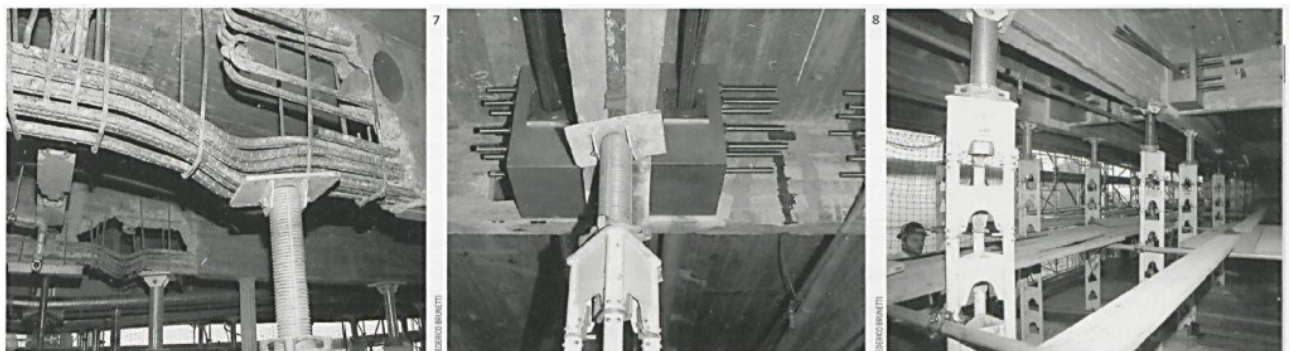
Figure B.4-2 Realignment of the reinforced concrete structures of the 26th floor. [42]

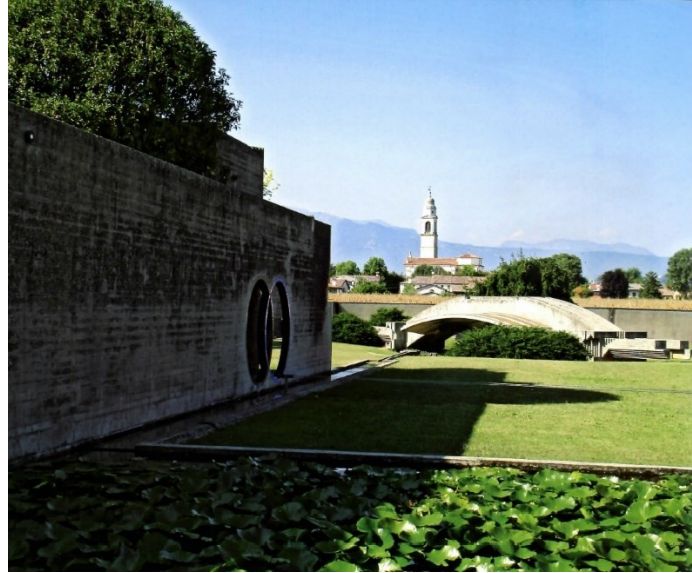
Figure B.4-3 View of the exterior [43]

Cleaning of concrete surfaces of the monumental “Tomba” (Tomb) of Brion Family, designed by Carlo Scarpa, was carried out with techniques tested both in the laboratory and in situ.

Based on the preliminary test results and the specific characteristics of the concrete, the conservation strategy started with the least intruding interventions possible, to be repeated in the short term, such as cleaning tests carried out at different levels to maintain the existing “patina” (Figures B.4-3-5). The interventions were classified according to the structural role of the element to be restored, the type and level of damage, and the potential impact of the intervention on the form and “meaning” of the work (Figure B.4-6-7).

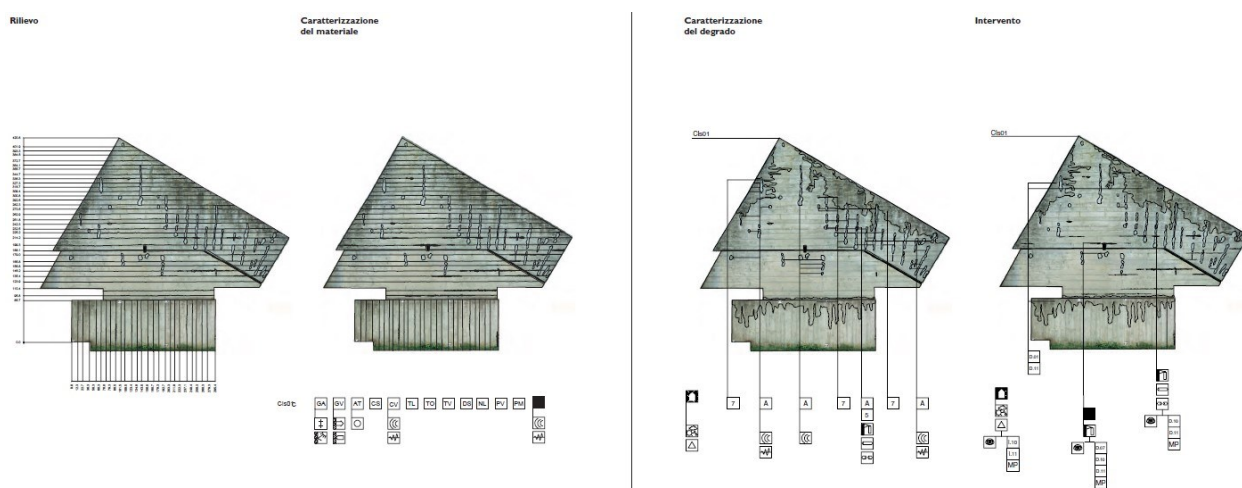
Figure B.4-6 Maps of external surfaces: Surveying, characterization of material, characterization of degradation and intervention [53].

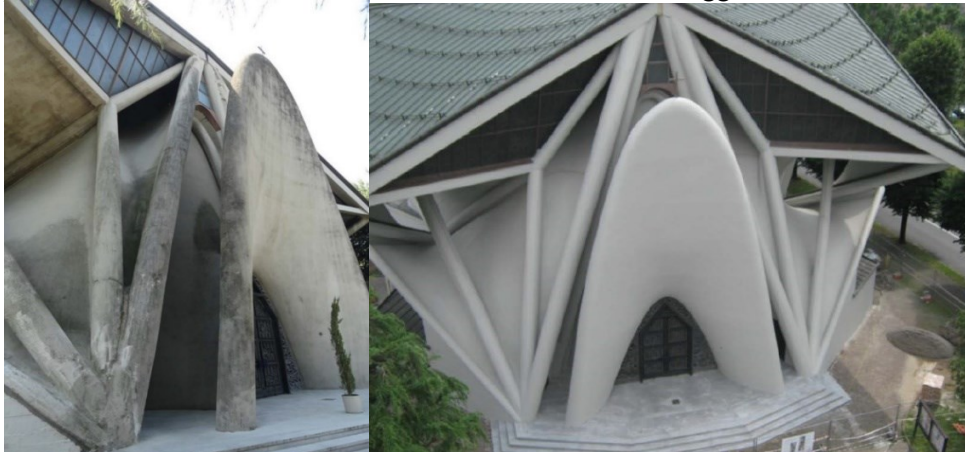
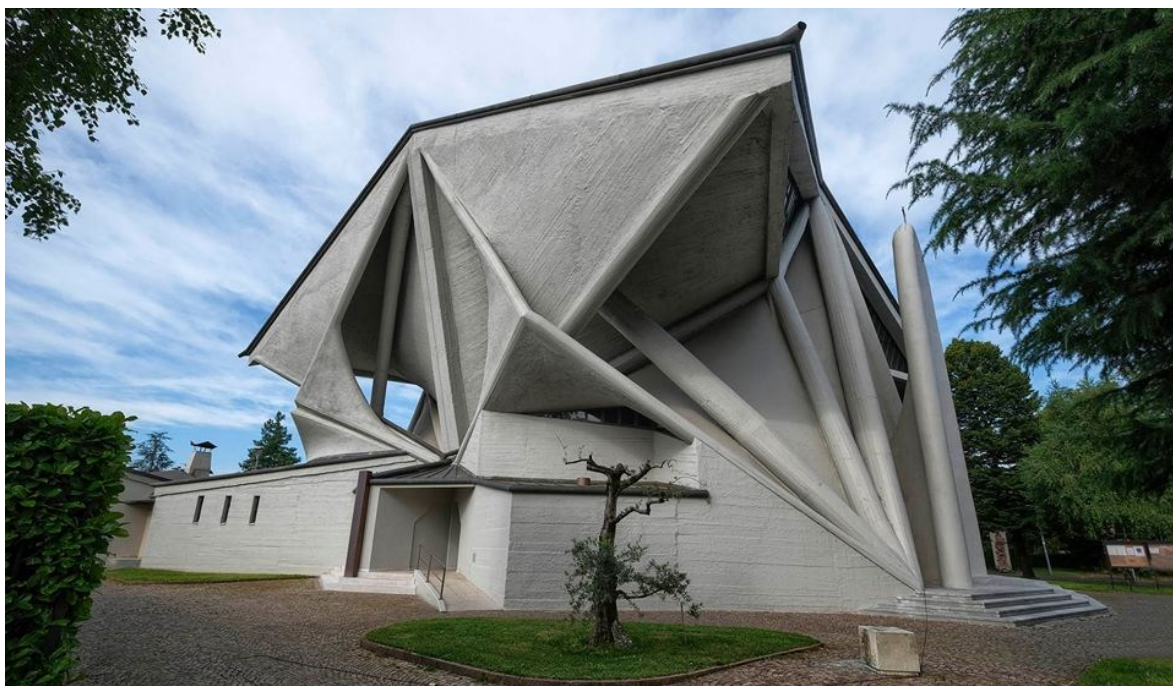
Figure B.4-8 External views of the main portal of the church [49]

The church, located in Longuelo district in Bergamo and designed by arch. Ing. Pino Pizzigoni, is one of the greatest examples of structures with concrete thin vault in Italy (Figure B.4-8-9). Built in the 1960s, the church-tent represents the point of arrival of a series of studies conducted by its designer on thin reinforced concrete structures, started in the 1950s. The church consists of four equal and independent parts, joined by a complete separation joint that allows each part to have a statically independent behavior. The supporting structure of the church consists of vertical and sub-horizontal columns with circular section, connected by thin vaults with double curvature. These elements were made by on-site concrete casting [49]. The slenderness of these structures and the scarce means available at the time of construction produced some defects that led to maintenance problems due to the particular vulnerability of reinforced concrete elements to aggressive environmental actions [49].

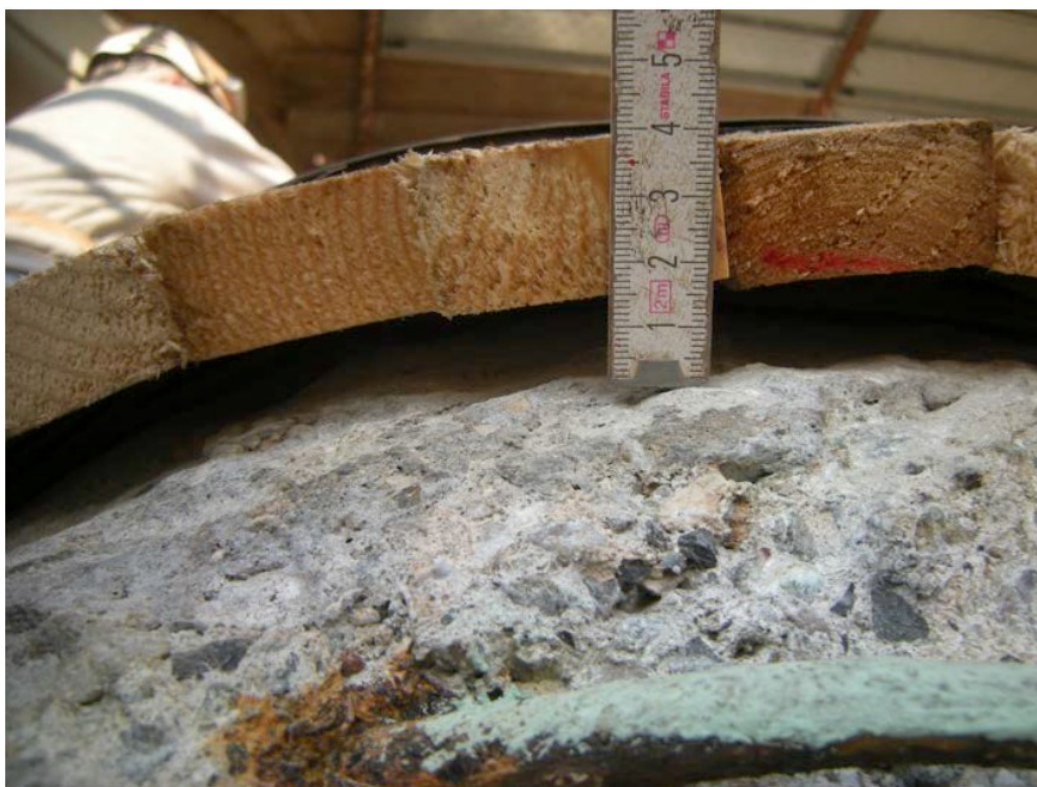
Figure B.4-10 Wooden formwork detached from the concrete substrate by at least 15 mm [49].

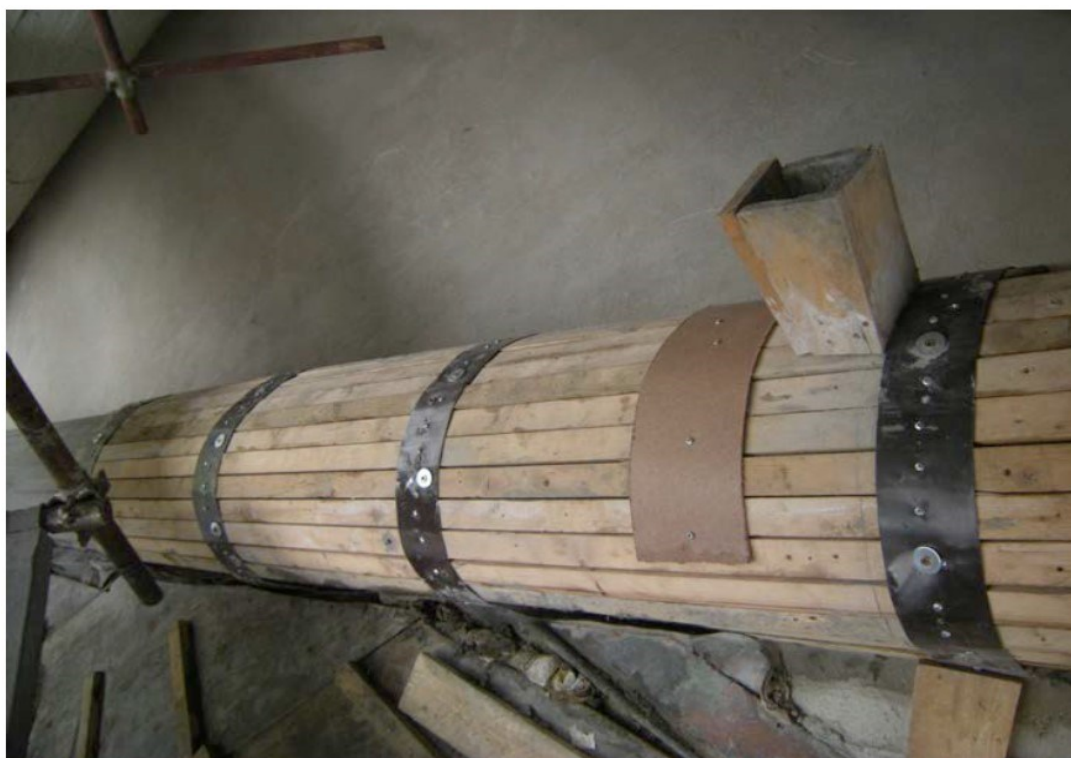
Figure B.4-11 Wooden formwork with "funnel" for the casting of the pourable mortar [49].

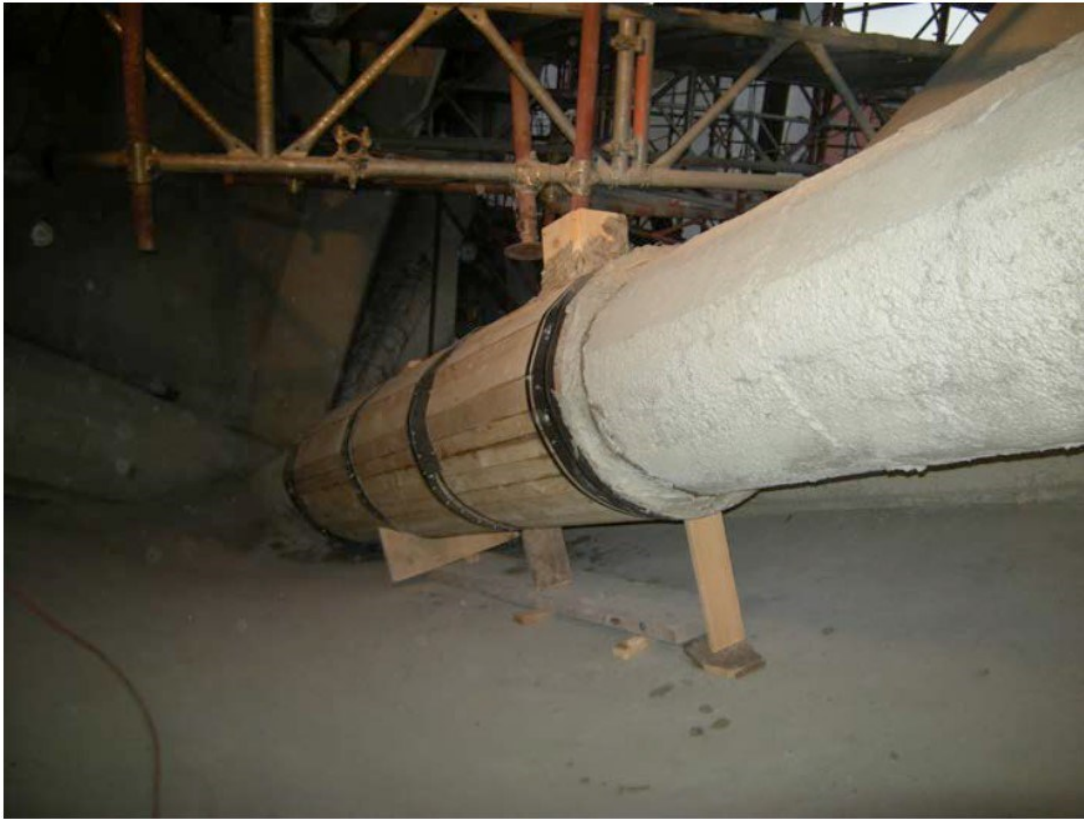
Figure B.4-12 Detail of the sealing of the formwork with mortar based on binding plaster [49].

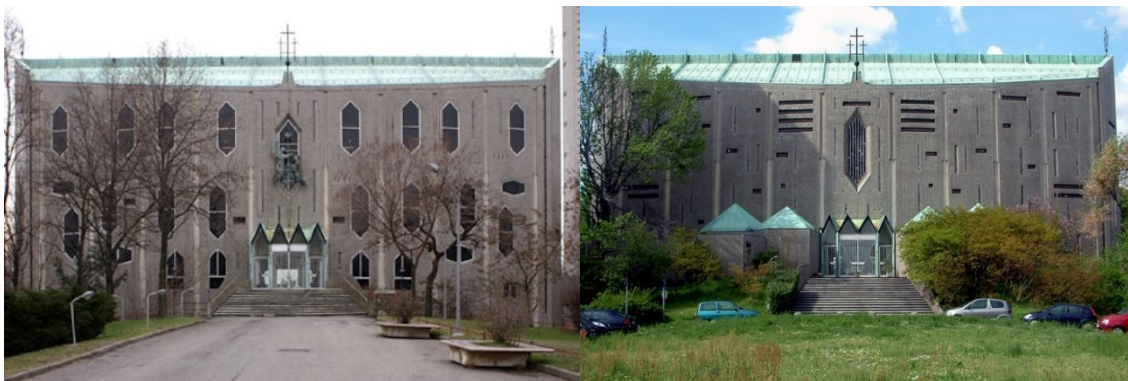
Figure B.4-13 External views

The church (Figure B.4-13-14), dedicated to Santa Maria Annunciata, is located in the area of the San Carlo Hospital in Milan. The church was designed by Gio Ponti between 1960 and 1963, and was completed in 1967. The structure of the church consists of a system of twenty pillars of exposed reinforced concrete façade that support ten trusses (also of reinforced concrete). The degradation of the columns was caused mainly by the corrosion of the steel reinforcement that caused the spalling of the cover layer (Figure B.4-15). The building is located in an urban environment free of chlorides, so, in this case, the corrosion of the reinforcement was mainly due to carbonation of concrete [50].

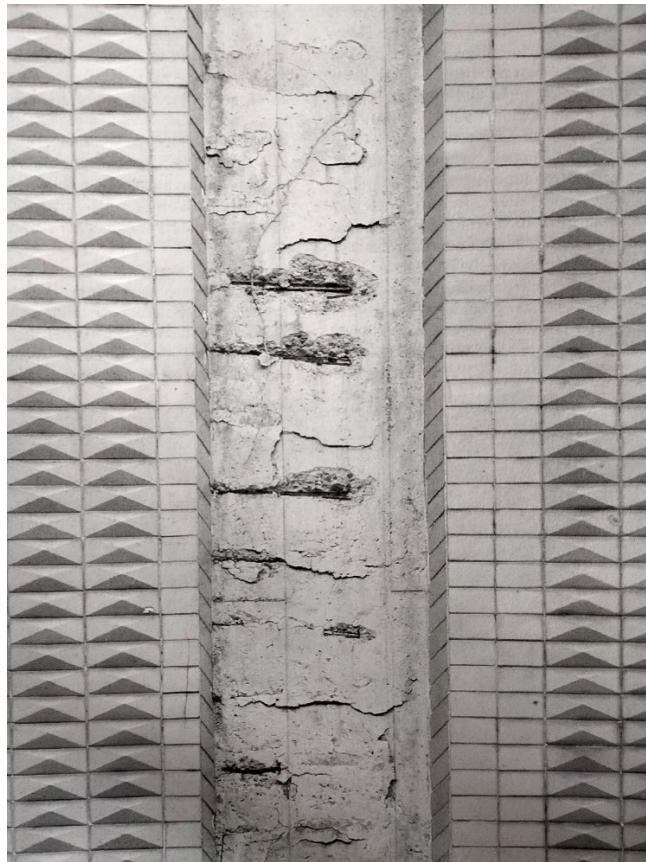
Figure B.4-15 Cracking and expulsion of cover caused by corrosion of reinforcement bars.⁴

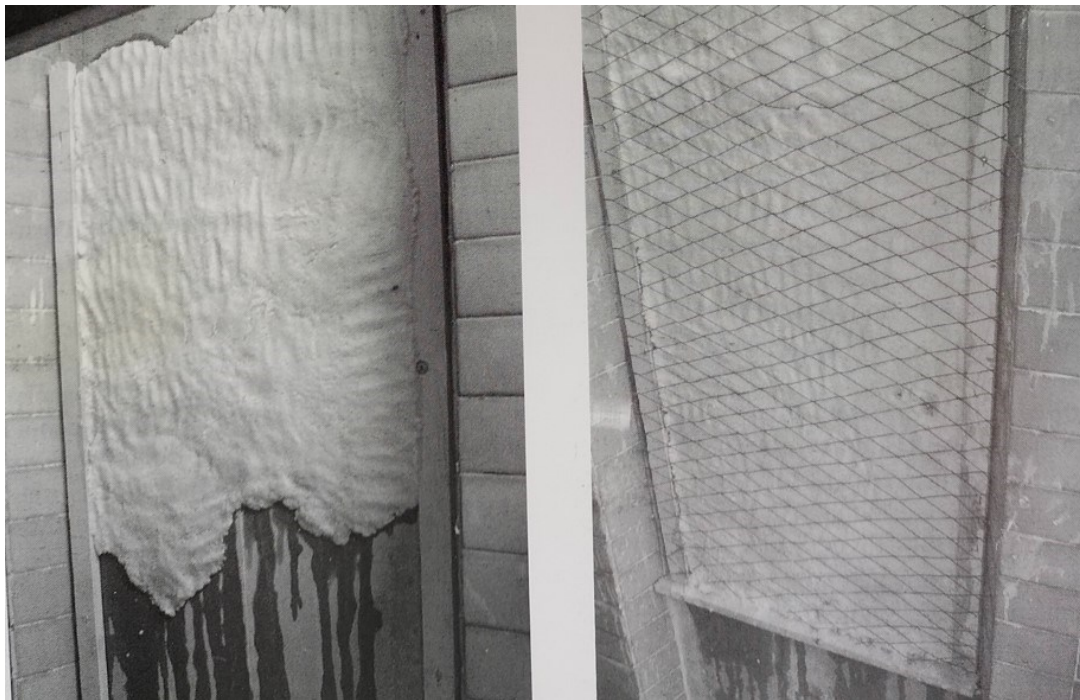
Figure B.4-16 Anode system: cellulose pulp layer on the left, titanium mesh on the right [50].

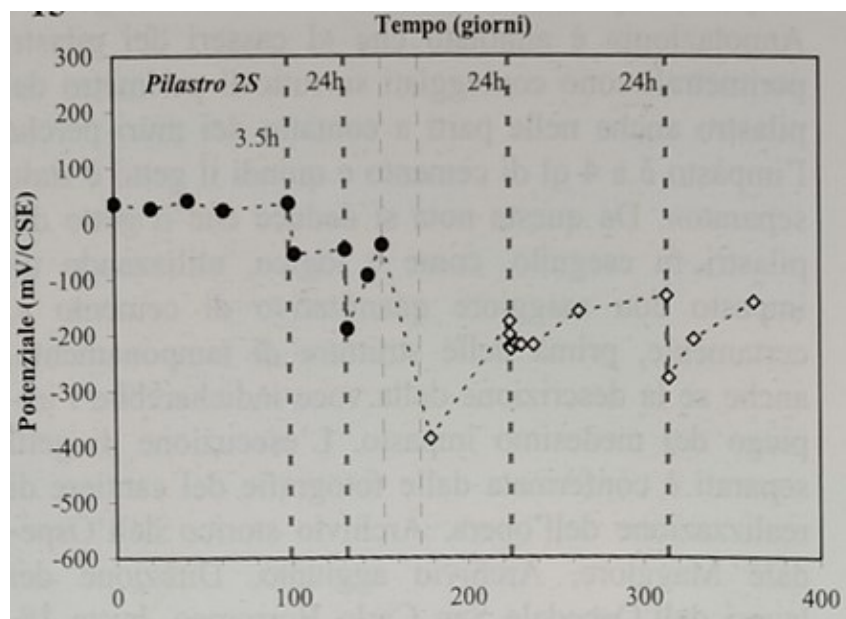
Figure B.4-17 Evolution over time of the mean potential values of the reinforcements subjected to electrochemical re-alkalization treatment [50].
