Merged Report on In-Depth Case Studies

TU Delft – Chair of Heritage and Technology

Editors: Gabriel Pardo Redondo and Silvia Naldini (TU Delft)

Date: November 19, 2021

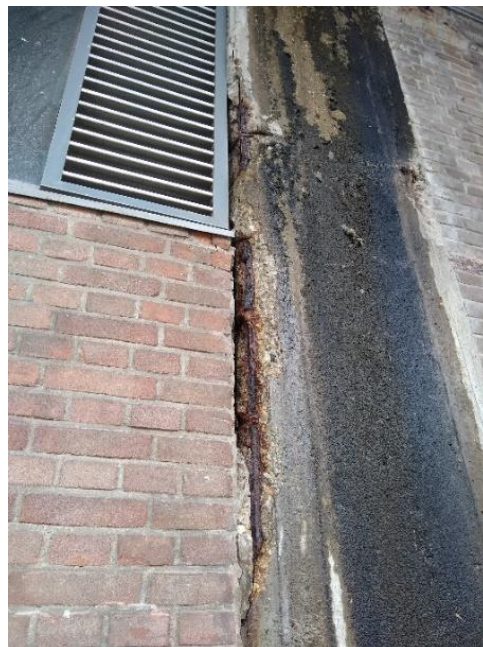
The exterior of the building concentrates extensive and severe damage, especially the south facade. The north wall, built in 1951, has an open continuous balcony on the first floor. The area of the balcony has extensive biological growth in the upper side and edge, and scattered spalling, cracks and rust layers in the underside of the balcony slab. Some of the columns of the ground floor, especially the ones closer to the expansion joints of the building, also exhibit scattered signs of damage induced by corrosion (spalling and cracks); the water seems to easily drip through the balcony slab and run down to the face of the columns.

Figure 5. Corrosion damage in column at the north facade (2020).

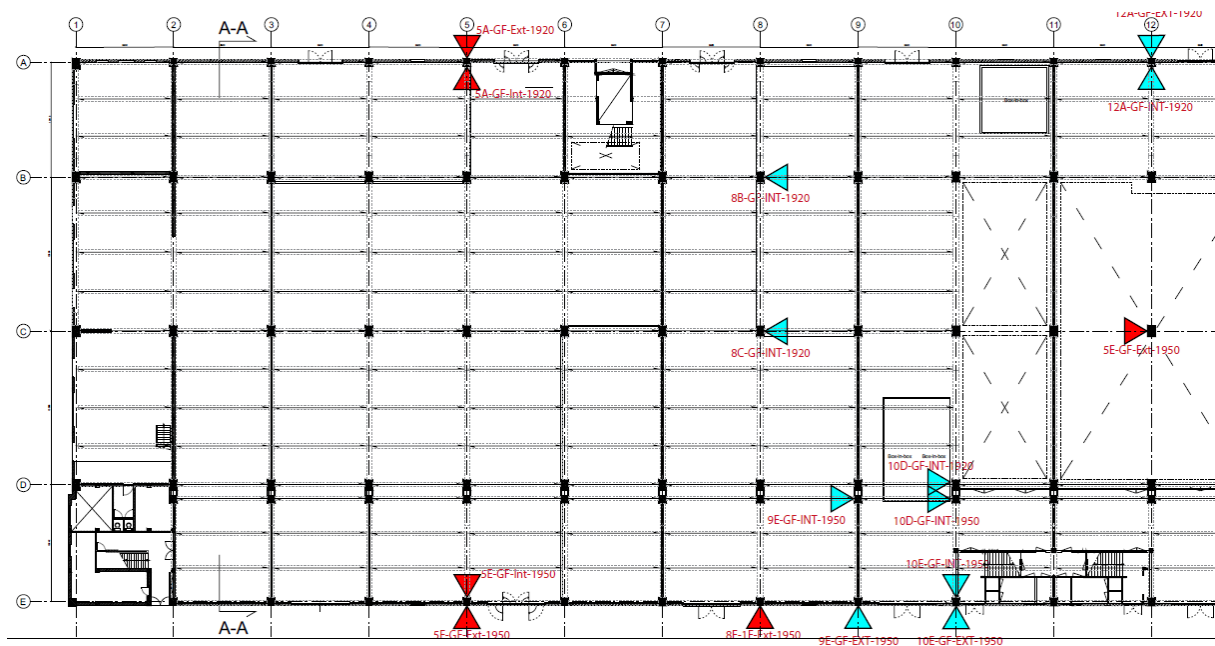
The tests were conducted on 16 columns on July and October, 2020. The columns were selected according to two parameters: exposure (interior and exterior) and age (from 1920 and from 1951)

Figure 8. Floor map indicating the columns tested. Red triangles denote columns tested in July and Cyan triangles columns tested in October.

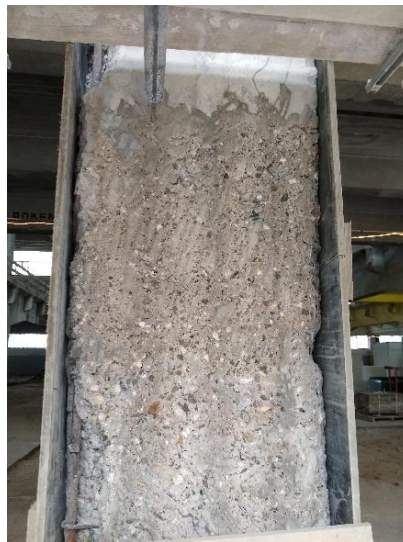
Figure 9. Exterior south column with render removed.

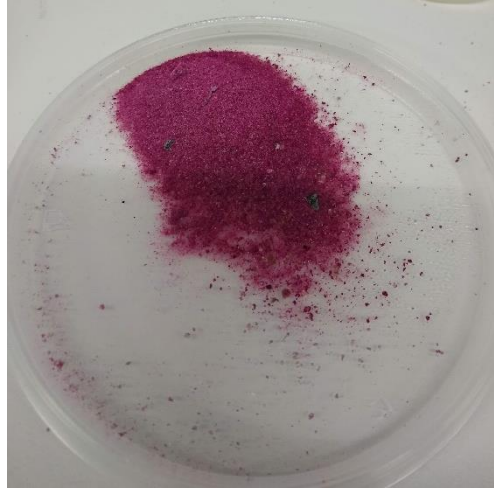
Figure 10. Powder sample in petri dish sprayed with phenolphthalein. The pink colour indicates a pH above 9.

The carbonation front of the 1951's columns was less than 10 mm in both exterior and interior columns. Whereas, the carbonation depth in the 1920's columns was 35 mm in the exterior columns, and 50 mm in interior (see Table 1). To note, the exterior face of column 5A (1920's column) had a 40 mm thick render applied in the 1980s. The carbonation profile revealed that the render was not carbonated, but the concrete from a depth of 50 mm had a slight carbonation, which had obviously occurred before the intervention.

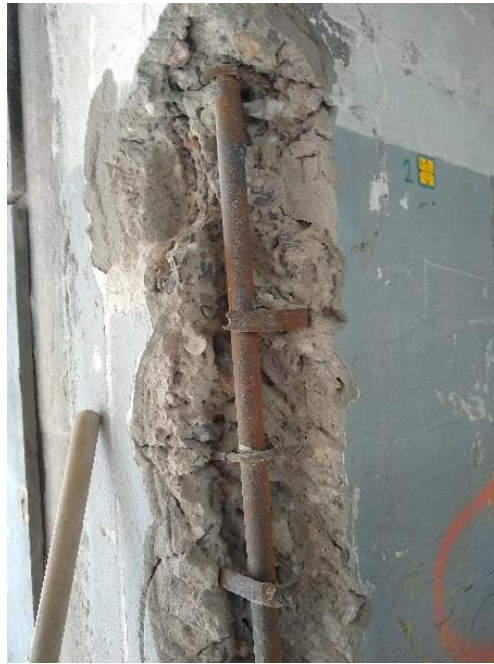
On average, the minimum concrete cover in the 1920's columns is about 40 mm, whereas the 1951's columns have a minimum average concrete cover of 22 mm. Exterior columns have between 4 to 16 mm more cover than interior columns. (refer to Table 1).

Figure 11. Exposed reinforcement in 1920's column.

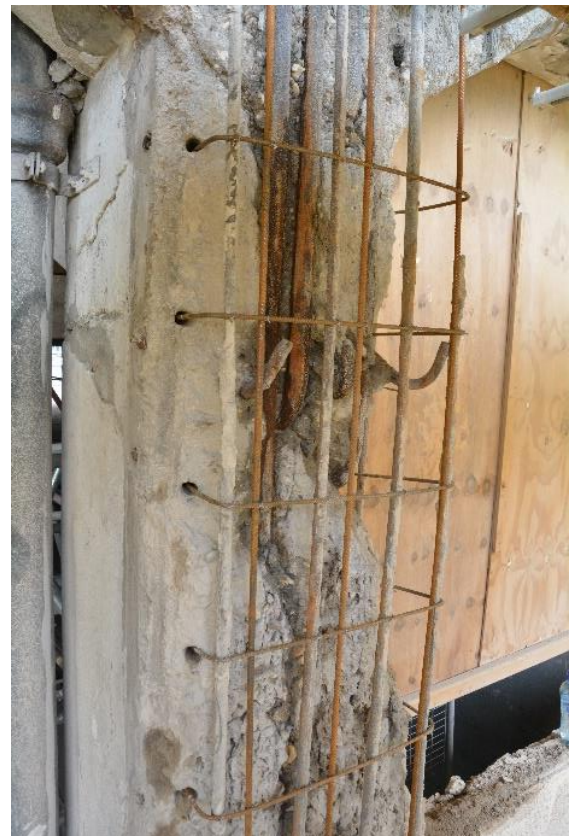
Proceq Profoscope was used to estimate the reinforcement layout and diameter. At the moment of the inspection, a few columns on the south facade were being repaired. The reinforcement of these columns were visible (Figure 12) and it was possible to confirm the readings obtained with the Profoscope.

The columns are reinforced with vertical round rebar with a diameter ranging from 18 to 32 mm, with a spacing between 150 and 250 mm. The horizontal reinforcement (or ties) has a diameter between 10 to 12 mm with a spacing between 250 to 350 mm on centre.

The main difference between 1920 and 1951's columns is the spacing of the ties. In the 1920s the usual spacing is 350 mm, whereas in the 1951s the maximum spacing is 250 mm.

Figure 12. Exposed vertical rebar in 1920 ground floor column (exposed side). The white-ish rebar is original (4 in total), the thinner slightly rusty rebar is new.

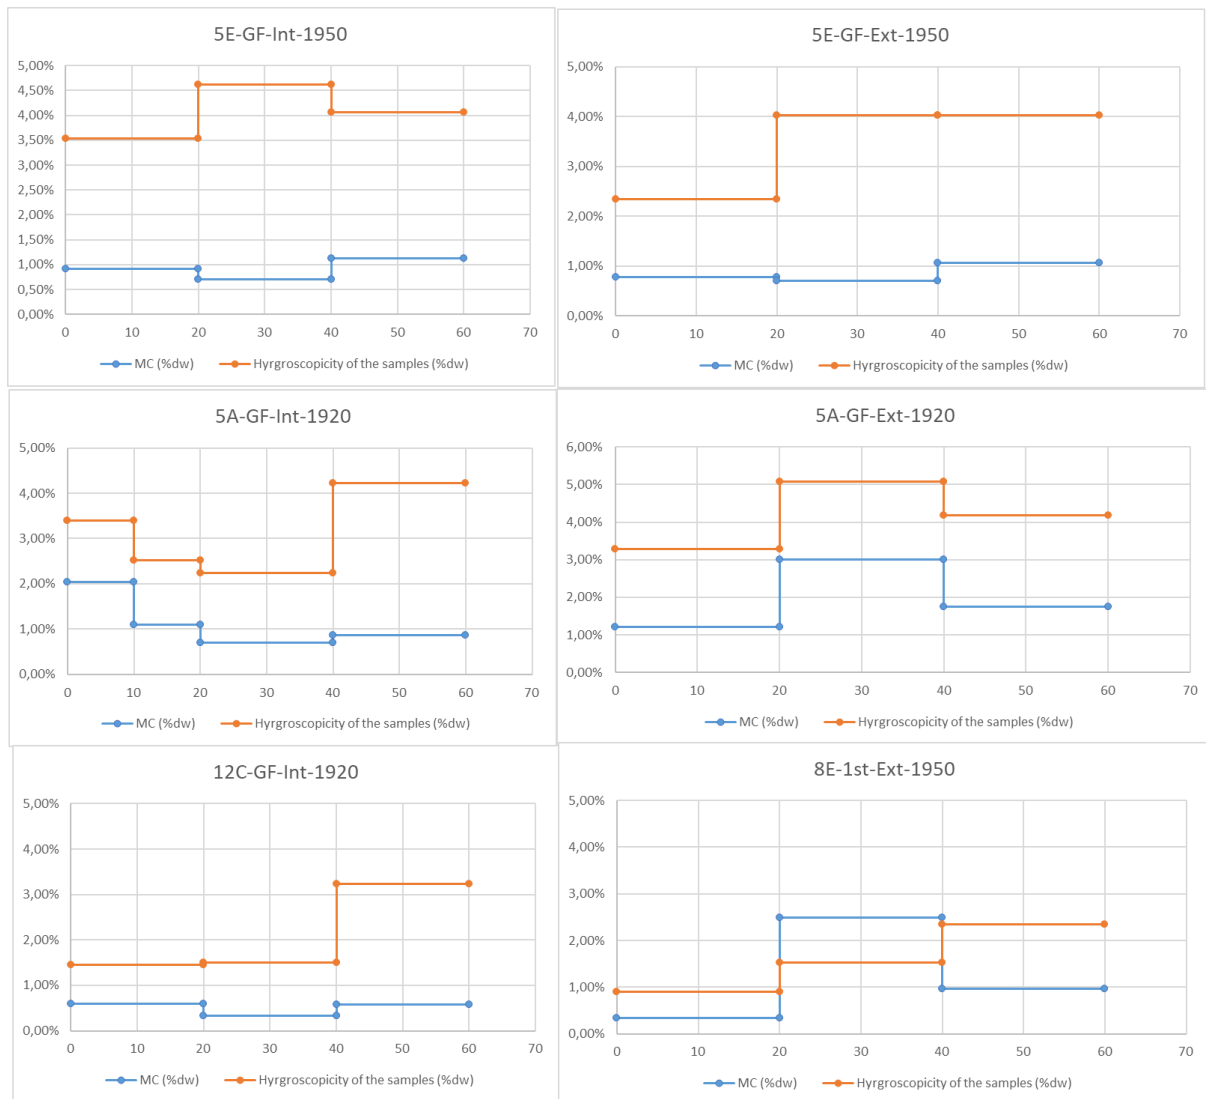
HMC is higher than the MC content in all but one case of the sample, column (8E-1st-Ext-1951) (see Figure 15). This means that no moisture source is present in these cases. The increase ranges from 1.67 times in the sample 5A-Int-1920, depth 0-10 mm, to 6.55 times in the sample 5E-GF-Int-1951, depths 20 to 40 mm.

The highest HMC were in exterior columns with values from 4% to 5% in depths 20 to 60 mm. The maximum HMC in interior columns was 4.5%.

1920's columns have higher HMC values in depths 40-60 mm. Whereas the 1951's columns have higher values in depths 20 to 40 mm. That gives an indication where the highest concentration of salts might be, which in this case was used to select the samples for a chloride analysis.

Figure 15. MC and HMC graphs of different samples.

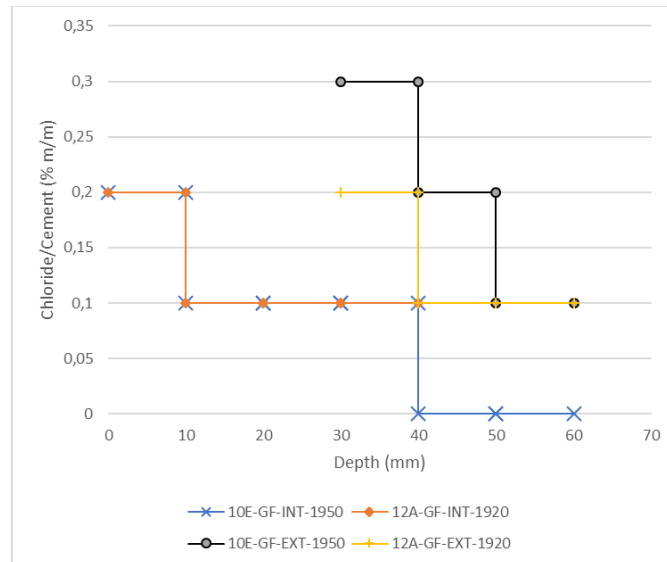
Both interior columns have similar profile (Figure 16), with a maximum chloride content per quantity of cement of 0.2% in the first 10 mm. In the area where the reinforcement is located (depths 20-40 mm), the chloride content is 0.1% or lower.

In the concrete surrounding the rebar of the exterior columns (30-50 mm), the chloride concentration is 0.3-0.2% in the 1951s, and 0.2-0.1% in the 1920s (Figure 16).

The results indicate that the chloride source comes from external sources and it is not in the concrete mixtures. The concentration decreases as the depth increases.

Figure 16. Concentration of chloride content in cement.

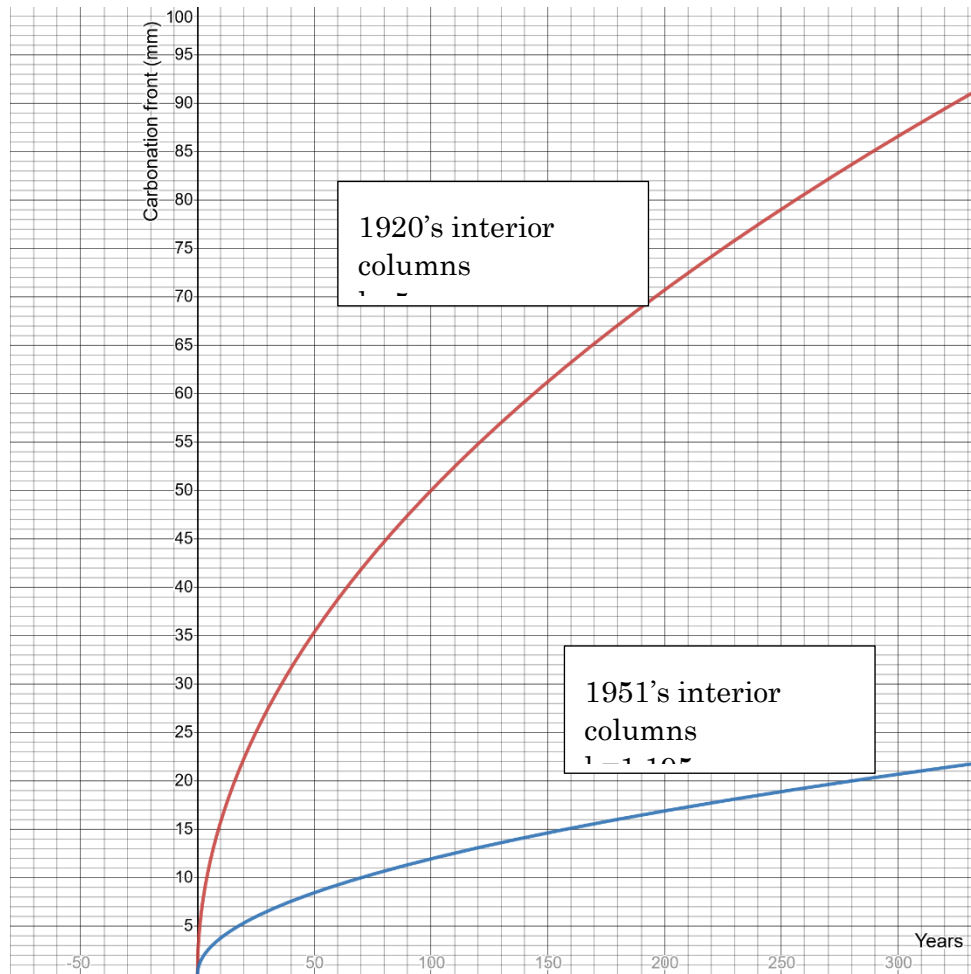
larger. The carbonation rate is a parabolic function related to a carbonation coefficient (K), multiplied by the square root of time (\sqrt{t}) according to Fick's first law [2,7]. In the literature, there are not a clear definition how to estimate K in existing buildings, since it is based on concrete composition and environment. Some authors have tried to establish a range of K values based on tests in existing buildings. For example, Monteiro et al. tested 87 concrete buildings up to 99 years old, obtaining values for K between 3.07 and 4.06 for unpainted concrete in relatively humid environments [6]. In the case under study, as the age and carbonation depth is known, the coefficient K can be obtained, resulting $K = 5$ for the 1920's and $K=1.195$ for the 1951's interior concrete columns. Once the coefficient K is obtained, the carbonation rate can be plotted to estimate when the carbonation front may reach the reinforcement (Figure 19).

Following this line of thought, identical concrete composition under similar environmental conditions should have similar carbonation rate. However, there is a substantial difference in carbonation between the interior and the exterior columns from the 1920s, there is not difference in the 1951's columns though. One explanation for the difference in carbonation rates of the 1920's columns is that, based on historical pictures, there was an original render, of about 10 mm, applied in the exterior face of the columns (Figure 18). Applying an additional render reduces the carbonation depth by increasing the cover. Another explanation is the difference of MC between interior and exterior columns. High MC can slow down the carbonation rate due to the fact that the water blocks the pores [8]. The difference of MC between the interior and exterior may not be substantial nowadays, but in the past, when the building was in use, the MC of the exterior columns was possibly higher due to splashes, and water run-offs when loading and unloading containers.

Figure 19. Estimated carbonation rates of 1920's and 1951's interior concrete columns according to Fick's first law.

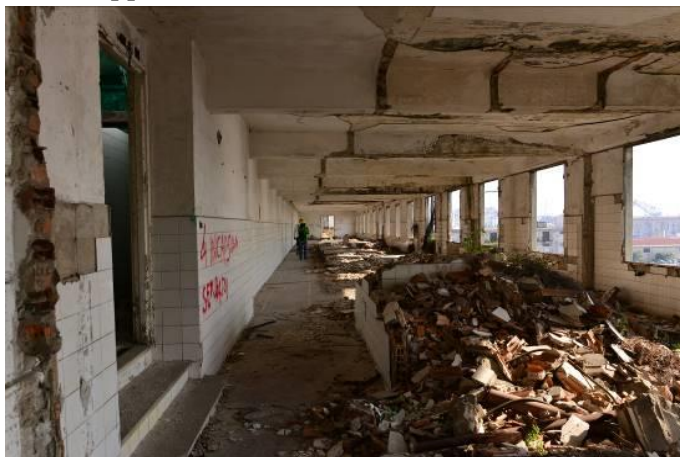
- Degradation of anthropogenic origins and causes. Location: all rooms. Particularly sensitive to changing rooms, offices, doors and windows on all floors, stairwells. Causes: lack of access control. During the dismantling phase of the installations, numerous slots were opened in the horizons to allow the dismantling and movement of the machinery to be removed. Dynamics: use of the premises for bivouacking and incongruous use of the materials and spaces. Effects: demolition of many internal partitions, damage to internal and external doors and windows, sanitary fittings, architectural surfaces, removal of materials (e.g. staircase coverings), furniture and documents still present in the complex. Possible developments: At present, together with the closure of all possible access points, periodic monitoring of the interiors by security personnel is also

accompanied; the combination of these conditions should allow this kind of damage to be stopped.

Example of anthropogenic degradation

Degradation of anthropogenic origins and causes: during the dismantling phase of the inner technological installations linked to the movement of grain, numerous holes were opened in the horizontal structures to allow the dismantling and movement of the machinery to be removed. The lack of access control to the complex, further, allowed the spoliation of the most valuable surviving materials (stone slabs, wrought iron parapets), the use of the spaces as bivouacs by homeless people and outright vandalism, with consequent heavy damages.

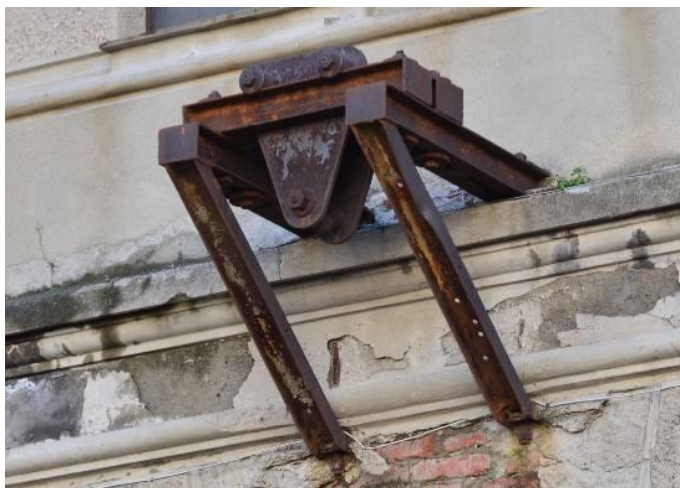
- Corrosion of iron and cast iron structures. Location: iron parapets at the solar pavilions, external doors and windows, boat mooring bollards, various metal items inside and outside the complex. Causes: condition of exposure of the element to atmospheric agents and chemical composition of the metal alloy. Dynamics: The processes are mainly of two types: chemical (contact with a compound such as oxygen or carbon dioxide) and electrochemical (processes of an electrical nature induced by the humid environment) and consist in the transformation of steel into "rust" (ferric oxides $\text{Fe}(\text{OH})_2$, $\text{Fe}(\text{OH})_3$, etc.). The process is particularly fast in the presence of atmospheric pollutants (hydrochloric acid, hydrogen sulphide, etc.). Effects: loss of mechanical strength of the material, which gradually detaches in the form of flakes and dust, thus allowing the phenomenon to be triggered in the inner layers. The conditions of exposure and the characteristics of the chemical composition of the artefact lead to different types of corrosion: uniform, disuniform, ulcer/crater, penetrating, cavernous, intergranular. Possible evolution: gradual reduction of the section of the artefact.

Oxidation and corrosion of iron and cast iron items: this is linked to their conditions of exposure to the aggressive environmental agents and lack of maintenance and renewal of protective paints (caused by carbonation or chloride) be ruled out, especially in the case of particularly damaged elements.

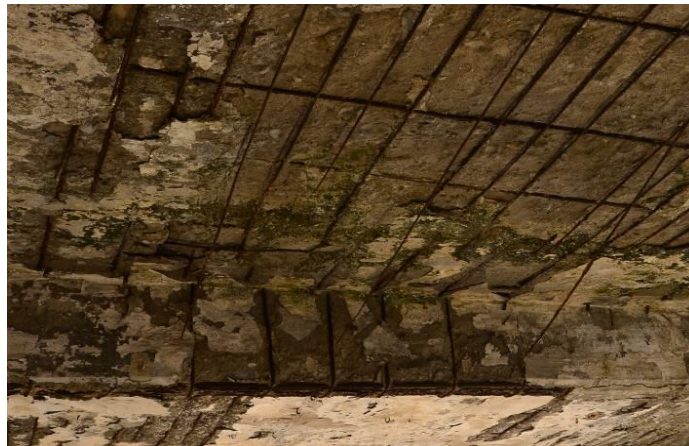
- Corrosion of internal concrete reinforcement. Location: the phenomenon is particularly evident in all the roof slabs, on the internal slabs of the central body, near the most exposed pillars (e.g. in the railway wagon loading gallery on the sea side and in the central body). Causes: condition of exposure of the element, inherent in it or generated by environmental alterations (e.g. water infiltration, exposure to marine aerosol due to damage to protection systems such as windows and doors). At a chemical level, this causes: advancement of the carbonation process which destroys the oxide film and with it the conditions of passivity; exceeding of a critical chloride content. Other causes: presence, in the case of structures affected by electric fields, of currents interfering with the reinforcement. Dynamics: Under normal conditions, the reinforcements inside the concrete passivate, i.e. they are covered with a thin, compact, coherent and uniform layer of protective oxide which blocks the advance of the corrosion process of the same. The chemical process consists in the transformation of steel into rust (ferric oxides Fe(OH)_2 , Fe(OH)_3 , etc.). Effects: Internal compressive stresses on the concrete and tensile stresses on the surface, due to the increase in volume of 2 to 6 times that of the iron from which they originate. These in turn generate surface cracks running parallel to the reinforcement rods, which increase progressively and culminate in the total expulsion of the cover. At the structural level, corrosion of the reinforcements leads to a reduction in the resistant section of the reinforcements, a reduction in their adherence, which may also cause a loss of anchorage. Possible developments: detachment of the cover and surface finishing layers; advanced states of corrosion may contribute to the collapse of structural parts.

Oxidation and corrosion of the reinforcements inside the concrete: as the effect of the carbonation of the concrete and the action of chlorides brought upon them by marine aerosols.

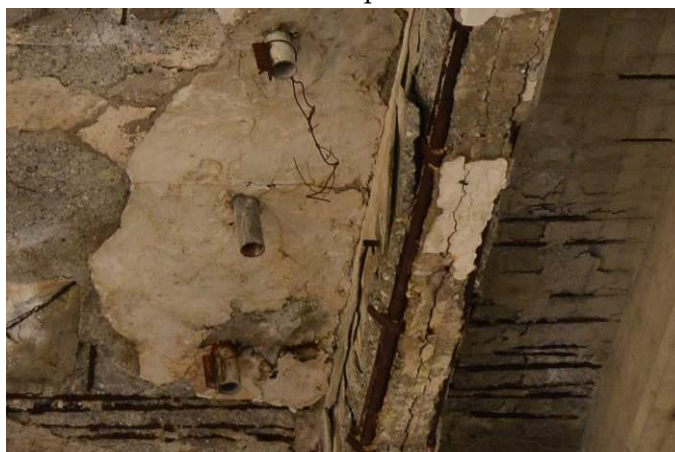
- Detachment/expulsion of concrete cover. Location: the phenomenon is particularly evident in all the roof slabs, on the internal slabs of the central body, near the most exposed pillars (e.g. railway wagon loading tunnels and central body). Causes: freeze-thaw cycles, sulphate attack, chloride attack, corrosion of the reinforcements Dynamics: increase in volume of the reinforcements due to corrosion causes detachment of the outermost material. Effects: loss of the cortical layer, which also has a

protective function for the reinforcement iron; loss of the covering plaster; worsening of the exposure conditions of the reinforcement. Possible evolutions: the worsening of the exposure conditions of the reinforcement causes an acceleration of the corrosion process of the reinforcement; it exposes the deeper layers of the concrete to degradation agents. The process leads to the progressive deterioration of the performance of the structural element until it collapses.

Detachment/expulsion of the concrete cover: this phenomenon is particularly evident in all the structures most subject to the carbonating action of atmospheric agents and chlorides brought in by the marine aerosol, such as the roofs slabs, the internal slabs of the central part of the complex, the most exposed pillars (e.g. in the tunnel exposed to the sea, hosting the loading and downloading railway wagons of the grain). The phenomenon can also be related to the mix composition of the concrete, the binder used as well as the metal alloy employed for the inner reinforcement, and cracks created by critical stresses, movements or deformations of the structures.

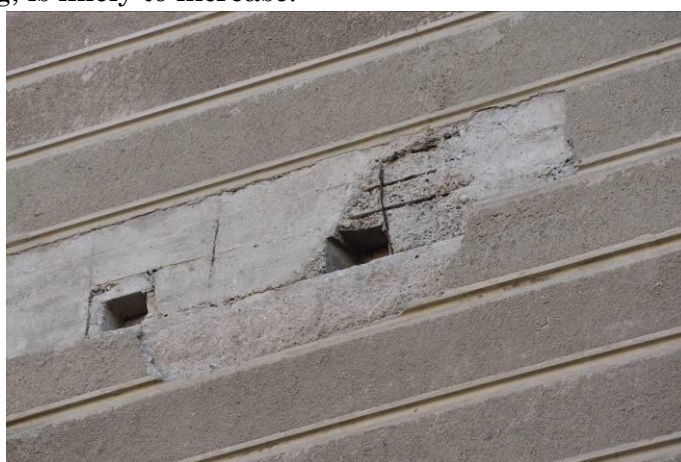
North facade

- Lack of plastering. Location: exterior elevations, interior surfaces in several areas. Causes: water run-off due to malfunctioning of rainwater collection and disposal systems; action of the concrete substrate; action of saline efflorescence (particularly in interiors), erosion, anthropogenic mechanical actions, freeze-thaw cycles, etc. Dynamics: absence is the final stage in the evolution of degradation phenomena due to erosion, efflorescence, disintegration, detachment caused by water infiltration or the action of the increase in volume due to corrosion of the underlying reinforcements and is therefore to be related to the other items. Effects: absence of plaster coating, even decorated (e.g. external facades). Possible evolution: the deterioration, without prejudice to the condition of the building, is likely to increase.

Lack of render: particularly evident on the external and internal elevations, due to deterioration caused by erosion, sulfating, freeze/thaw cycles and to anthropogenic action.

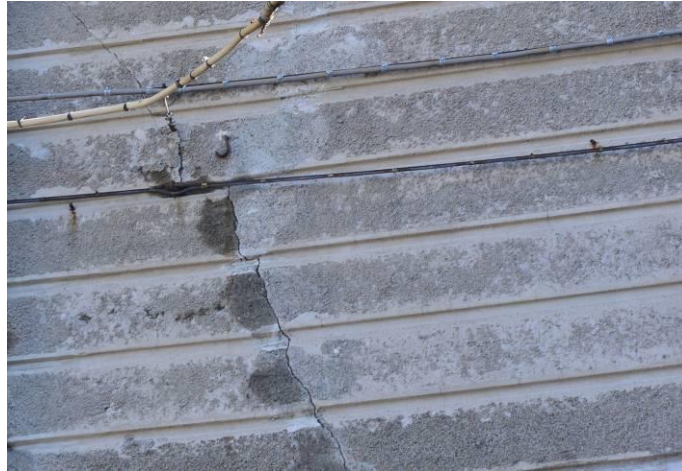
Noth Facade

- Erosion. Location: external facades, internal walls near openings.
Causes: percolation of rainwater, wind action. Dynamics: mechanical and chemical action due to water run-off as a result of surface exposure conditions or, in more serious cases, damage to structures protecting the surfaces (cornices, eaves, etc.) and/or abrasion of windblown dust.
Effects: gradual. Possible evolution: In the absence of protective measures, degradation will continue to extend.

Erosion: widespread on all external surfaces and in particular those below the damaged water collection systems (gutters, downpipes, etc.), as well as on the parts of the elevations most exposed to wind.

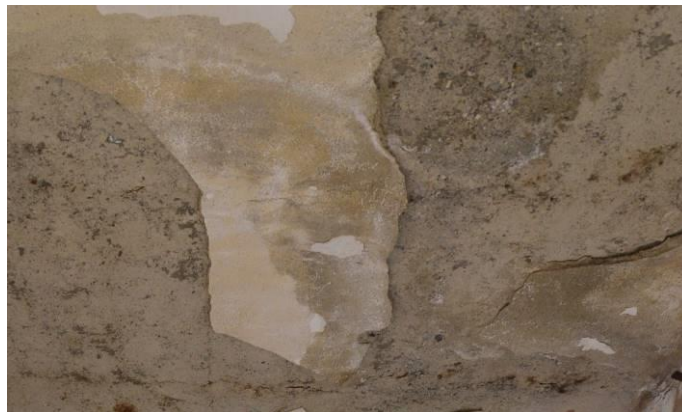
- Salt efflorescence. Location: various portions of internal and external plaster, structural elements in contact with the ground (in particular sea tunnel for loading railway wagons). Causes: exposure to atmospheric agents, capillary rise from the ground, wind action. The phenomenon is caused by the crystallisation of salts, particularly chlorine and sulphur brought in by marine aerosols and rainwater. Dynamics: formation of substances with a crystalline appearance inside the material, causing the most superficial parts to detach (crypto-efflorescence). Effects: gradual loss of material and/or impoverishment of its strength characteristics (disintegration). In the case of concrete, this is related to the phenomena of corrosion of the reinforcement (in particular chlorides) and therefore to the detachment of the iron covers and the formation of swelling, expulsion of material, chalking in the case of sulphates. Possible evolutions: the phenomenon is destined to evolve over time.

Saline efflorescence: present above all on the surfaces most exposed to the aggression of the atmospheric agents, in particular with water stagnation, or the action of marine aerosols and on the structures directly in contact with the ground (pillars and masonry)

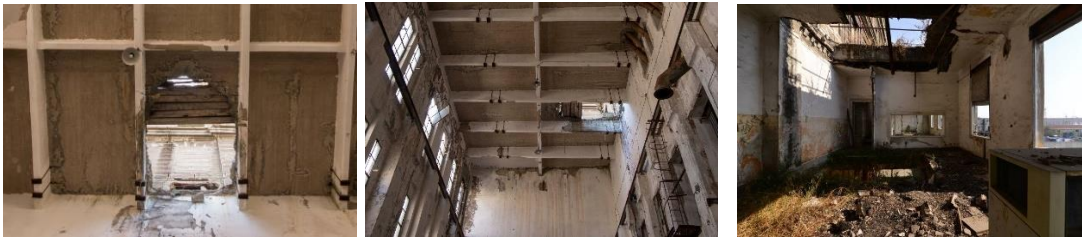
- Lacking parts in floor structures. Location: roof and floor slabs of the pump room, mainly in the sea area (offices, changing rooms), internal slabs of the main building, first floor slab (slab of the railway track portico). Causes: mechanical actions (anthropogenic, by falling portions of the floor above), collapse due to corrosion of the reinforcement rods and degradation of the concrete. Dynamics: the deterioration of the concrete and reinforcement causes a loss of strength which leads to the element collapsing even under its own weight. The fall of the mass of the portion of the slab can cause damage to the one below. In some slabs, slots have been intentionally opened to allow materials to be removed and dropped to the ground. Effects: formation of rainwater ingress paths, loss of functionality of the floor. Possible evolutions: the advancement of the deterioration phenomena is destined to amplify the phenomenon. Several horizons are in a state of imminent collapse.

Lacking parts in the floor structures: it is mainly the effect of the above mentioned dismantling of inner machineries and installations. There are also some limited portions of the complex that have collapsed due to localized deterioration of the structures.

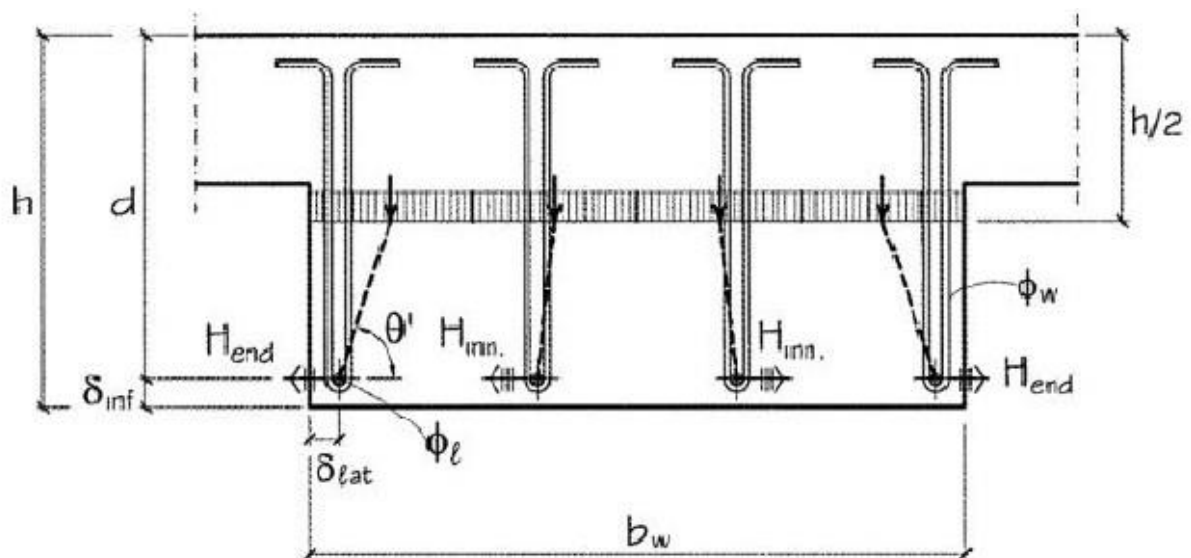
With regard to the degradation of the constructive elements, and not only of the material, the problems are mainly related to the shear reinforcement of the structural elements. The presence of open stirrups and U-shaped connectors leads to a fragile behaviour (shear failure of the beams and failure of the nodes) since an effective confinement of the concrete is not guaranteed. In this regard, the evaluation of the shear behaviour of the deflected elements is a problematic aspect of the construction type under consideration.

- reinforcing steel with a low carbon content, which gives the cracks typical of elements reinforced with high ductility steel;
- the transversal reinforcing bars (open U-shaped stirrups made of iron plates or rods) which are not able to provide adequate confinement to the concrete struts of the resistant truss.

Both aspects undermine the assumptions on which the model of the truss with variable inclination proposed by the current Technical Standard is based: in particular, due to the high ductility of the steels used, the core reinforcement is not able to limit the crack openings formed at the time of the first shear crack. This results in large deformations and the relative crack pattern is characterised by lesions which do not allow the crossing of compressed connecting rods with inclinations smaller than those corresponding to the yield crack.

Model of analysis of the transversal behaviour of a beam with U connectors

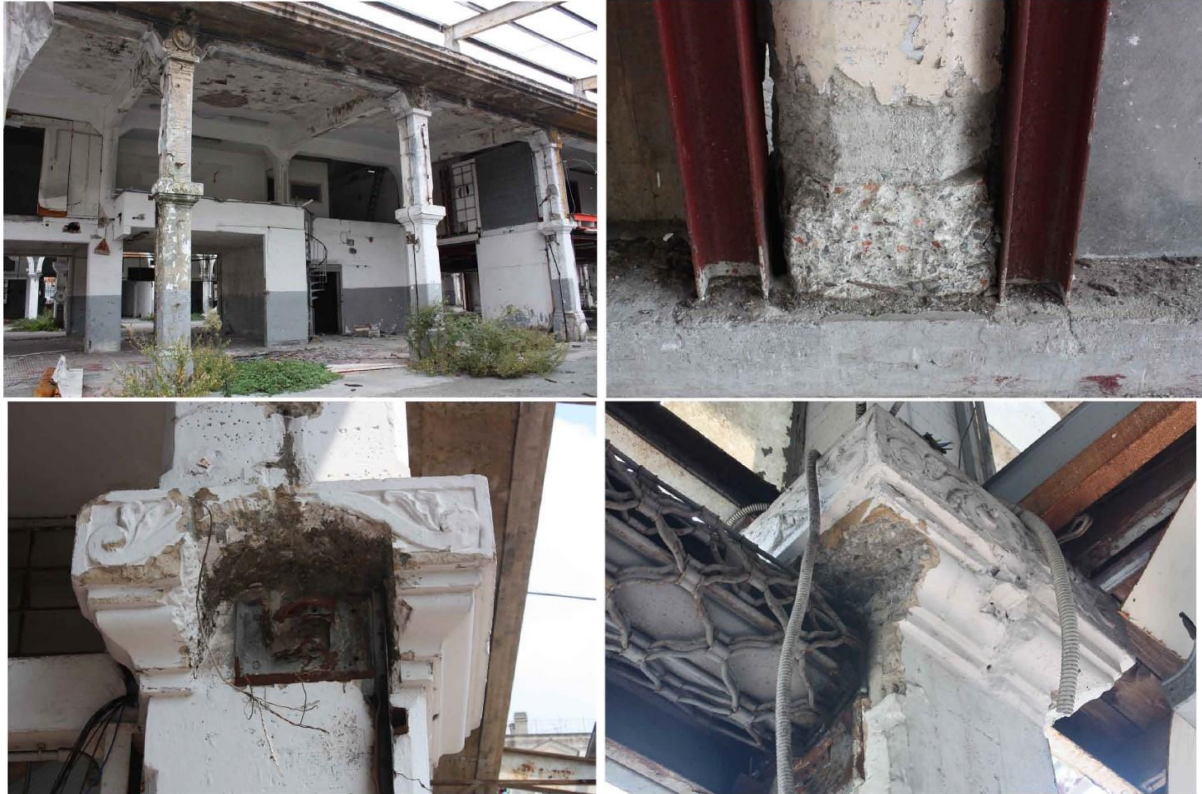
Several modifications to the pavilions have been realized over time, after their construction, in an uncontrolled way by the responsible of the single sales areas of the market: addition of steel beams, removal of glass partitions, insertion of technical installation in the reinforced concrete floors, anchoring of windows and doors to the pillars, new paintings etc .

The complex has been closed and abandoned since about ten years (precisely, since 2009, when the market was transferred in the western part of the city) and this has provoked a progressively degradation mainly due to huge and diffused water infiltration from the roofs and the broken or lacking windows.

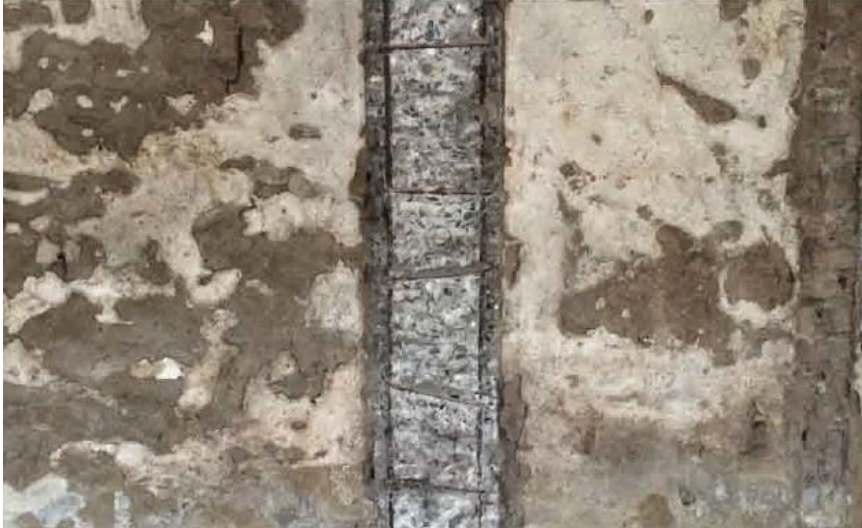
- saline efflorescences in the form of whitish substances with irregular diffusion and geometry.
- organic patina in the form of green deposit. The areas concerned could indicate both the presence of an excess of water and a poor quality of the conglomerate in terms of porosity.
- plaster breaks in continuity between the coating layers with respect to the substrate. The phenomenon could also be attributed to the structural changes and interventions made over time to the constructive elements.
- expulsion of ferris covers probably due to the depassivant action of chloride present in the material.
- static-constructive failures and deficiencies of slabs and inflexible elements due to corrosion of the irons placed on the underside of the reinforced concrete joists and the addition of slabs on the perimeter beams (canopy D).

Saline efflorescences

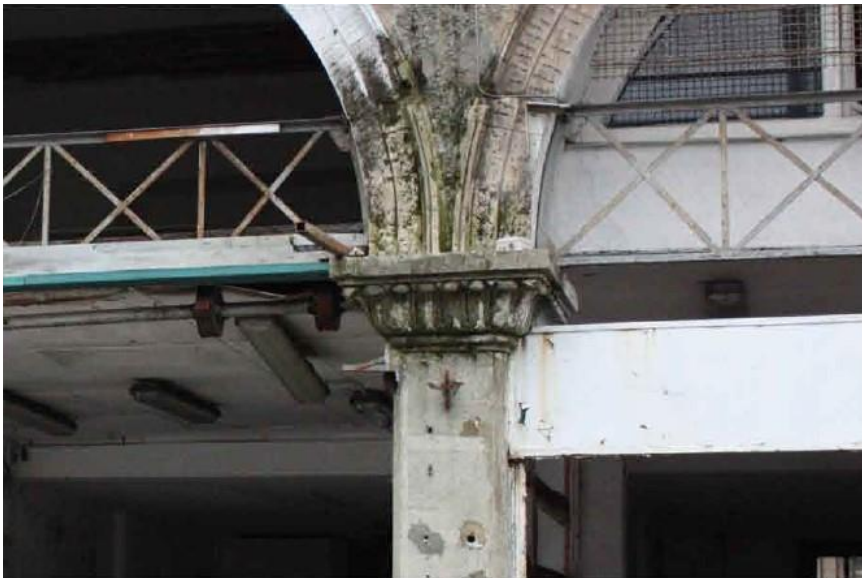
Biological patina

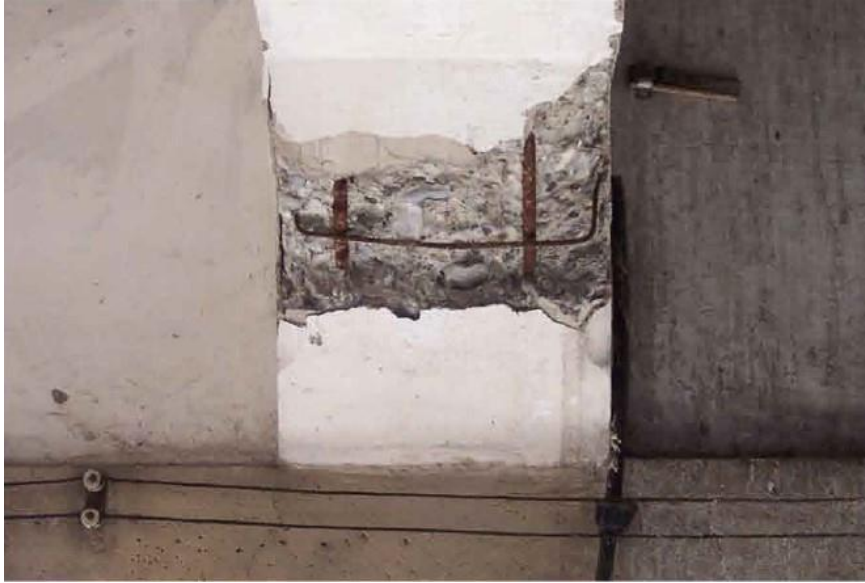
The prevailing degradation of reinforced concrete structures relates to: corrosion and shearing of the reinforcement bars, cracking, detachment and expulsion of the concrete cover, crumbling of the floors, salt efflorescence, patina and biological colonisation, missing structural parts (columns and beams). The others constructive components (like frames and surface treatments, for example) suffer for many others degradation phenomena like: lacking parts, erosion, loss of cohesion, surface depots (coherent and incoherent), fissures and cracks, among others.

Expulsion of the iron cover

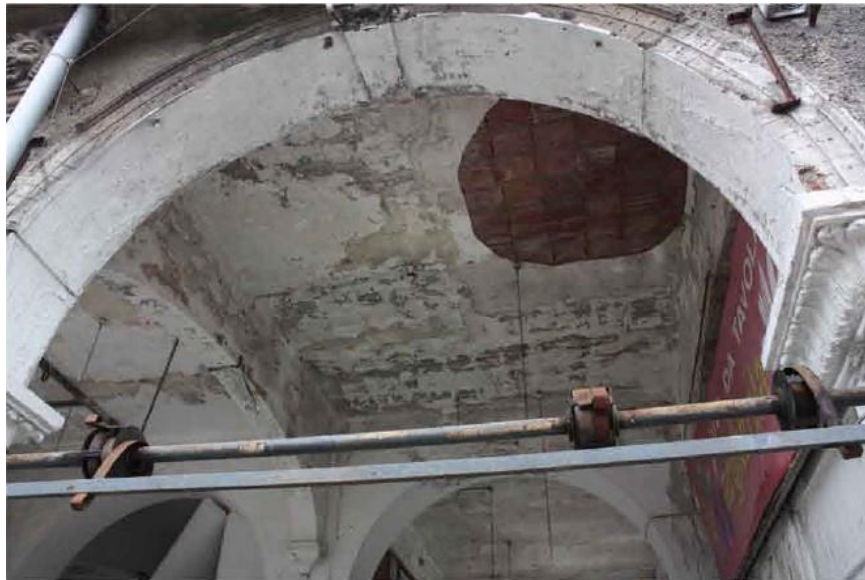
Detachment of plaster

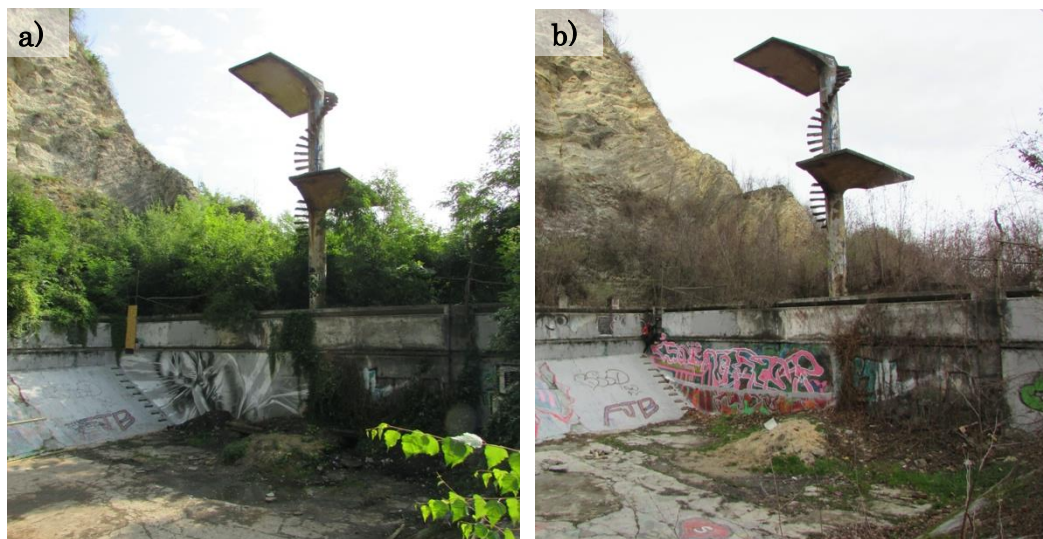
The structure of the diving tower and the swimming pool are in a state of ruin, i.e., it is virtually impossible to restore its original state without discarding most of the original materials.

Figure 5. General view of the diving tower and its surroundings: a) Photo taken on 21.7.2020, b) Photo taken on 27.2.2020.

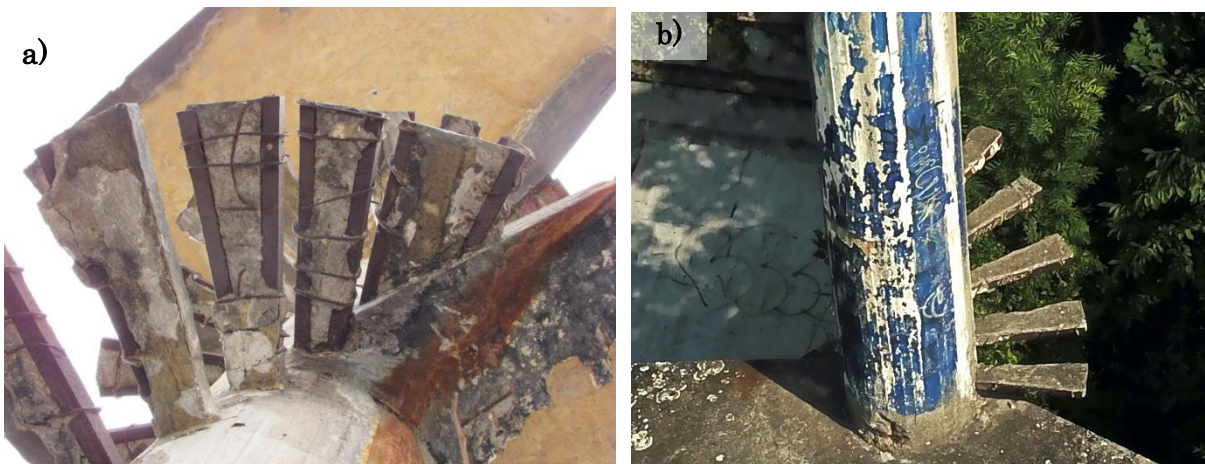
The stair steps have lost most of the concrete cover triggered by the corrosion of the reinforcement (Figure 7.a). In general, the concrete surface layers remain only on the top of the steps (Figure 7.b). The handrail that once spiraled along the stairs is absent. The first ten stair steps from the ground level have been removed for safety reasons since the complex is accessible to the public.

Figure 7. Details of the stair steps: a) View below the steps to the lower platform, b) Top view of the steps to the highest platform.

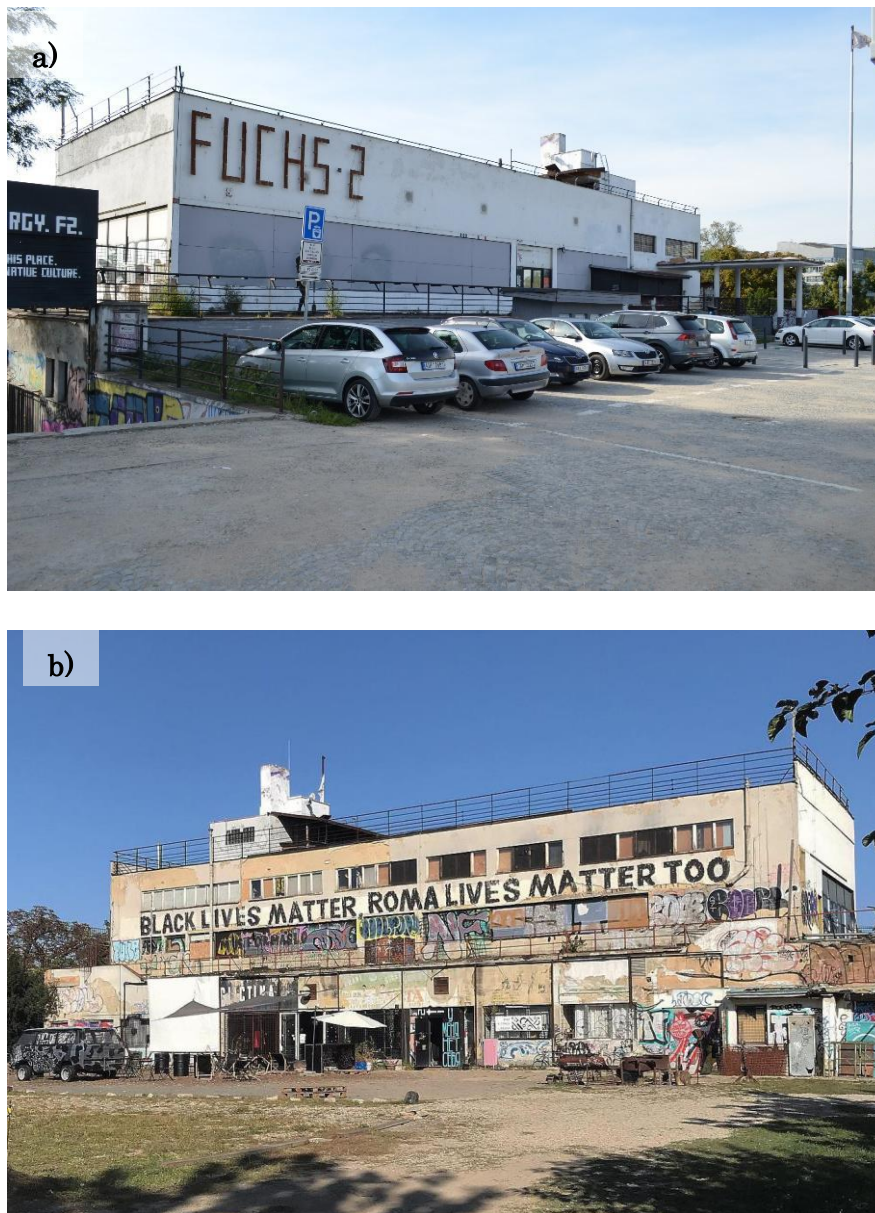
Figure 14: The recent state of the restaurant building: a) main façade, b) Western façade.

Despite reopening for public activities, the building remains in a poor state, only the most urgent repairs and the basic maintenance are being applied. Independently of the recent usage, a restoration of the building is being planned, a structural and historical survey of the building has been performed [2]–[6] and an architectural reuse plan has been proposed [1]. It follows the idea of the restoration of the building to the original 1930's state, removing the later interventions (Figure 15). It is in question if this approach is relevant as the original ice rink is missing.

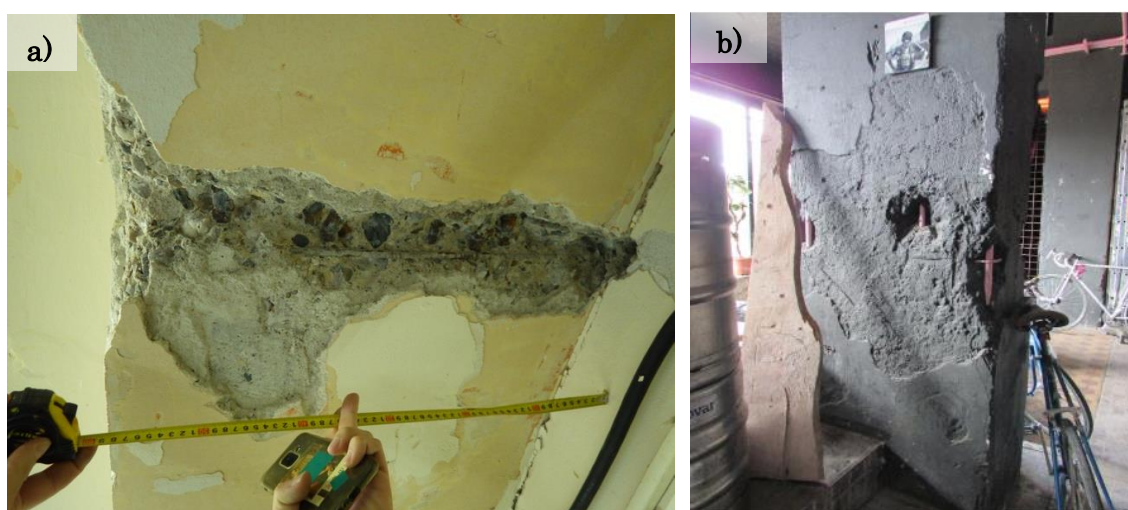
The visual inspection of the structure was performed on 15.5.2020. The description of the damage types was done according to the MDCS atlas [12]. A comprehensive survey was conducted in 2015 [5], in which material samples were collected and tested to identify the composition of various structural elements. The sampled areas were not repaired and, in some elements, the steel reinforcing is exposed (Figure 19).

Figure 19: Sampled areas in 2015: a) Aspect of a sampled beam, b) Aspect of sampled column.

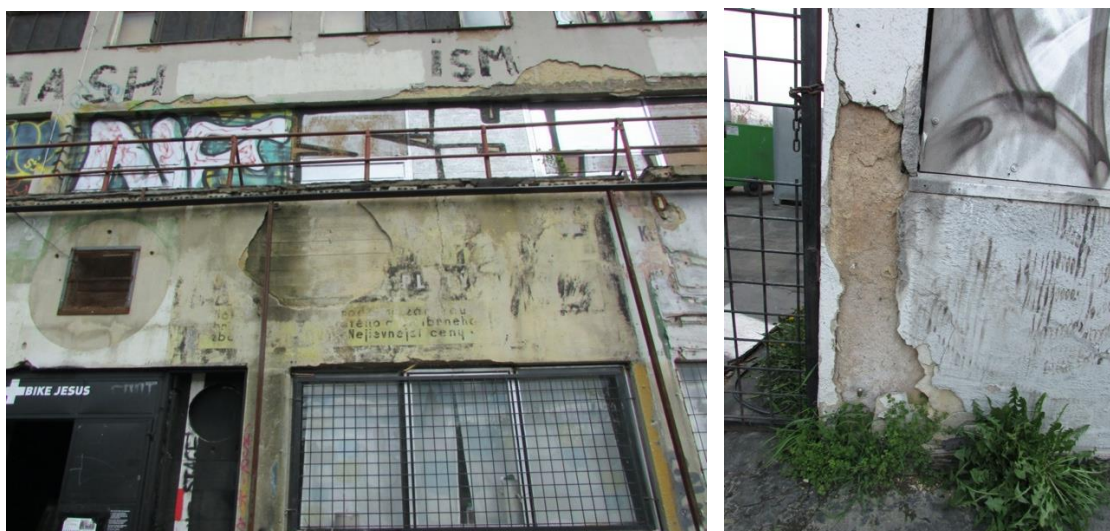
The exterior of the building is covered with a cement plaster, but only in the Western facade the plaster is original, but it is peeling off in many areas (Figure 20.a). The non-original plasters also show disintegration (delamination) in several areas (Figure 17.b).

Figure 20: Aspect of the cement plasters showing lacunas resulting from delamination: a) Detail of the original plasters preserved in the Western facade, b) Non-original plasters in the main façade.

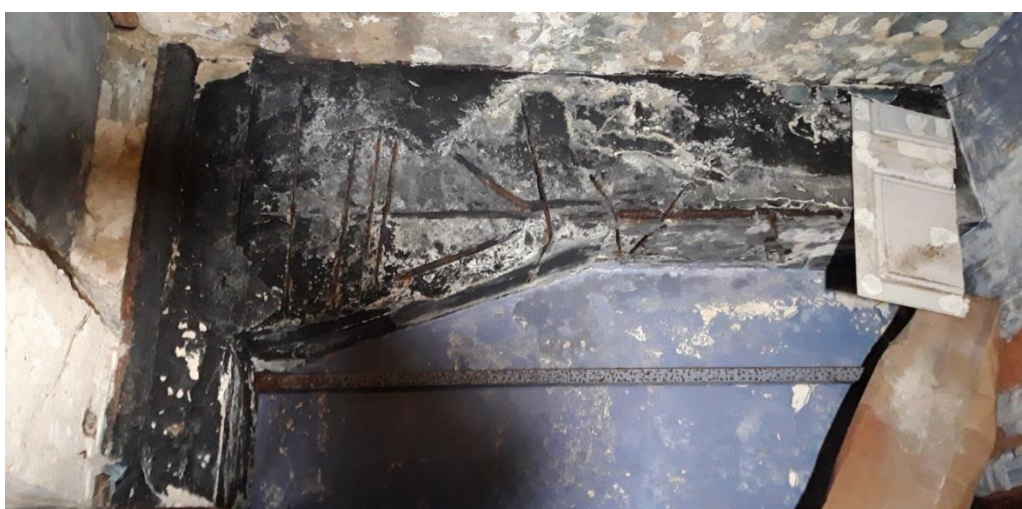
The load-bearing RC structures are generally in good condition, but there are local failures due to water infiltration triggering the corrosion of the reinforcement (Figure 21).

Figure 21: Corrosion of the reinforcement of a cantilevered beam due to water infiltration (basement – 2PP level).

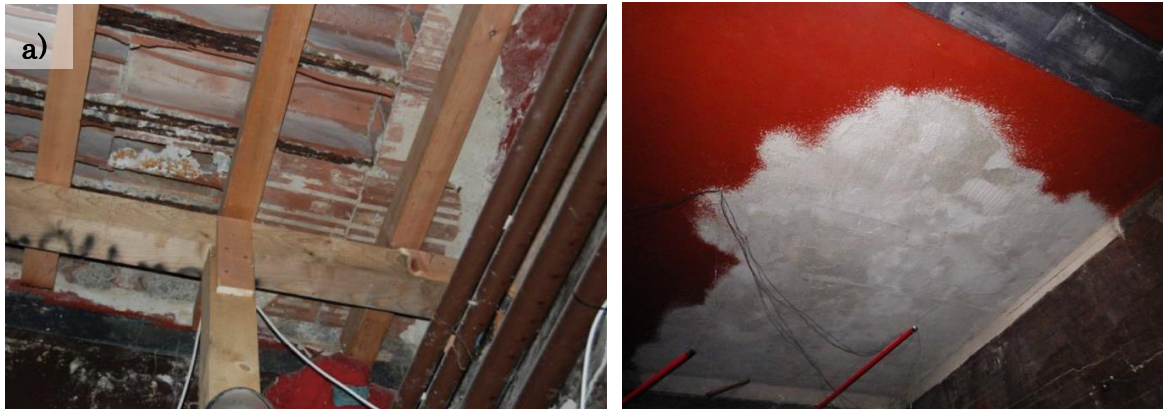
The condition of the ceramic ceilings is generally poor due to the corrosion of the reinforcement (loss of rebar diameter) leading to crumbling of the ceramic formwork. This is most severe in the slab of the terrace area (level 1NP). This is probably due to water infiltration since the top of the slab is exposed to the exterior of the building. Moreover, this slab spans further than the typical interior bay, over 5.5 meters, which could cause more substantial deflection and ponding of water above. There is severe damage to the concrete, steel reinforcing, and ceramic material. The area is currently shored with wood posts and beams (Figure 22.a). The steel reinforcing is visible between the ceramic from below, showing of corrosion of the reinforcement. Adjacent to the temporary shoring, there is an area of the ceiling that has been repaired, possible using

a textile reinforced mortar or a steel reinforced grout system (Figure 22.b). In some areas, the structure is beyond repair and need to be replaced as also stated in the 2015 report [5].

Figure 22: Aspect of the ceilings made of ceramic formworks (level INP): a) Corrosion of the reinforcement due to water infiltration leading to failure of the ceramic material with temporary shoring of the slab, b) Recent repair of composite slab damage.
