Merged Report on In-Depth Case Studies

TU Delft – Chair of Heritage and Technology

Editors: Gabriel Pardo Redondo and Silvia Naldini (TU Delft)

Date: November 19, 2021

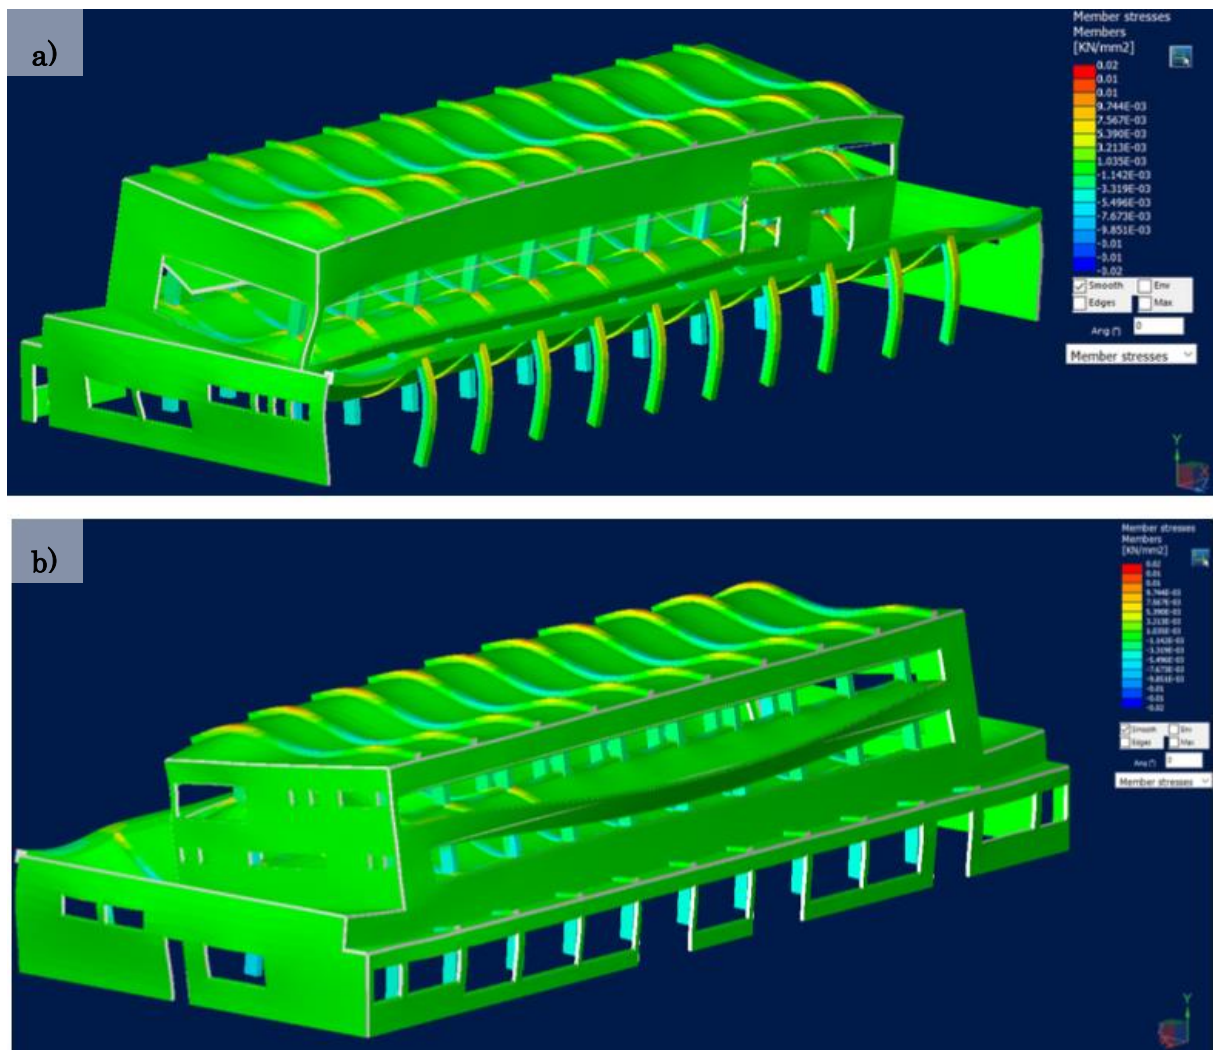
Looking at the deflected shape, it is clear how the load from the wall affects the behavior of the entire structure (Figure 25). The most significant behaviour relates to how the balcony area on level 2NP supports the wall on the western wall while that support does not exist at the eastern wall. Therefore, significant weight of the wall on the eastern side of the building is concentrated on the roof framing, while it is distributed more evenly on the west side. This disproportionate loading causes the entire building to rotate. The maximum deflection of the center of the roof edge due to this rotation is less than 5 mm.

Figure 25: a) Member stresses for controlling load combination in the deformed shape from the southeast b) Member stresses for controlling load combination in the deformed shape from the northwest.

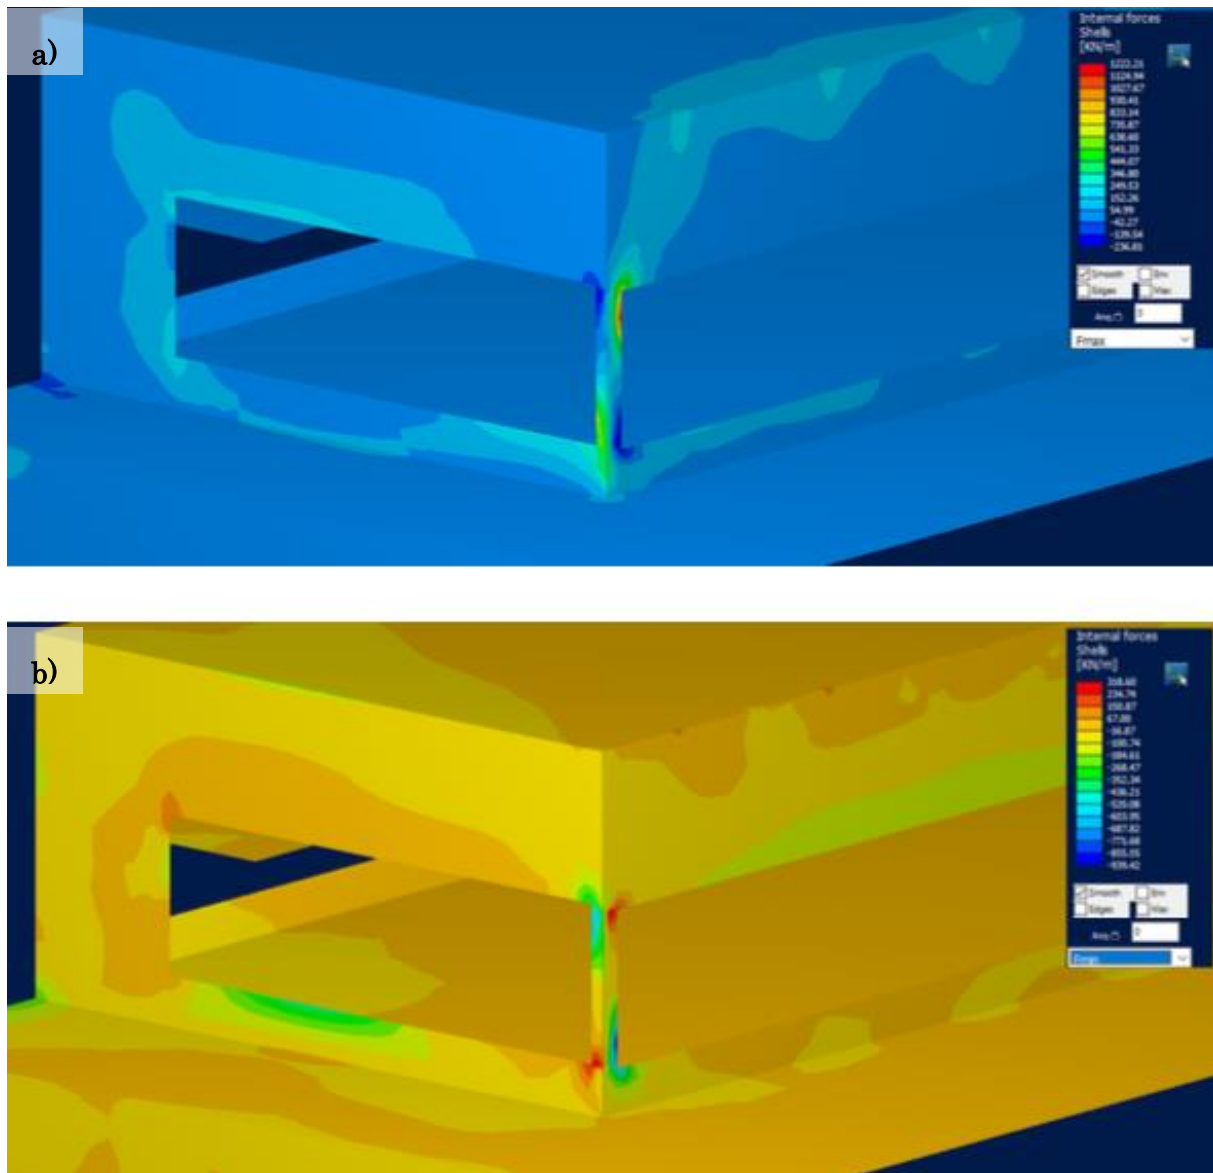
Since the window openings are so long, it allows the walls at each level of the building to behave independently of the other wall areas. The downside of this is that the elements that connect the different wall areas are typically slender and transfer a large amount of load. This is most obvious example of this is the post between windows at the southeast corner of the building between levels 1NP and 3NP (Figure 26). These concentration of force and stresses could cause cracking and damage. This is something that should be inspected in greater detail and would also be a candidate for more in-depth non-linear analysis. The other result of this load transfer is that the slab below has to support all the load. There is no beam directly below the wall in this area, so the slab is supporting it. This cause a significant amount of relative deflection at about 6 mm. The bearing conditions and reinforcement of this slab should be examined further to verify the adequacy of this condition.

Figure 26: a) Maximum internal force envelope of southeast corner post b) Minimum internal force envelope of southeast corner post.

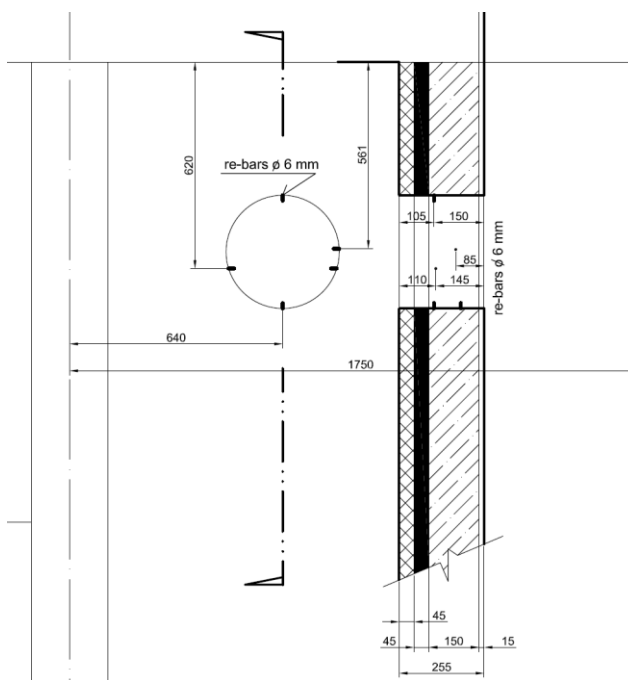
The wall structure from exterior to interior is the following: a render of varying thickness (15–30 mm), a reinforced concrete wall (150 mm), thermal insulation (45 mm) and unreinforced concrete (45 mm). This was determined at the position of a hole made to build in a ventilator. There it was also possible to detect the remains of metal bars that were cut away, Figures 28 and 29. Only 6 mm wires were found present in this section.

Figure 28: Structure of the wall in the position of a secondarily placed ventilation.

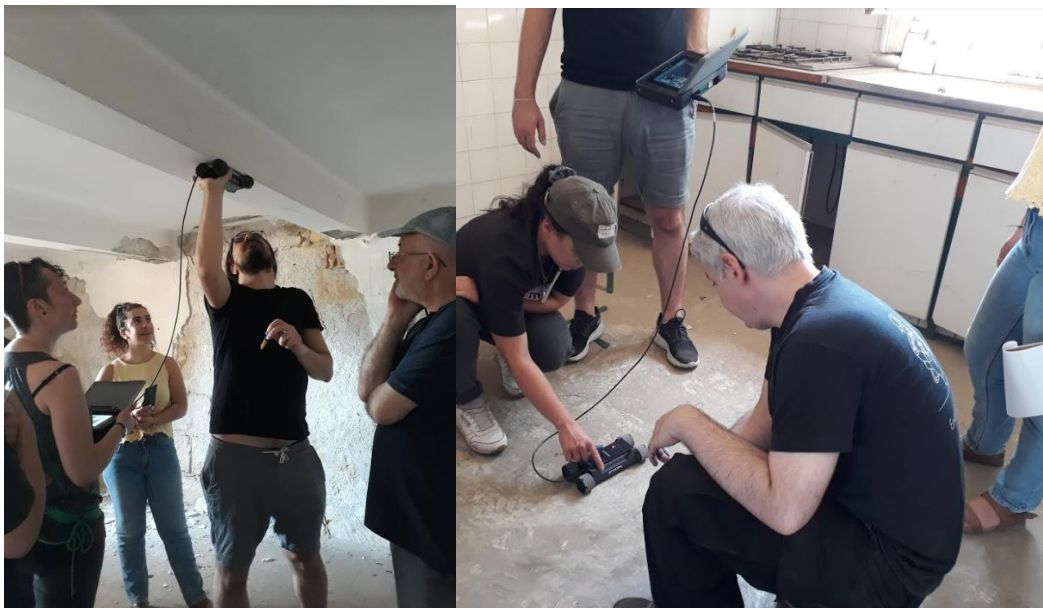
Extended survey was performed for the verification of the geometry and member sizes. For the detailing information, only some of the original construction drawings were found, consisting mainly of the slab reinforcements. In order to enrich this information, a rebar detector (PROCEQ) was used to verify the slab reinforcement in relation to the original drawings and to detect the steel bar reinforcement, the bar cover and diameter in the beams and columns (Figure 27).

Figure 27. Rebar detection and diameter/cover measurement.

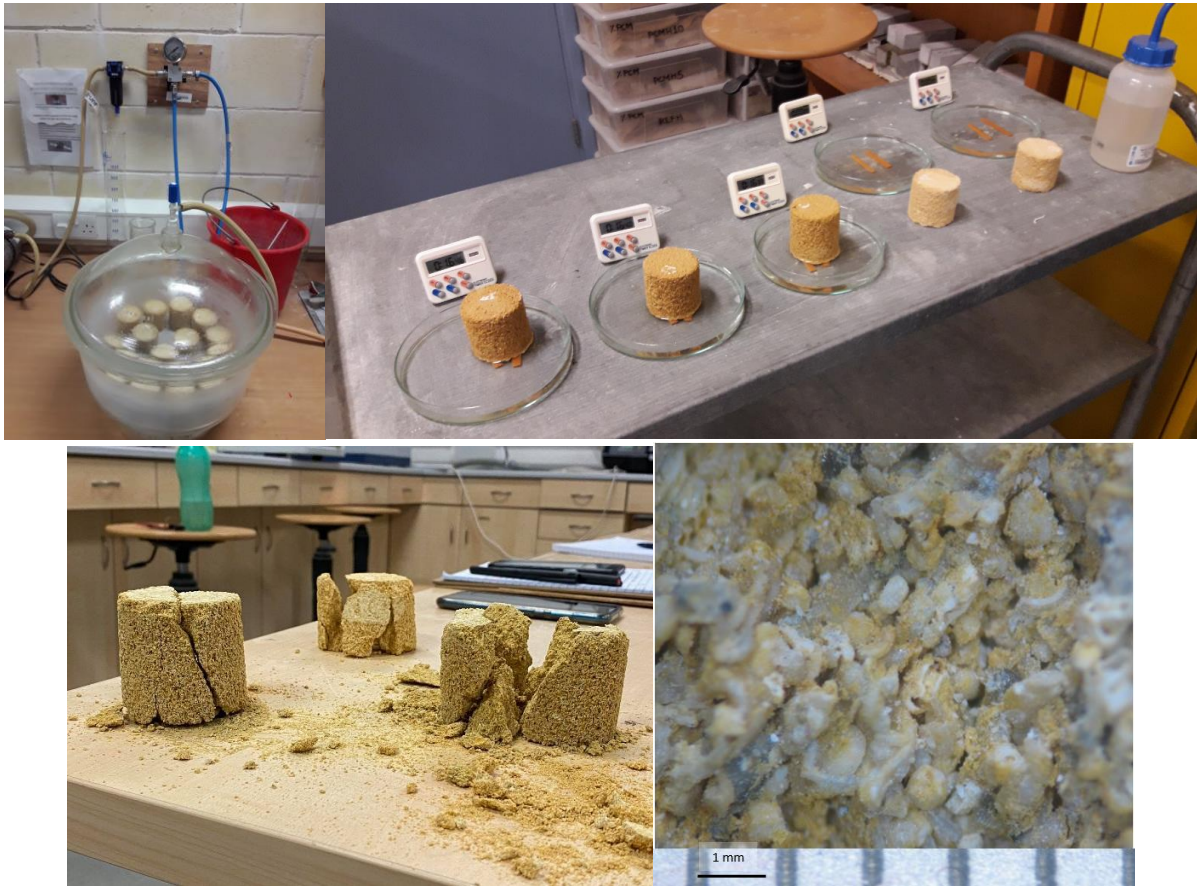
The natural stone may be described as bioclastic limestone, according to EN 12670 [16], with high calcite percentage. This stone belongs to the Nicosia Formation (Pliocene, 4Ma), and has an average apparent density of 1513 kg/m^3 and an open porosity of 38.6%, while the capillarity coefficient ranges between $3324\text{-}4150 \text{ g/m}^2/\text{s}^{0.5}$ (with a linear relation between the capillarity and open porosity). The compressive strength ranged between 1.67 and 3.13 MPa, with an average of 2.49 MPa, with higher strengths observed in the stone samples taken from the front porch's external masonry surface.

For the mortar, the binder:aggregate ratio ranged between 1:3.5-1:6; the binder consisted mostly of carbonate minerals (calcite and magnesite > 49%), while the aggregates were of ophiolitic origin. Hence, the composite may be classified as a lime-based mortar.

Figure 29. Tests on masonry materials: Specimens in vacuum vessel, Water absorption test by capillarity, Failure planes from stone compression, Stereomicroscopic view of sample S1 (16x)

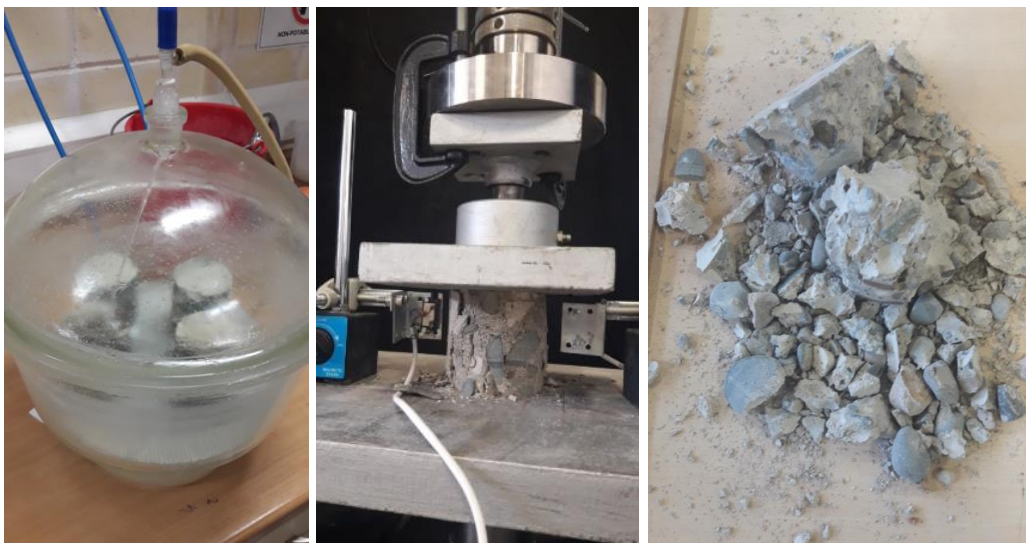
Figure 30. Tests on concrete: Specimens in vacuum vessel, Testing apparatus for concrete in compression, Failure of concrete in compression.

The concrete samples showed low variability in the test results, even though concrete at the time the building was constructed was manually mixed in small batches. The average apparent density was found to be 2181 kg/m³, while the open porosity was 18.3%. The average compressive strength was 15.21 MPa, resulting from samples of 1:1 width to depth ratio, therefore characterized as mean cube strength, with the lower value of 13.92 MPa obtained from the roof slab, and 17.11 MPa obtained from the column sample of the external front porch. The maximum aggregate size from the samples tested was recorded as 52 mm; the aggregates may be characterized as uncrushed river material. Visually the mix design showed no apparent voids, even though at the time there were no mechanical means of compaction, without visible voids or cracks.

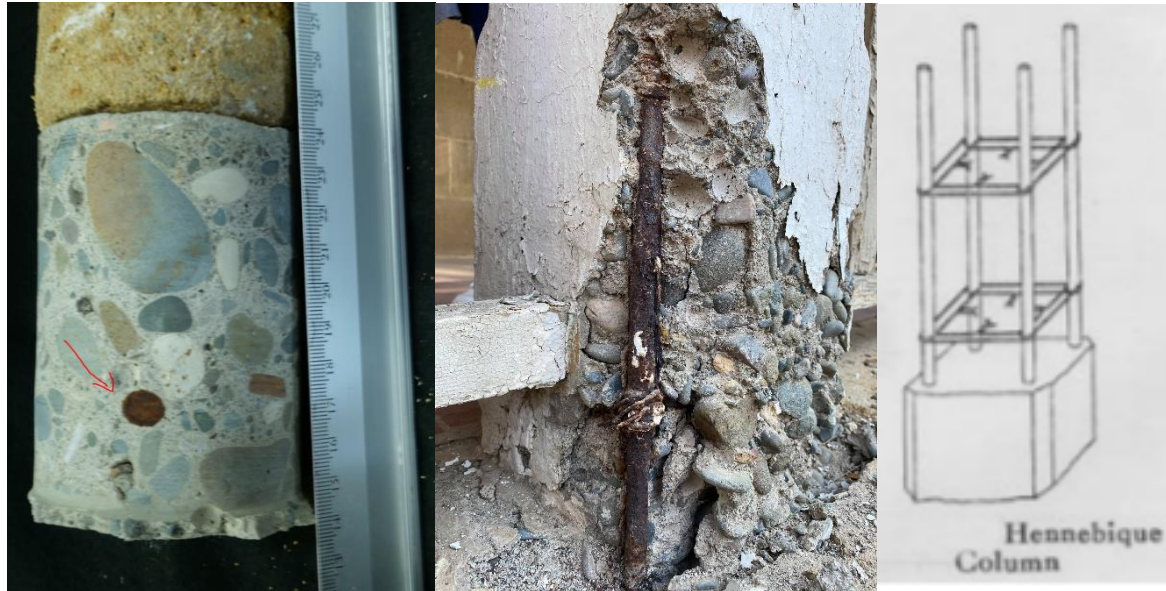
The cover of the reinforcement was established both by the use of the PROSEQ rebar detector and also from one of the samples taken from the slab that cut through the steel bars (as well as from the columns that suffered from cover delamination and the reinforcement was thus visible). The concrete cover of the longitudinal bars was in the order of 20 mm.

Figure 32. Reinforcement in slab sample, Exposed reinforcement in column, Hennebique column tie of bars

The slab reinforcement was in the order of 8 mm diameter and in consistency with the original plans that were found. Based on the slab cored specimen (Figure 32), the re-bar was in a good state without any visible corrosion. The longitudinal reinforcement of the columns, based on the exposed element (Figure 32) and on a series of measurements with the rebar detector was determined to be in the order of 5/8" (15.875 mm), since inches were used at that time for bar sizing, while no stirrups were used to confine the longitudinal bars (only some thin wires to hold them in place during casting). This is in agreement with detailing plans found in the bibliography (Figure 32).

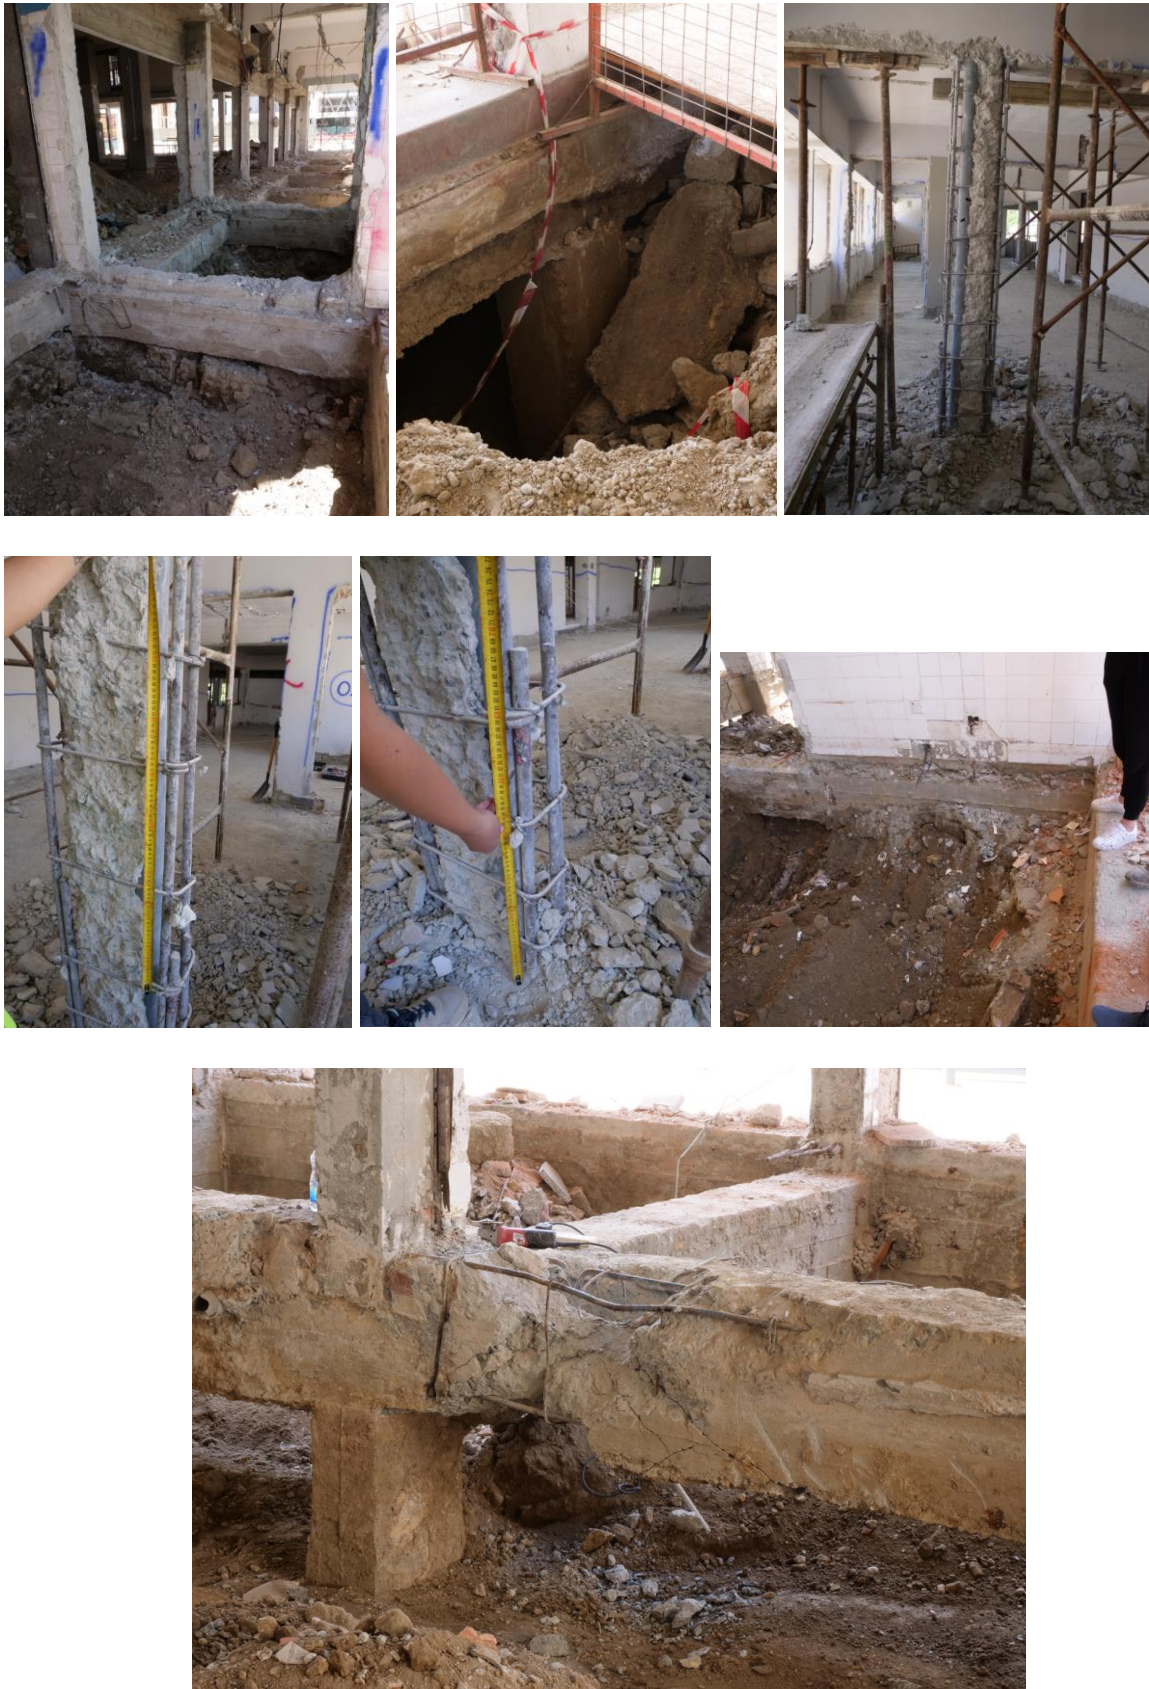
Figure 46. Exploratory excavations and concrete cover removal during retrofit works

The reinforcement was in close agreement with the original detailing drawings. Exploratory excavations showed that the columns continued up to 2 m underground in order for the foundation to reach a solid ground. Some caves were found below the ground floor slabs. The columns at the foundation level were connected with beams with very sparse reinforcement. Many of the columns had drainage pipes embedded in them, something that is now forbidden by the Codes. Stirrups in beams were sparse, not suitable for ductile structures and the formation of plastic hinges at the edges of members. The lap splicing of the longitudinal reinforcement was also found to be less than what is required as per current seismic codes. Additionally, the reinforced concrete walls shown on the original drawings were connected only on beams at the foundation level, leading to the conclusion that they cannot attain flexure due to the lack of foundation system. Photo evidence of the above is shown in Figure 46.

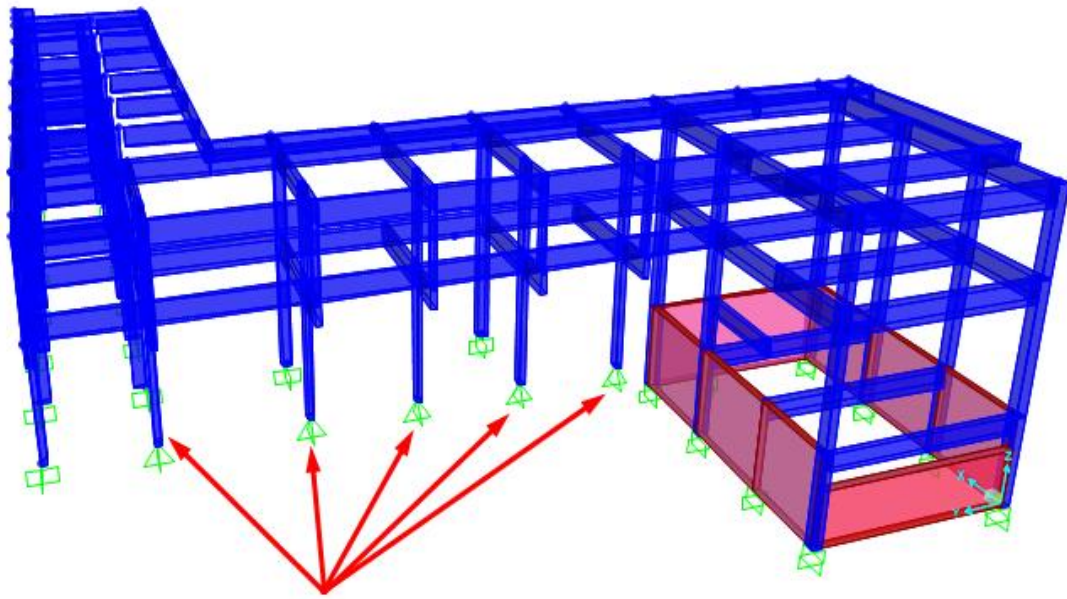
Figure 47. Simulation of the structure in SAP2000 and hinge assignment at the bottom of columns

The structure was modelled in the commercial program SAP2000 [6] in order to assess its capacity under seismic conditions. The reinforced concrete beams and columns were simulated as 2-node frames. The mean average strengths were used for determining the properties of the various materials. For all the elements in the structure under study, modifiers were used to decrease the stiffness of the cross sections to the actual cracked stiffness, assessed by the actual Moment-curvature diagrams with the use of RESPONSE2000 [9], in order to take into consideration the stiffness degradation during the seismic event [10,11]. Diaphragmatic action was applied to all the nodes of the floor levels. The members were connected to the ground with linear links, according to the properties of the foundation system and the soil, while the walls in the basement under the soil level were assigned with springs that allow movement away from the soil, but prevent movement when in contact with it. All the floor slabs were assigned with the load combination of $G+0.3Q$, with additional load for the finishing of the floor surfaces. The live load was chosen based on the Cypriot Annex of Eurocode 1 [12]. This load combination was also used to derive the mass of the structure for the modal analysis. Some of the columns of the GF were assigned with hinges (zero moment), at their bottom node, due to the increased axial load ratio $\nu=N_{G+0.3Q}/(A_c f_c)$ (Figure). Note that those columns are subjected to a value of ν that is close to the limit of 0.4 that corresponds to balanced column failure, which identifies the limit of brittle response in the Axial – Load vs. Moment Interaction Diagram. This load ratio is estimated from service life loads only, without considering the additional axial load that the seismic overturning action will impose to the columns. On account of the high value of ν and the reported corrosion of reinforcement in the base of those columns, it is concluded that no moment can be resisted in their base; thus, a hinge was assigned in the model.

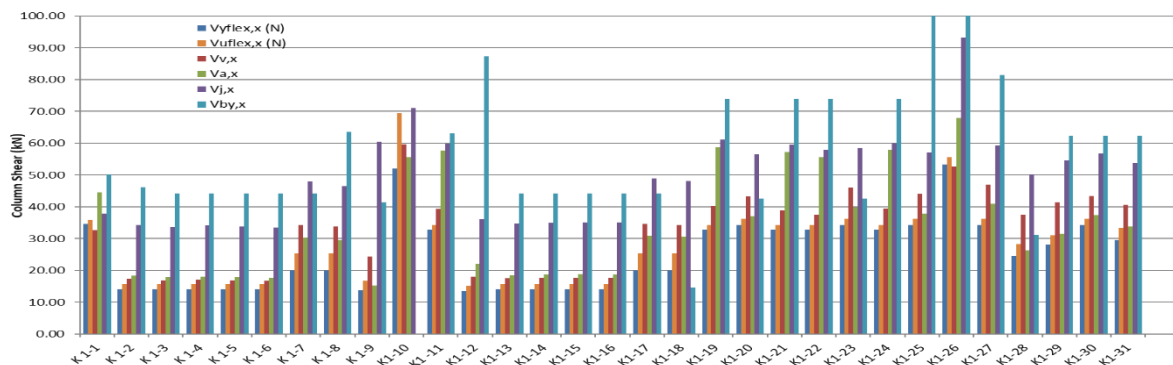
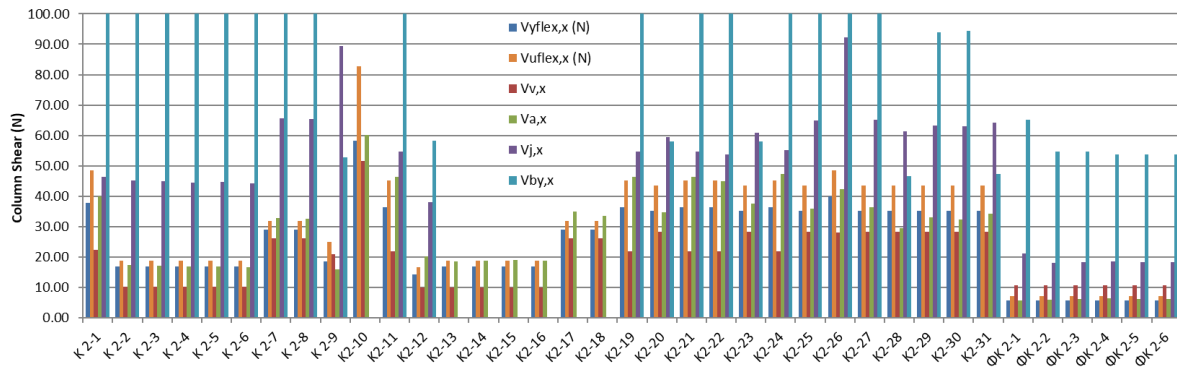
Figure 49. Shear force for different mechanisms of failure for the X-direction of seismic action, for the ground floor columns (top) and the 1st floor columns (bottom)

The results from the analysis performed are shown for the X-direction in the charts of Figure 49. The first assumption to be made is that in almost all cases the failure of the columns will prevail yielding of the beams. This is attributed to the wrong type of design of RC members of the era that required “strong beams-weak columns”. The earthquakes that followed showed that, that kind of design was wrong, leading to collapse of the members, while modern seismic codes, through the capacity based design approach, have rectified the approach promoting a “strong column-weak beam” design.

Additionally, the results indicate that most of the columns in the ground floor will behave in a ductile manner with flexural failures, except for some columns with very high axial load that will show brittle failure of the compressive zone prior to yielding of reinforcement, and some cases of brittle shear failure for loads parallel to the weak axis of the members. On the contrary, most of the columns in the 1st floor will fail due to brittle shear failure, due to their short length, in combination with the very sparse stirrups, having a spacing of more than 300 mm.

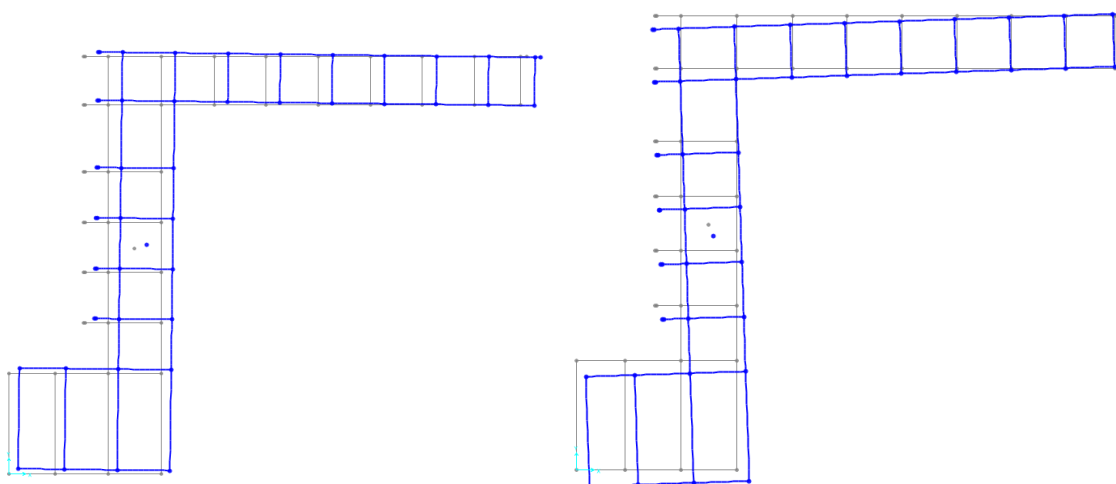
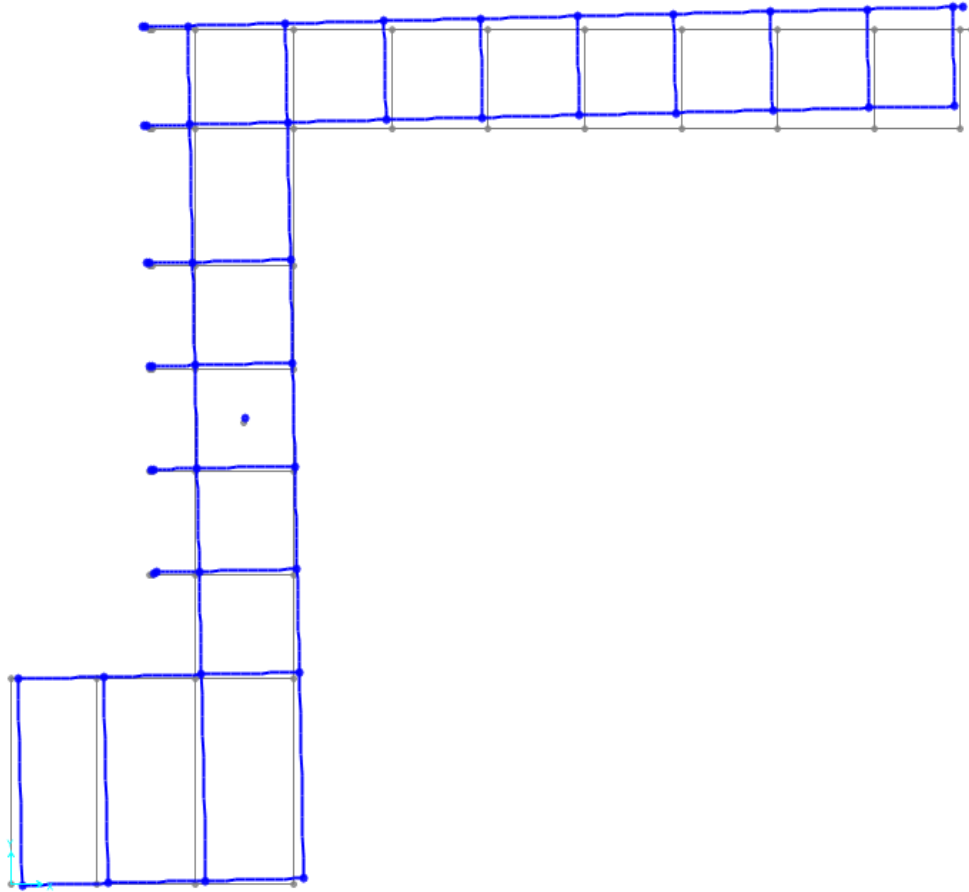
Figure 50. 1st mode $T=1.003$ sec, 2nd mode $T=0.95$ sec and 3rd mode $T=0.495$ sec.

The first three modal shapes of the structure are depicted in Figure 50 and their characteristics are recorded in Table 7. While the first mode of the structure is primarily translational in the X-direction, with a very high period, compared to new structures designed as per the Eurocode, the second and third modes are combined translational to the Y-axis and rotational around the Z-axis. This is in agreement with the finding that the CM has high eccentricity to the CR in the X-direction.

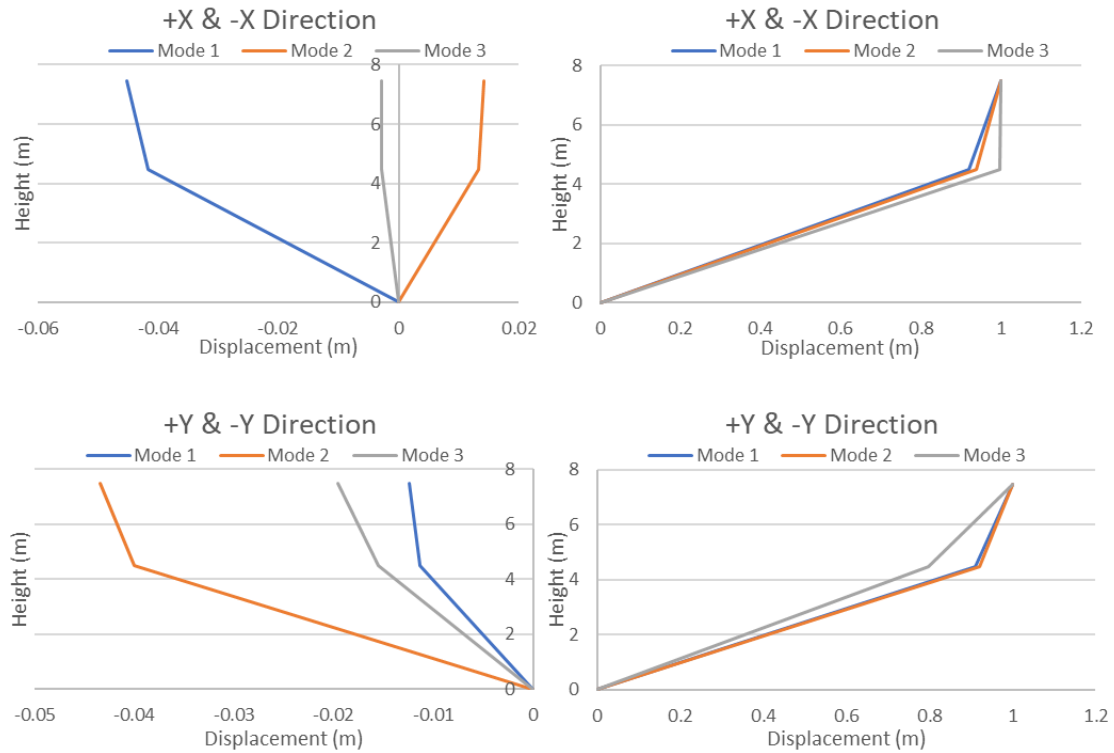
Figure 51. Displacements from modal analysis (left) and Mode shapes heightwise (right) at the CM

Additionally, when the mode shapes are plotted heightwise in Figure 51, it is clear that the structure behaves as a pilotis, with a soft ground floor storey, indicating that during the seismic loading most of the displacement that will be induced in the structure due to the motion, will be undertaken by the ground floor columns, leading to increased levels of ductility demand.

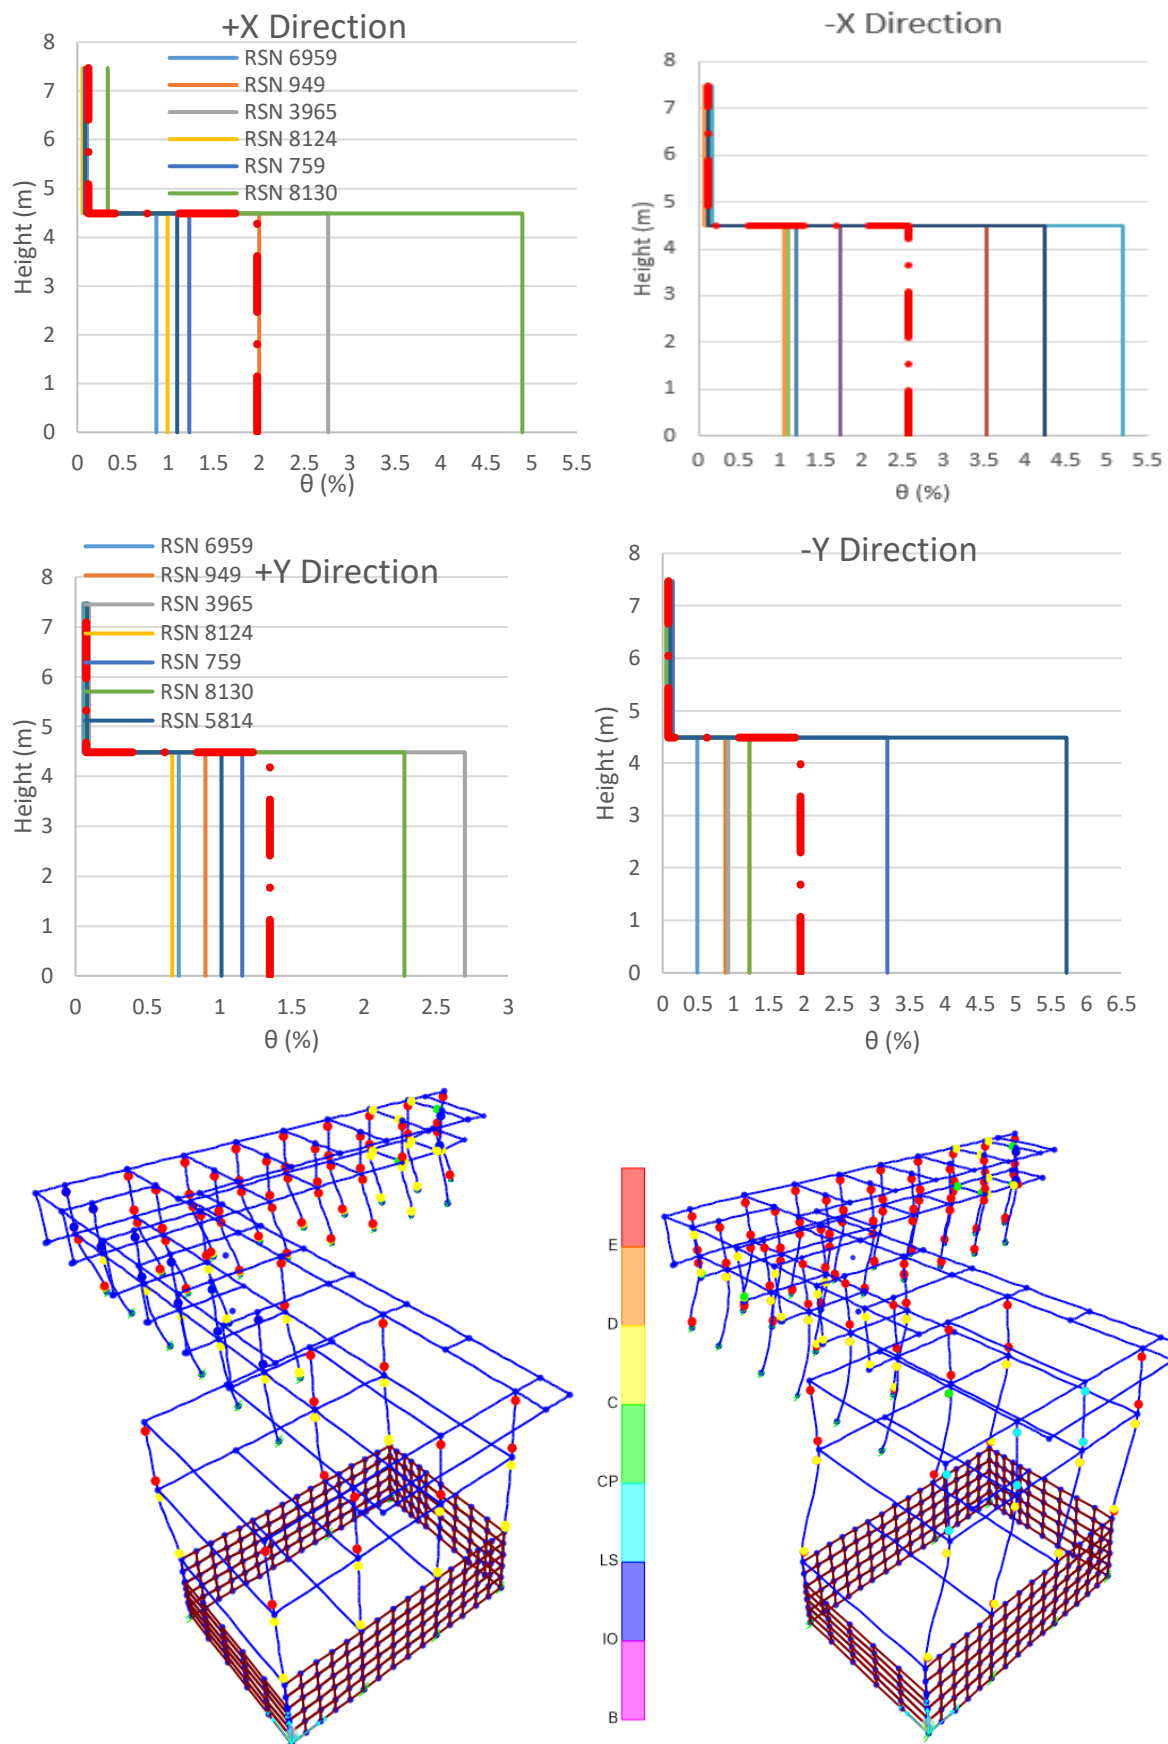
Figure 53. Drift demands from all accelerogram combinations and Damage level of the structure for combinations (RSN 759) and (RSN 8130)

Figure 53 depicts the drift demands along the height of the structure, from all load combinations, and the levels of damage of the members from the analysis. Even though the 1st floor columns undergo a very low level of drift in the order of 0.5% (related to the yielding of the flexural reinforcement), it is seen that most of them have failed and are in levels of damage not accepted by the assessment performance objectives. This is due to the previous conclusion that the 1st floor columns collapse in brittle shear failure prior to yielding of the flexural reinforcement. Additionally, the drift demands in the ground floor, in the order of 2-2.5%, require great drift ductility of the ground floor columns, in the order of 4, yet the members seem able to perform them, albeit in the level of significant damage, something that is accepted by the Performance objective.

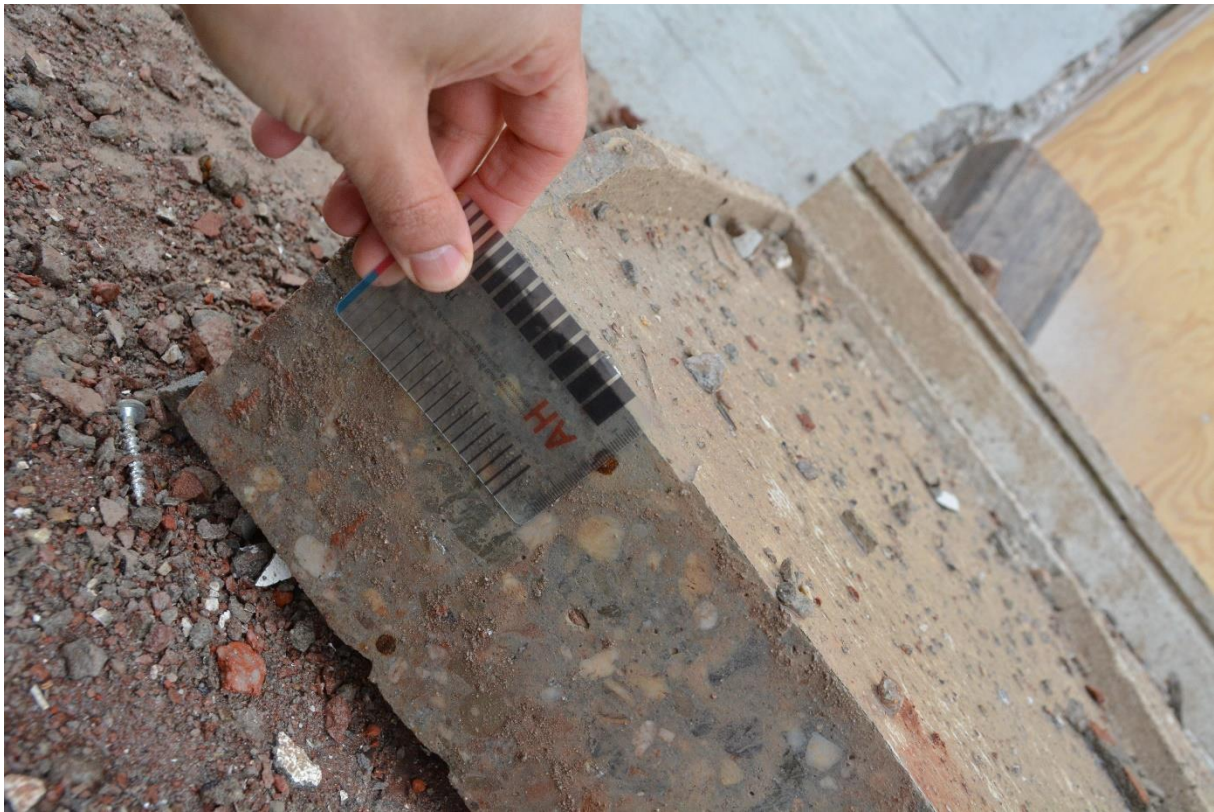
The existing reinforced concrete has an estimated compressive strength of 38.5 MPa (+/- 3.77) assessed with Schmidt Hammer (refer to Section 0). The reinforcement is plain round rebar and has a concrete cover in exterior columns between 20 to 25 mm; the cover in walls varies between 20 to less than 10 mm, as the thickness of the walls varies. The coarse aggregates of the concrete are natural and round, with maximum side dimension of 20 mm. The binder used in the concrete is unknown, but given the grey colour and the year of construction, it is very likely that is Portland cement (Figure 55).

Figure 55. Section of the wall cut during the 2021 renovation.

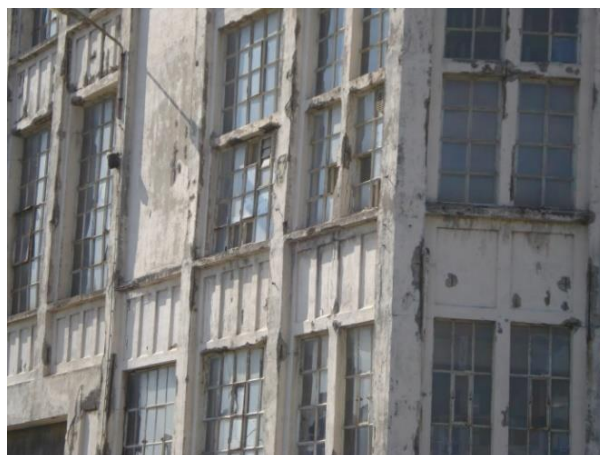
The damage found in 2010 were vertical individual cracks in walls under windows, and spalling in exterior columns and walls (refer to Figure 57 & Figure 58).

Figure 57. Damage in 2010. Source: TNO.

Given the type of damage, and the testing performed in the building (refer to Sections 0 & 0), the likely cause of the damage is carbonation-induced corrosion. The visible cracks are aligned with the reinforcement, suggesting expansion forces due to corrosion. Spalling was localized in areas of reinforcement where the concrete cover is minimum. From the pictures obtained, pitting corrosion is not visible; neither is it mentioned in the documentation related to the intervention.

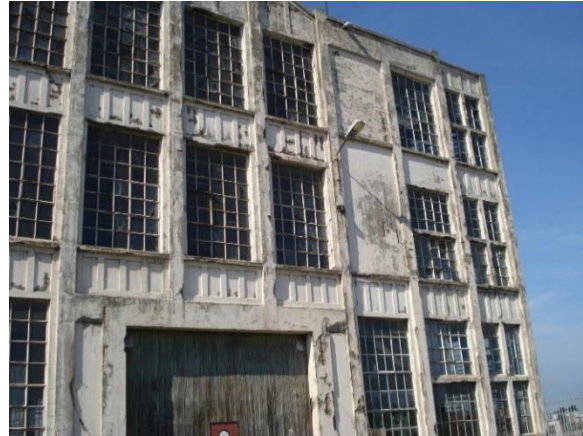
Figure 58. Condition of the building in 2010. Source: TNO.

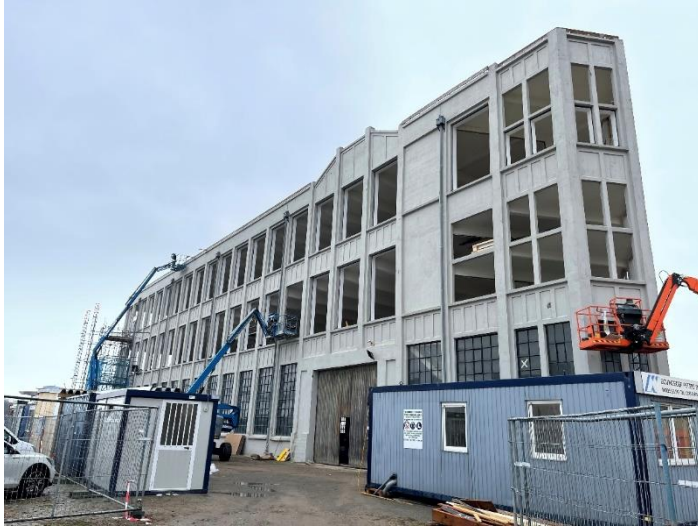
The concrete façade did not show signs of generalized damage (Figure 63). Scattered damage was found in a few locations. The damage consisted in small spalling and was located in the areas of the wall below the windows (Figure 64). The damage did not seem to correspond with previous patch repairs.

Figure 63. East facade condition in 2021.

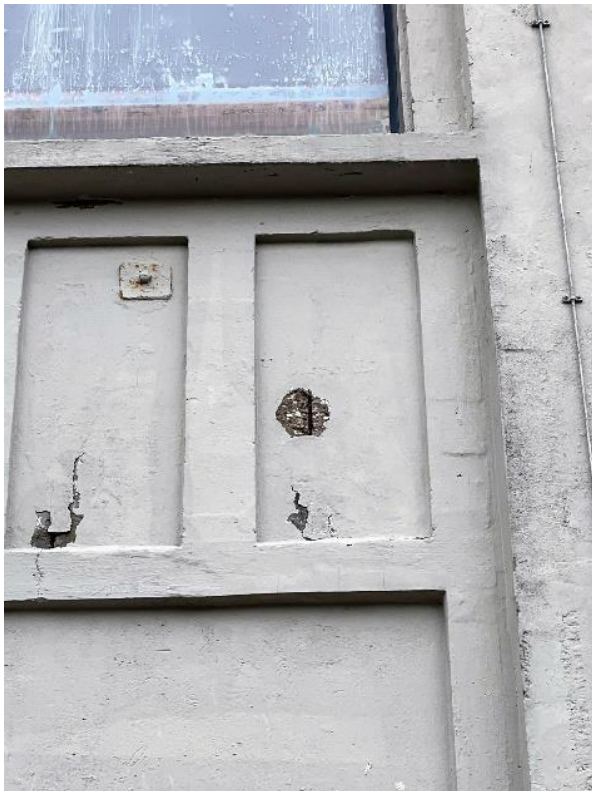
Figure 64. Spalling and incipient spalling recorded in the thinner parts of the wall in 2021.

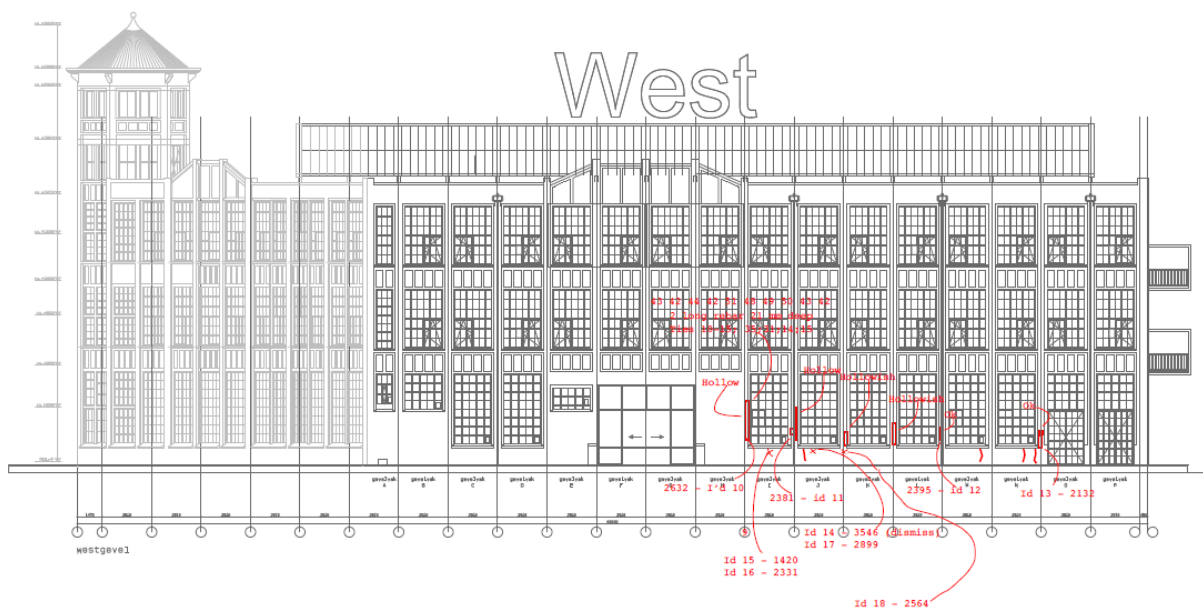
Figure 65. Annotations of the inspection and tests in the west facade.

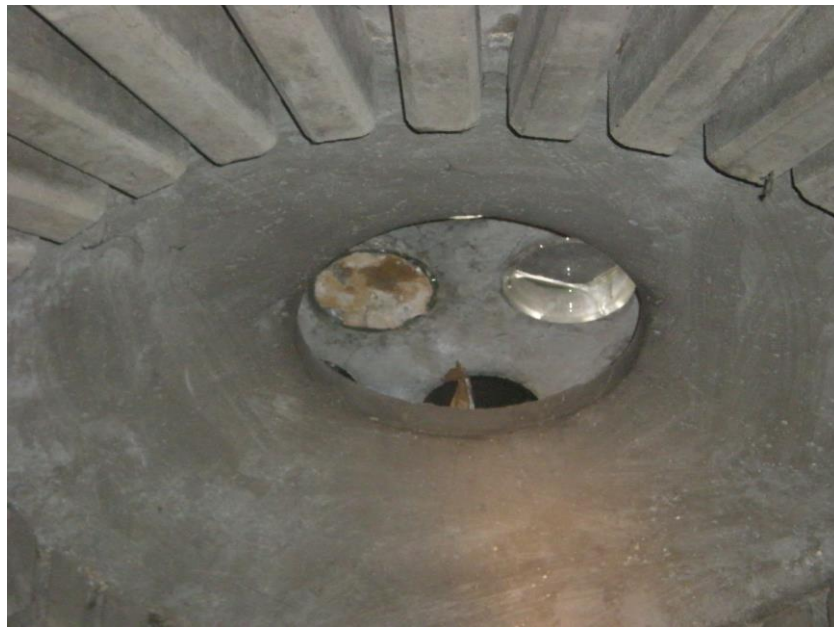
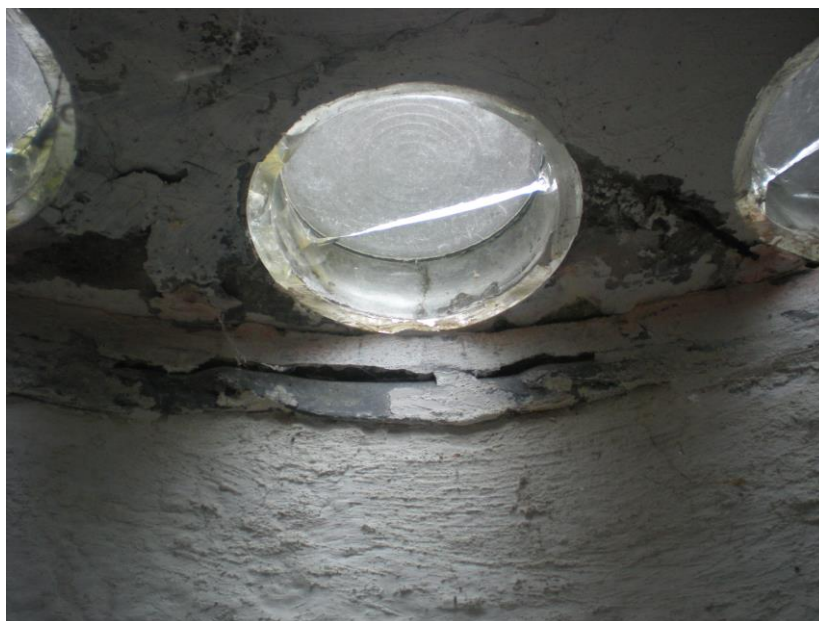
Infiltration of the roofing system, which Director Marcenaro had already complained about when the work was not yet completed (but the museum had already been inaugurated), following a violent downpour and probably due to the way the flooring in the Archbishop's Palace courtyard had been constructed, reappeared and occurred several times over time, especially in the area of the glass-cement skylights in the tholos below. On the intrados of the ceiling, in fact, the reinforcement rods of the concrete were visible, already oxidised and corroded and no longer protected by the layer of concrete cover, which probably triggered carbonation of the concrete (2011, before the intervention).

View of the deterioration (photo G. Franco)

The deterioration of these elements was probably related to thermal stress and certainly to mechanical stress induced by the incongruous use of the Archbishopric courtyard as a parking space for cars and motorbikes. In order to temporarily repair the most serious cracks, some of the glass diffusers of the skylights had already been covered with a layer of mortar or sealed with silicone to stop the infiltration of rainwater into the tholos, thus compromising their readability from inside the museum.

The most significant intervention was the repair of the block-glass skylight and their light diffusers (many of which were broken and some blocked up altogether). To prevent the leaking that became apparent during the study phase from becoming worse, the three existing discs in block glass were replaced with similar but newly manufactured discs.
