Merged Report on In-Depth Case Studies

TU Delft – Chair of Heritage and Technology

Editors: Gabriel Pardo Redondo and Silvia Naldini (TU Delft)

Date: November 19, 2021

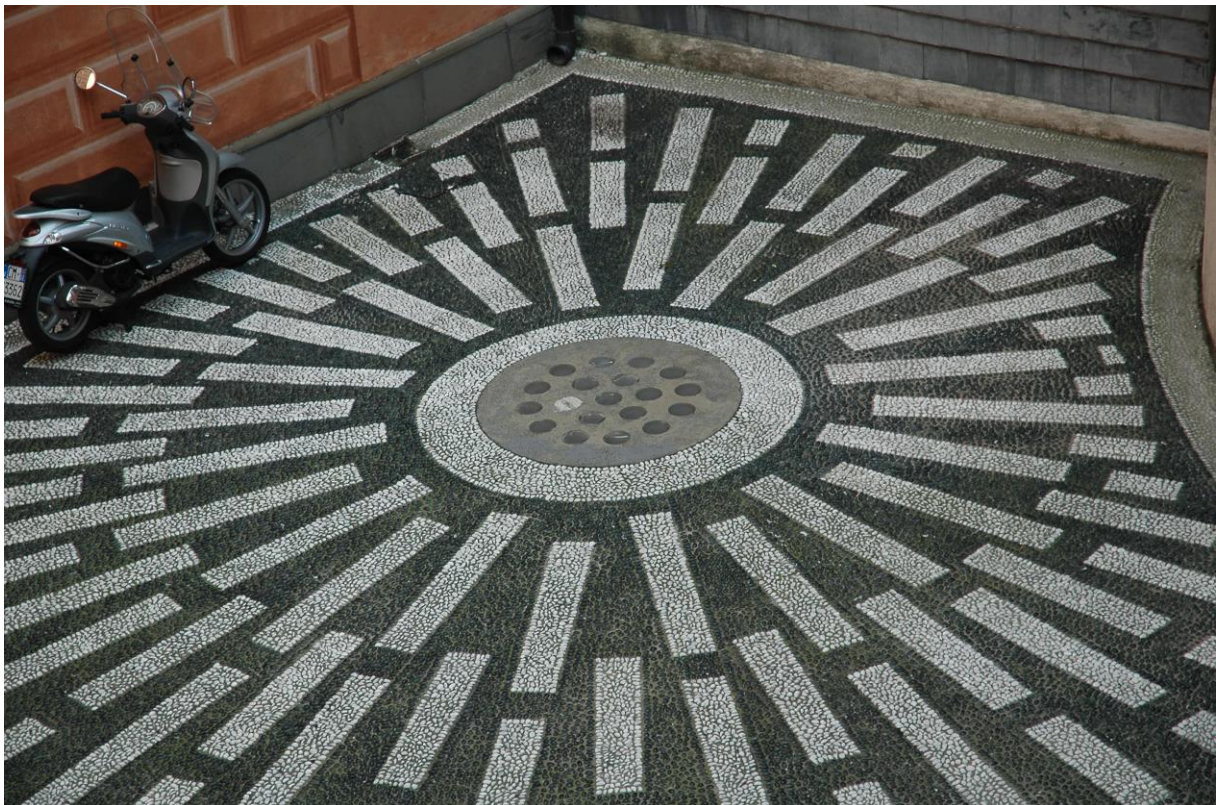
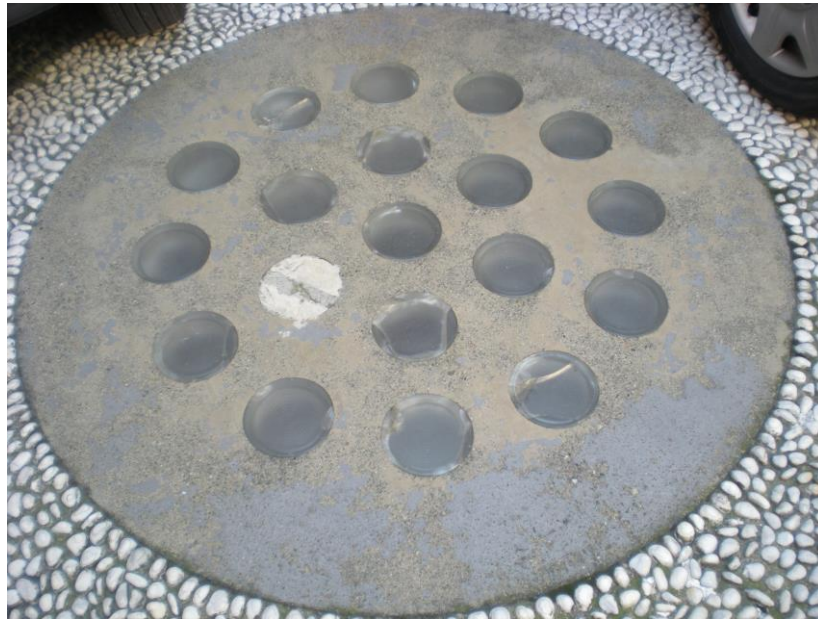
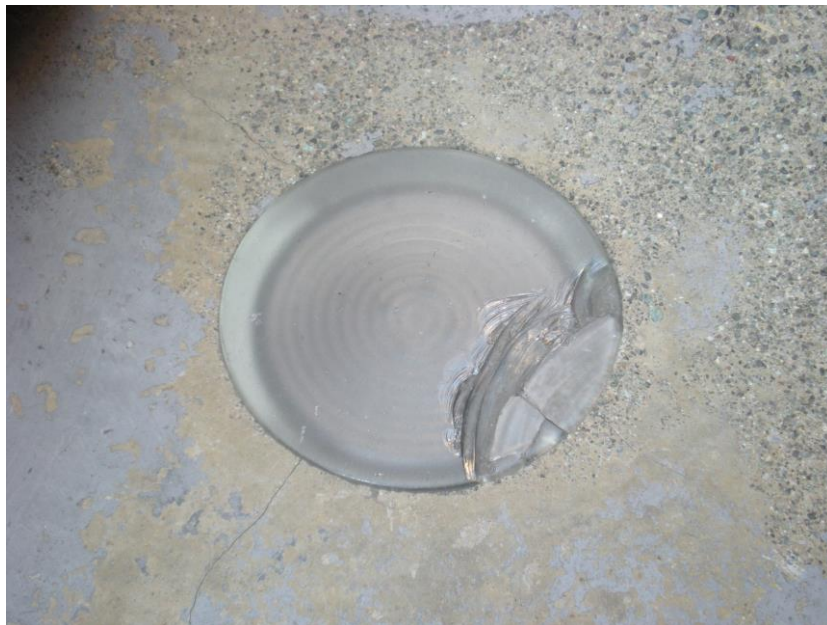
In spite of these precautionary measures, water infiltration occurred repeatedly in the intervening years, with visible results especially in the tholos where the Zacharias Cross is displayed.

Temporary reparations (photo G. Franco)

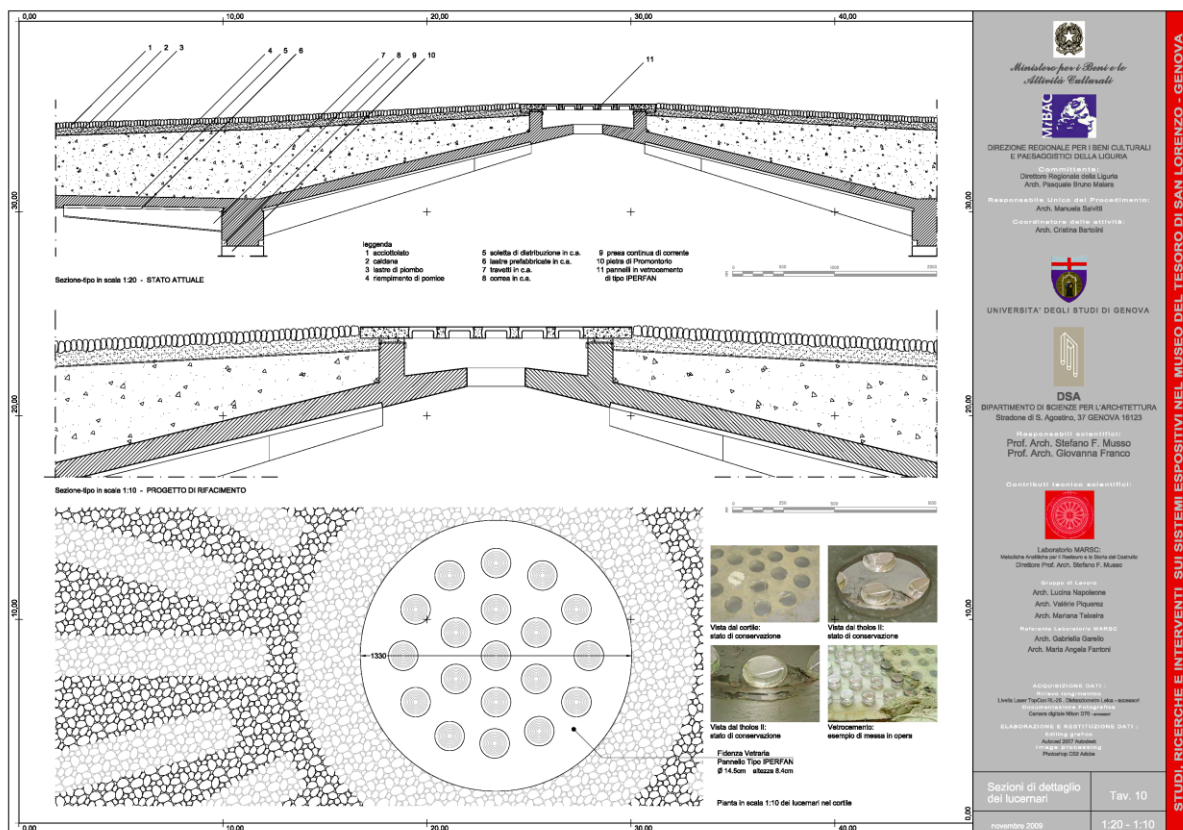
Detailed drawing of the intervention on the glass-concrete discs (Architecture and Design Department, the authors)

Since the "useful life cycle" of the glass-cement panels was inevitably considered to be over, they had to be replaced in their entirety, and the problem of the unavailability of the original glass diffusers had to be addressed. The company merged with the company Seves Glass Block, based in Florence, which continues to produce glass "cups" with a cylindrical base, but smaller than those used in the museum, with a production diameter of 11.7 cm. However, given the small number of pieces (less than 60), it was possible to find some pieces belonging to the same batch, stored in some of the warehouse funds of the firm that had taken over the stocks of the original supplier, which has now disappeared. They were of the same size and had the same surface finish (concentric stripes) as those in place but were irreparably damaged and unrecoverable. They could therefore be inserted into new

reinforced concrete panels (discs) of similar size and shape to the existing discs but now inefficient (133 cm diameter, 5.5 cm thick). Given the delicate nature of the work, it was recommended that, in order to prevent possible future damage to the relocated glass diffusers, the transit and parking of cars and motorbikes in the courtyard of the Archbishop's Palace should be limited as much as possible, especially near the skylights. In short, the work involved the following:

- removal of the original discs (lifted out mechanically, after breaking through a few of the diffusers);
- breaking up the first ring of cobble stones in the courtyard paving immediately around the discs;
- removal of the related backing and the lead-sheet waterproofing;
- installation of the new prefabricated discs (these were completely flat and not shaped at the edges – a feature that appears on the original designs); re-laying of the backing and new lead-sheet waterproofing and levelling of the ground around the ring supporting the slab
- re-laying the cobbles around the new disc.

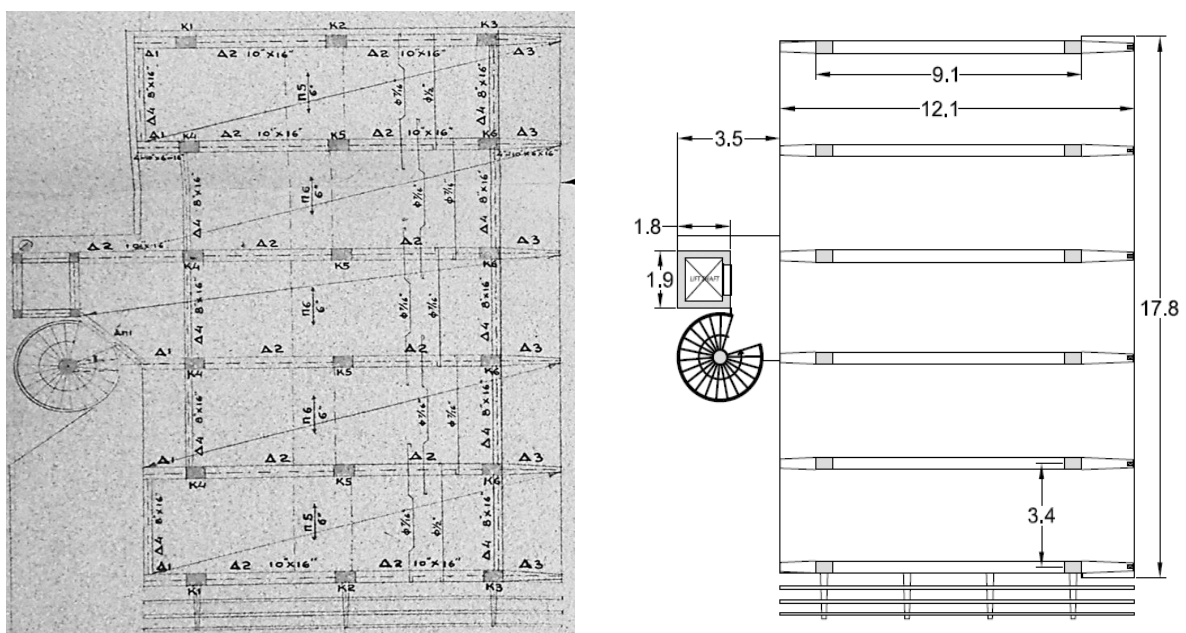
When comparing the original set of drawings to the recent survey drawings created for the restoration of the building in 2008, some important discrepancies of the structural system were found. The original drawings showed a series of columns located in the middle of the main frames from the ground level up to the roof level; this row of columns was not found during the recent surveys, as illustrated in Figure 76. The absence of these columns was confirmed during the site inspections that followed.

Figure 76. Typical floor plan as per: the original design (left) [7] and the survey plan (right)

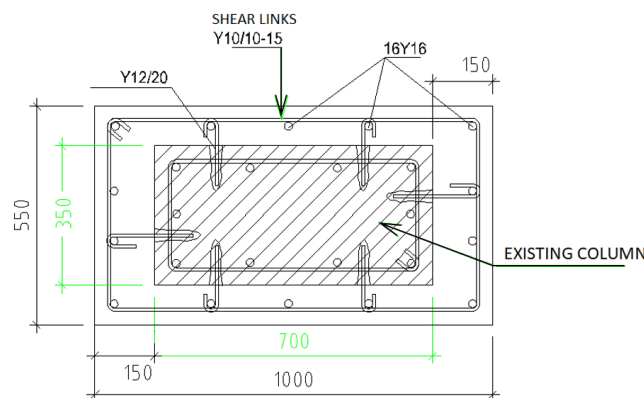
Figure 77. Reinforced Concrete jacketing detail [7]

The information on the structural aspects of retrofit works carried out were collected from the calculation set and structural report of the retrofit design, and through an interview with the Structural Engineer of the project. According to these sources, 26 columns at the two basement levels were strengthened with the RC jacketing technique, as per the detail shown in Figure 77, while the rest of the columns at the upper floor levels (121 in total) were retrofitted with 2 layers of carbon FRP. Prior to applying the FRP, all damages related to the corrosion of reinforcing steel were rectified. No strengthening works were carried out at the foundation level, or on the beams and slabs of the building [7].

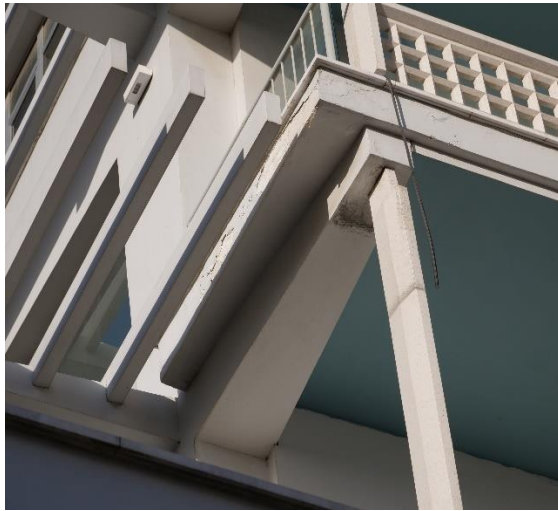
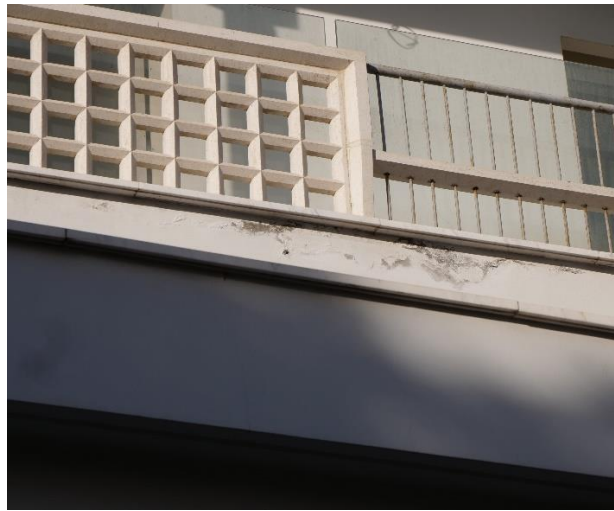
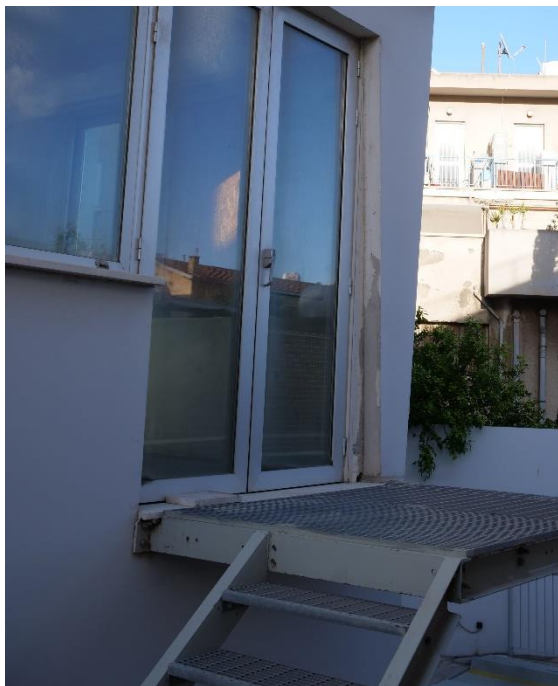
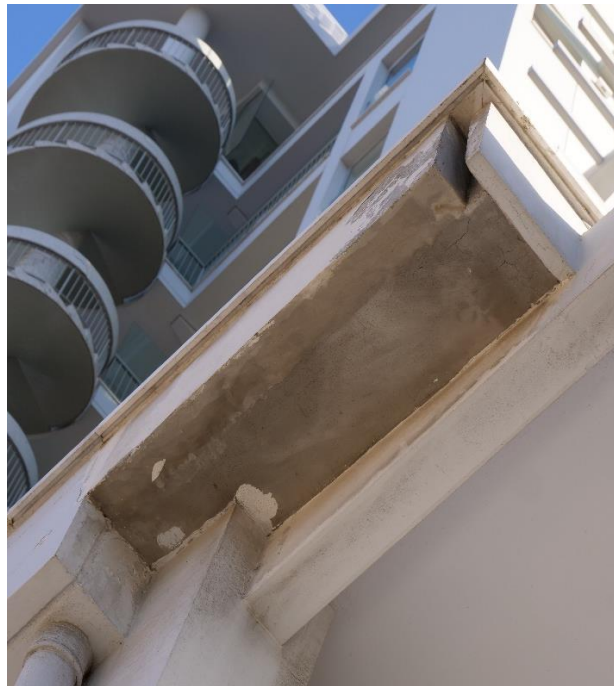
The damages identified during the visual inspection (post-retrofit inspection) were not severe and were mainly related to moisture ingress, causing peeling/flaking of external plasterwork and painting (Figure 79). The other type of damage found was microcracking at the junction points of beams-columns and horizontal cracking of the wall finishes (Figure 80). The most severe defect found was related to steel reinforcement corrosion and the corrosion of other embedded metal elements in concrete, that led to local concrete spalling (Figure 81). Inside the building, no significant defects were identified, although the majority of the concrete elements were not visible because of the addition of false ceilings and drywall partitions.

Figure 79. Minor defects related to moisture ingress causing plaster and paint flaking

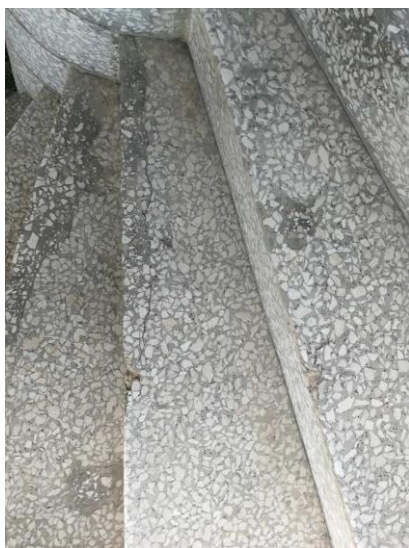
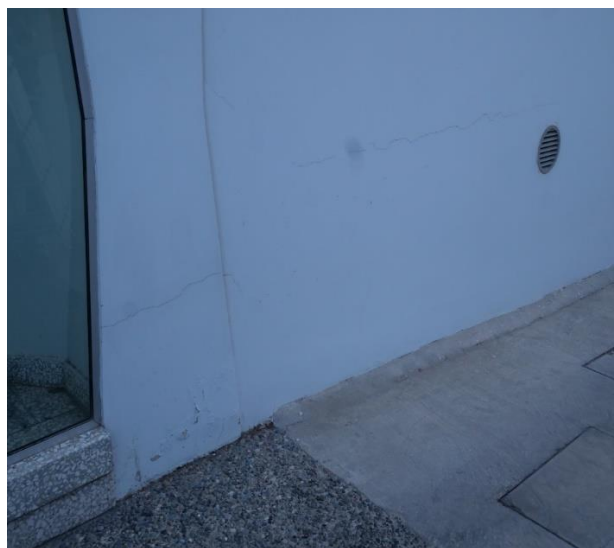
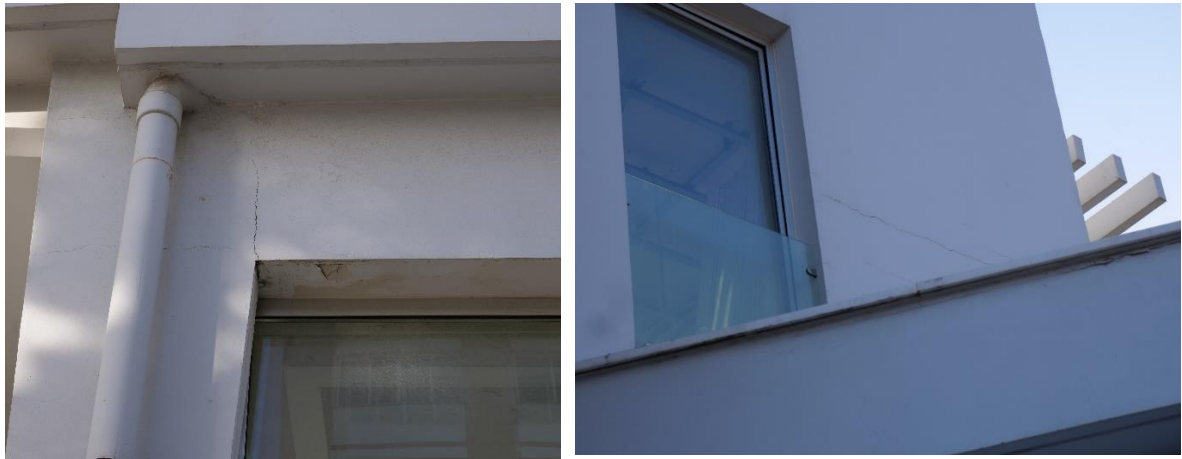
Figure 80. Micro-cracks on concrete elements and wall finishes

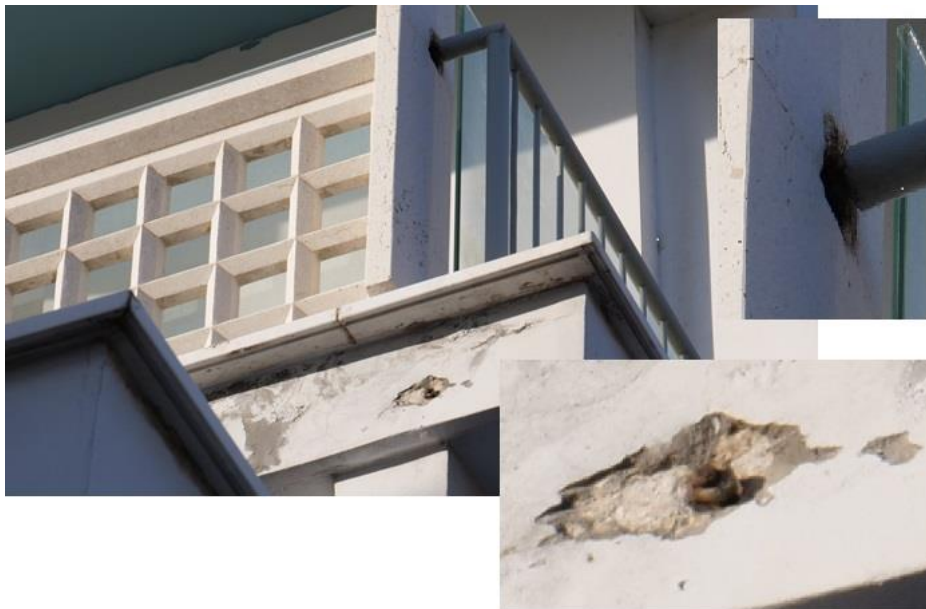
Figure 81. Reinforcement and other embedded metal corrosion causing local concrete spalling

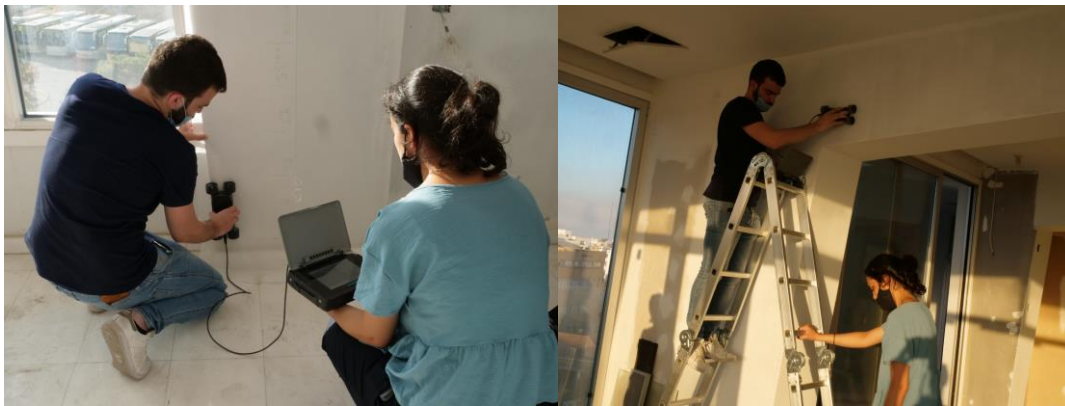
A survey was performed for the verification of the geometry and size of the various elements. The original construction drawings showed great variation compared to the as-built investigation. In order to increase the detailing information, a rebar detector was used to detect the steel bar reinforcement, the bar cover and diameter, both in the beams and columns (Figure 82). The steel used in that era was mild S220 without ribs.

Figure 82. Rebar detection and diameter/cover measurement

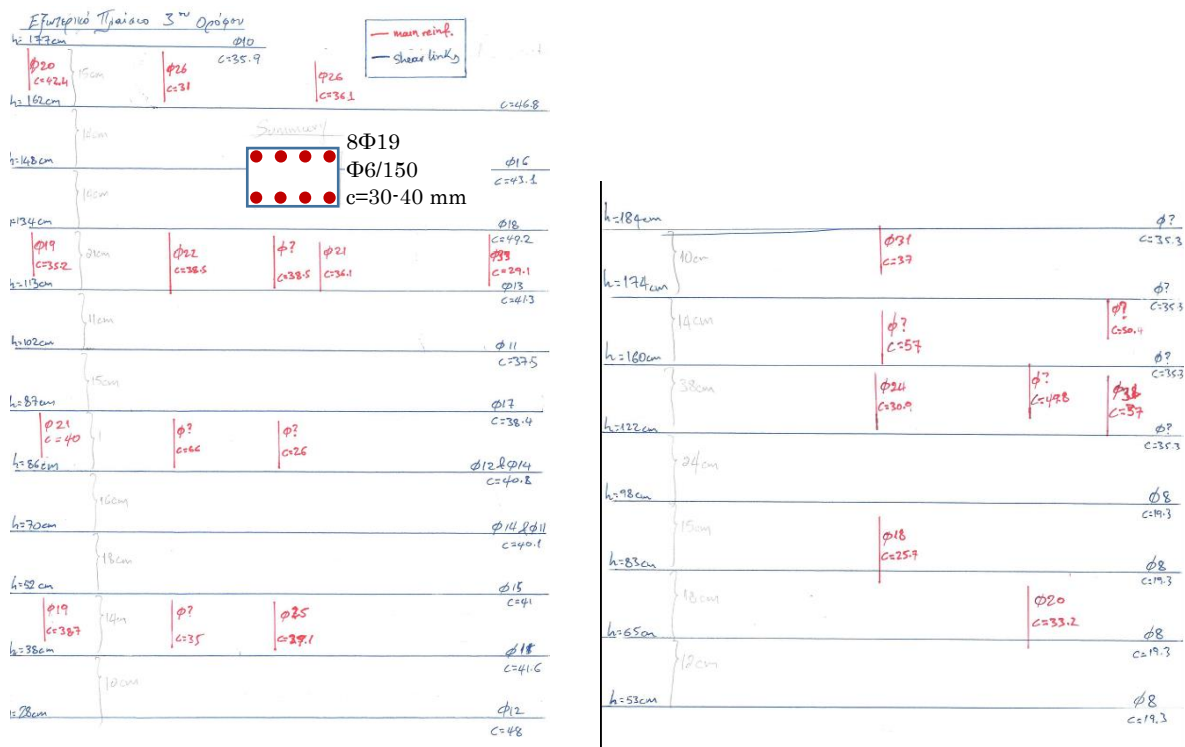
The reinforcement layout and diameter were measured with the rebar detector on two columns and one main frame beam at the 3rd floor level, which was the only floor accessible. The first problem encountered was the difference between the dimensions of the beams and columns between the original drawings and the as-built findings. As per the original drawings, the columns and beams should be of constant rectangular shape, while in reality they were built as tapered. Additionally, measuring the reinforcement was difficult, especially of the corner rebars, because of the use of metallic corners during the retrofit of the building. Yet, the rebar diameters were in close approximation to the ones mentioned in the original plans, as the columns during that time served only to transfer vertical loads to the foundation. The measured values are depicted in Figure . The main issue encountered during the measurements was the absence of reinforcement -both longitudinal and transverse- within the joint between the columns and the beams, which was also of a wider area than normal, due to the tapered geometry of the members.

Figure 84. Reinforcement measurements on 3rd floor columns; external frame (left) and internal frame (right)

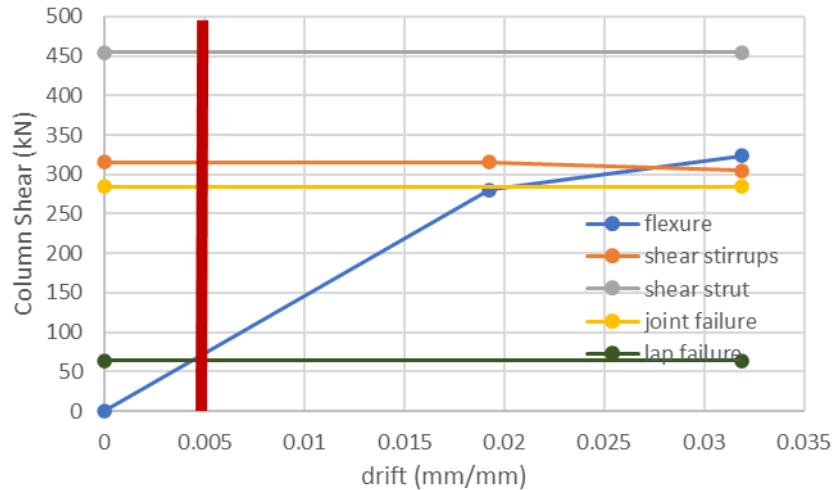
Figure 88. Comparison of different failure mechanisms in the bottom of the column

The above analysis shows that the prevailing mode of failure of the main frames of the structure will be brittle lap splice failure. Especially for the external frames, the failure load will be 64 kN per column, or 128 kN per frame.

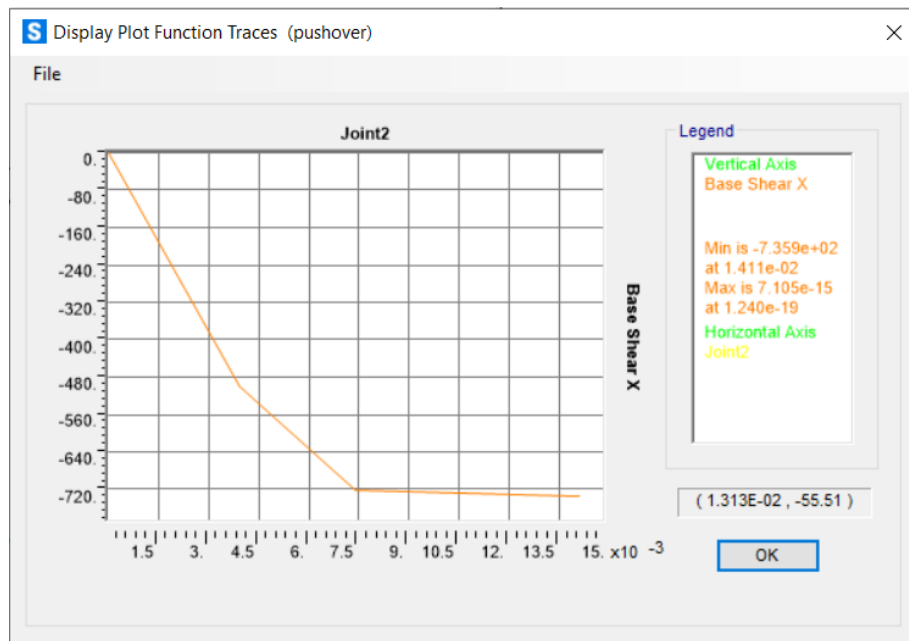
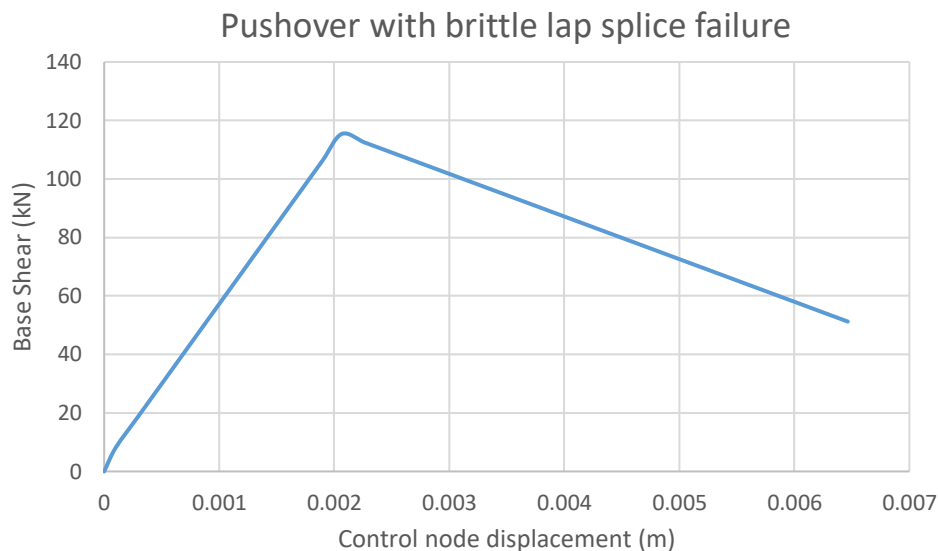
Figure 91. Pushover curve with ductile hinges (top) and brittle hinges (bottom)

The pushover curve in the case of the ductile hinges is shown in Figure 91 (top). The frame behaves elastically up to a load of 720 kN, corresponding to yielding of the flexural reinforcement in the columns, while after that a plateau appears, suggesting a great amount of ductility for the frame up to the failure of the hinges. The actual behavior of the frame is depicted in the bottom part of the same figure, where the brittle lap splice failure was incorporated in the properties of the hinges. In this case, the frame was not able to reach its yield load as before, since the columns failed at a Base Shear of 120 kN, and after that the frame's capacity to transfer loads dropped to zero.

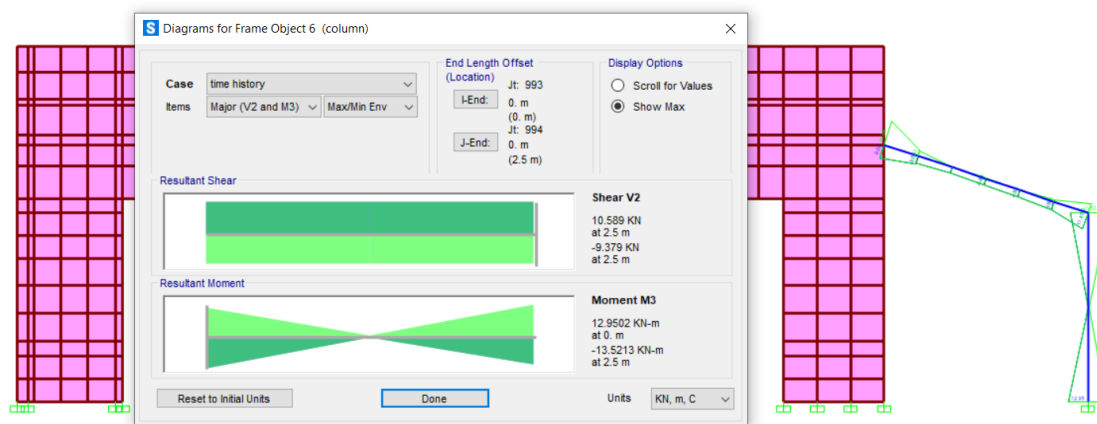
Figure 36. Moment and Shear envelope of Time History analysis of an external column.

The Moment and Shear envelope exhibited by one of the porch columns in the Time History analysis is depicted in Figure 36. Both the shear force and the drift demand suggest that the reinforced Hennebique columns will result in premature shear failure due to the seismic excitation. The low strength of the concrete, the low axial force, as well as the lack of stirrups will all contribute to this brittle type of failure during the design seismic demand.

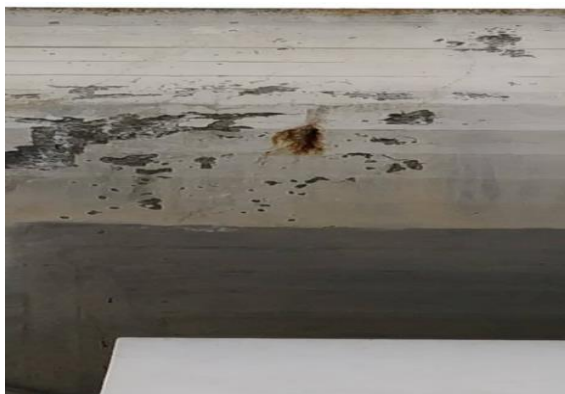
Corrosion is evident in some of the slabs of the 1st floor, especially at the locations where the rain water is not properly removed from the roof and in the columns of the ground floor, where cover has spalled and the reinforcement is exposed. The slabs at these locations have black stains and show cover delamination. All deterioration in reinforced concrete is connected with moisture, carbonation and corrosion of the reinforcement. The walls in one of the shops also have some diagonal cracking, that suggests minor settlement of the foundations. Mosses and blemishes were recorded to be extensive in the exterior surfaces of reinforced concrete.

(a) Rust stains

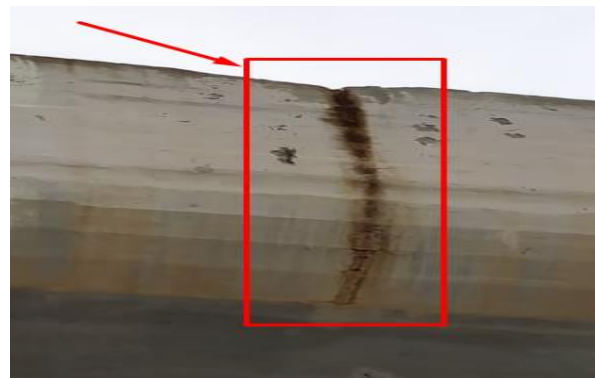
(b) Rust stains

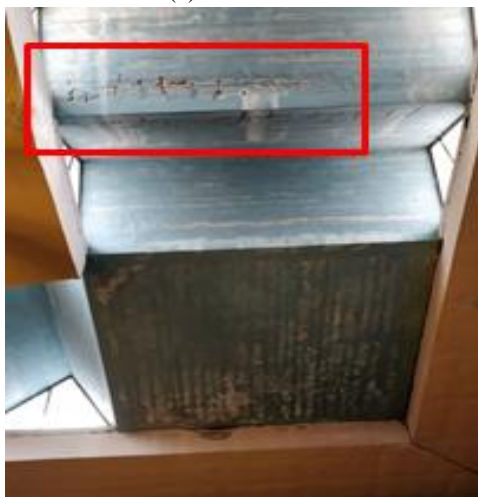
(g) Poor cover – exposure of reinforcement

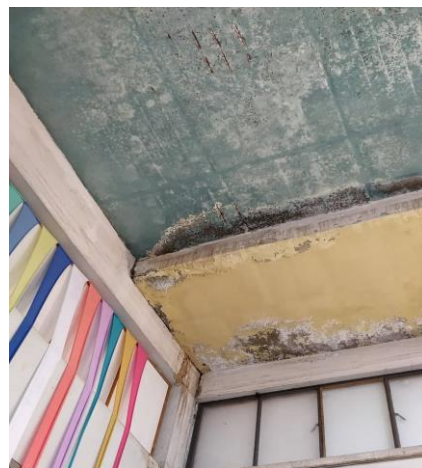
(h) Poor cover – exposure of reinforcement –

extensive erosion

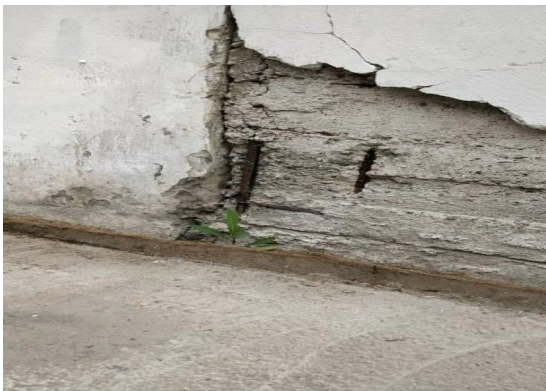
(c) Cover delamination and rebar corrosion

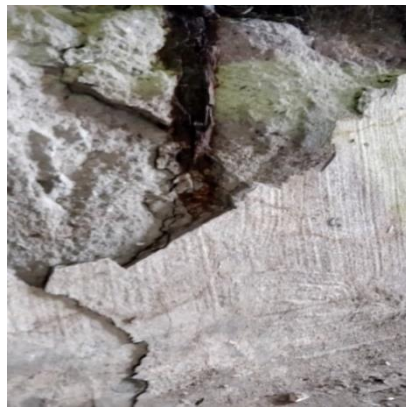
(d) Cover delamination and rebar corrosion

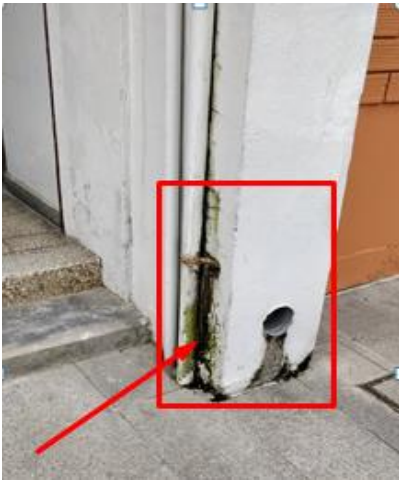
Typical damages were recorded and are shown in Figure 25. Cracks are visible in most of the beams of the structure. Drainage from the roof passes through some of the external columns of the building, increasing moisture in the columns and inducing potential corrosion to the reinforcement. The base of the columns with drainage systems, in fact, shows extensive concrete cracking, probably due to the corrosion of the reinforcement. The overall state of the building is rather good, despite its abandonment and lack of maintenance for many years. In general, there are no visible cracks from seismic loads on the reinforced concrete elements.

(e) Water drainage passing through columns with extensive stains and cracking

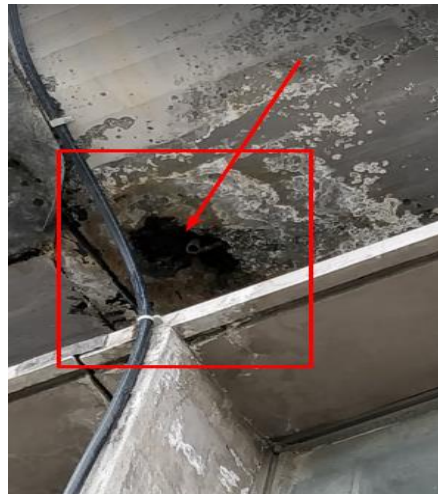
(f) Mold, stains, efflorescence internally under slab

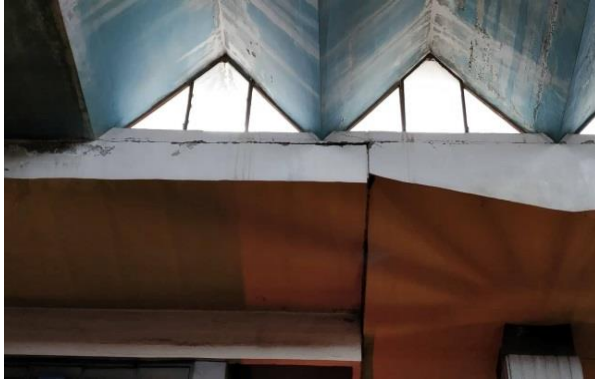
(i) Deformations in the cantilever slab

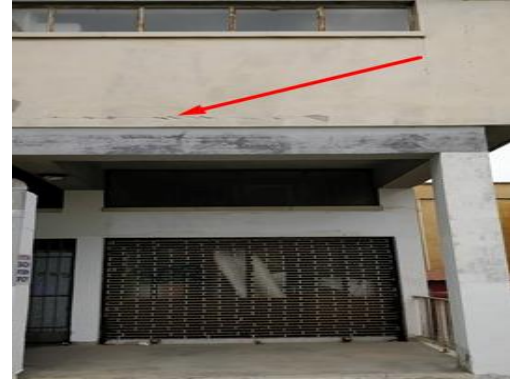
(j) Horizontal cracks at the connections of the infill walls with the structural system

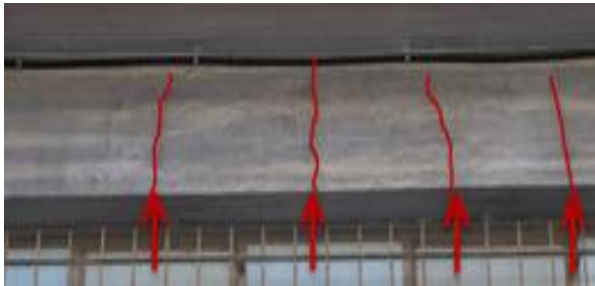
(k) Deflection cracks on beams

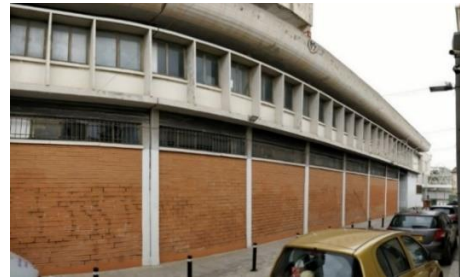
The building is of Reinforced Concrete cast on site and consists of four statically independent parts, separated with construction joints (3-5 cm). One part has a basement, but the rest of the structure has two floors above ground. Only the East-South part (green frame) of the structure was selected for analysis in this report, as shown in Figure 40, while some preliminary seismic assessment was also performed for the West part (red frame). The four individual parts consist of R/C slabs, beams, columns and walls; the latter, according to exploratory excavations, are supported on connecting beams without footings. Most frames in the perimeter of the building have brick infill walls that do not extend to the full column height, thus creating captive columns.

(l) Short columns due to partial infill walls

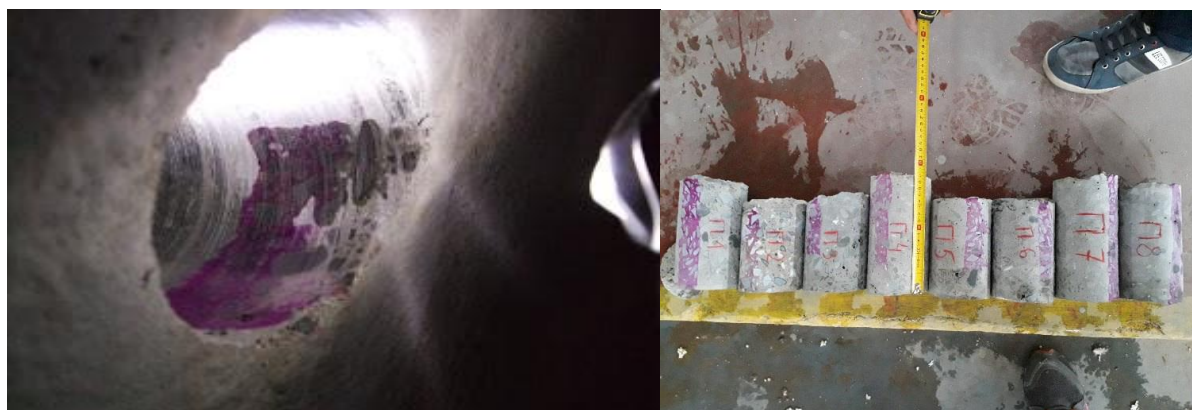
Figure 43. Coring of concrete samples and carbonation depth test.

Figure 43 depicts the tests for the determination of carbonation depth on the structural members after core extraction and on the cores themselves, using phenolphthalein (EN 14630). The uncarbonated concrete shows in purple colour. The carbonation depth at each test location is registered in Table 3. The results indicate that, in most cases, carbonation depth was less than the cover of the reinforcement, with only limited members (highlighted) exhibiting values up to the cover depth.

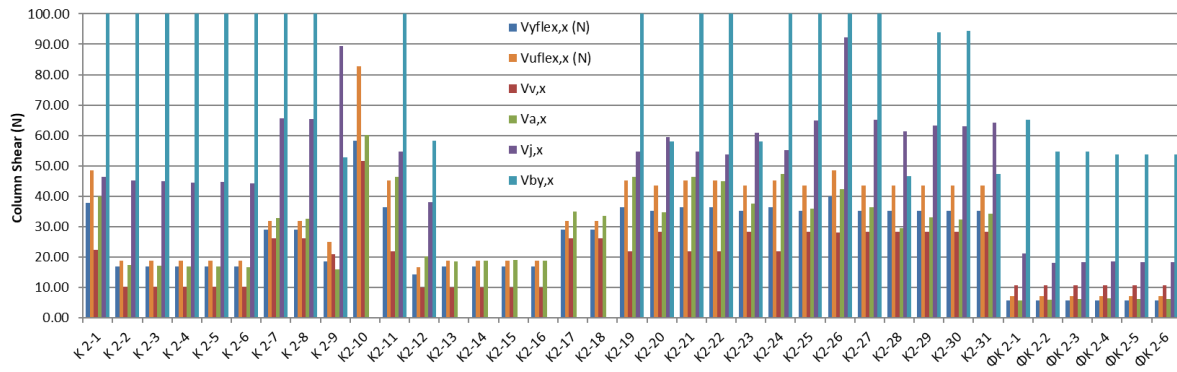
The results from the analysis performed are shown for the X-direction in the charts of Figure 49. The first assumption to be made is that in almost all cases the failure of the columns will prevail yielding of the beams. This is attributed to the wrong type of design of RC members of the era that required “strong beams-weak columns”. The earthquakes that followed showed that, that kind of design was wrong, leading to collapse of the members, while modern seismic codes, through the capacity based design approach, have rectified the approach promoting a “strong column-weak beam” design.

Additionally, the results indicate that most of the columns in the ground floor will behave in a ductile manner with flexural failures, except for some columns with very high axial load that will show brittle failure of the compressive zone prior to yielding of reinforcement, and some cases of brittle shear failure for loads parallel to the weak axis of the members. On the contrary, most of the columns in the 1st floor will fail due to brittle shear failure, due to their short length, in combination with the very sparse stirrups, having a spacing of more than 300 mm.

Figure 49. Shear force for different mechanisms of failure for the X-direction of seismic action, for the ground floor columns (top) and the 1st floor columns (bottom)

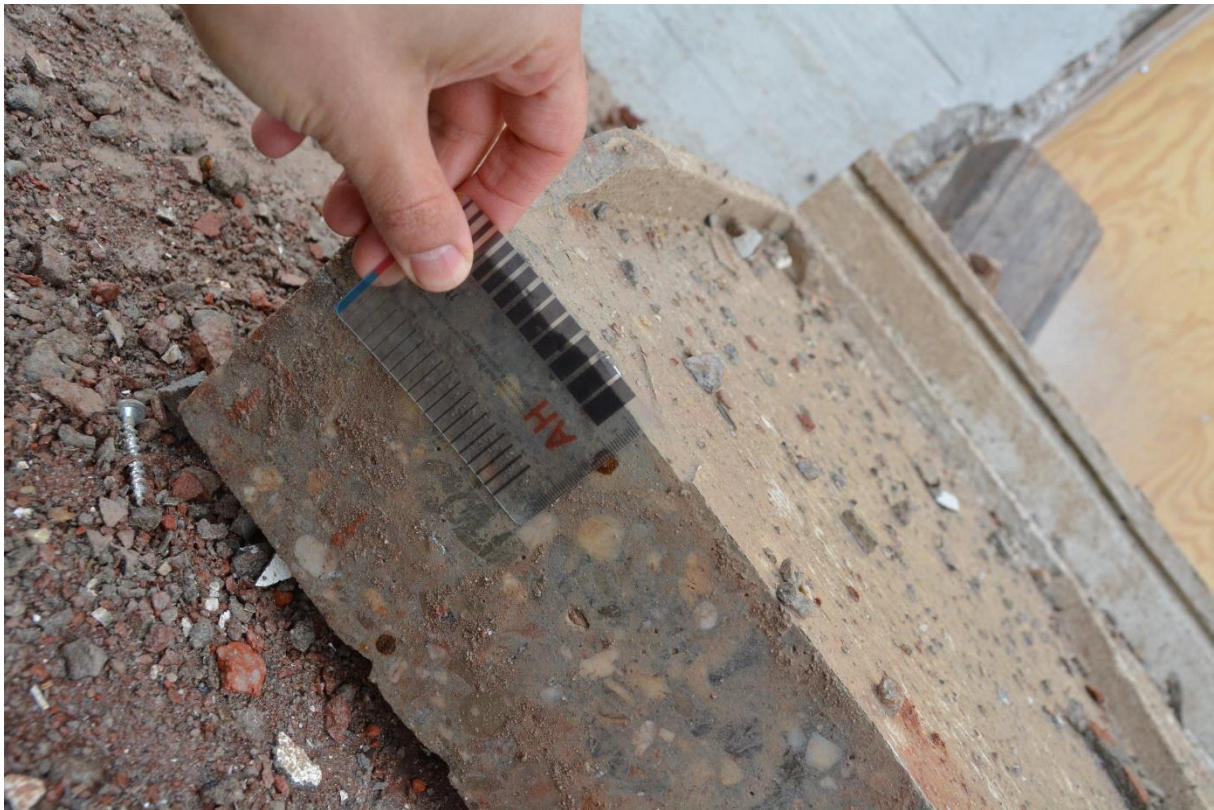
The existing reinforced concrete has an estimated compressive strength of 38.5 MPa (+/- 3.77) assessed with Schmidt Hammer (refer to Section 0). The reinforcement is plain round rebar and has a concrete cover in exterior columns between 20 to 25 mm; the cover in walls varies between 20 to less than 10 mm, as the thickness of the walls varies. The coarse aggregates of the concrete are natural and round, with maximum side dimension of 20 mm. The binder used in the concrete is unknown, but given the grey colour and the year of construction, it is very likely that is Portland cement (Figure 55).

Figure 55. Section of the wall cut during the 2021 renovation.

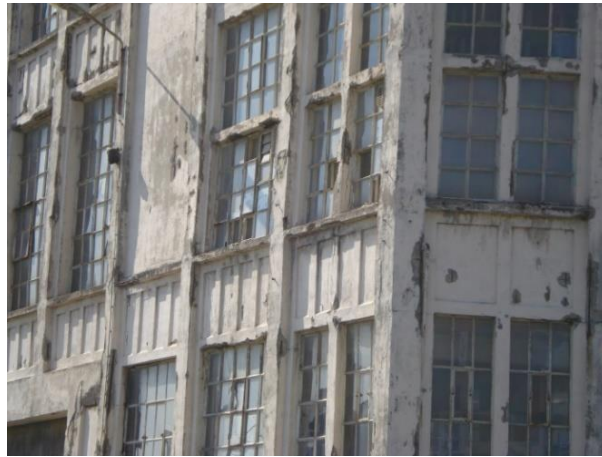
The damage found in 2010 were vertical individual cracks in walls under windows, and spalling in exterior columns and walls (refer to Figure 57 & Figure 58)².

Figure 57. Damage in 2010. Source: TNO.

Given the type of damage, and the testing performed in the building (refer to Sections 0 & 0), the likely cause of the damage is carbonation-induced corrosion. The visible cracks are aligned with the reinforcement, suggesting expansion forces due to corrosion. Spalling was localized in areas of reinforcement where the concrete cover is minimum. From the pictures obtained, pitting corrosion is not visible; neither is it mentioned in the documentation related to the intervention³.

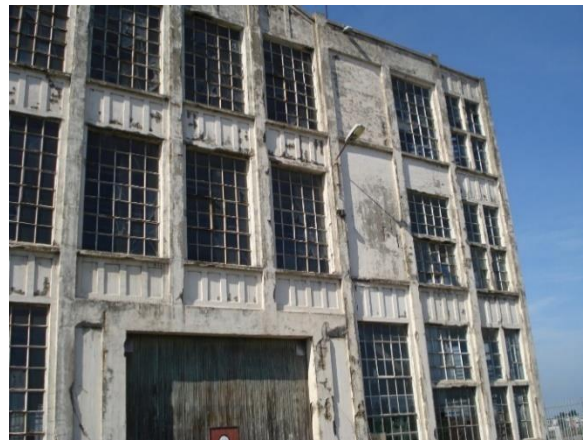
Figure 58. Condition of the building in 2010. Source: TNO.

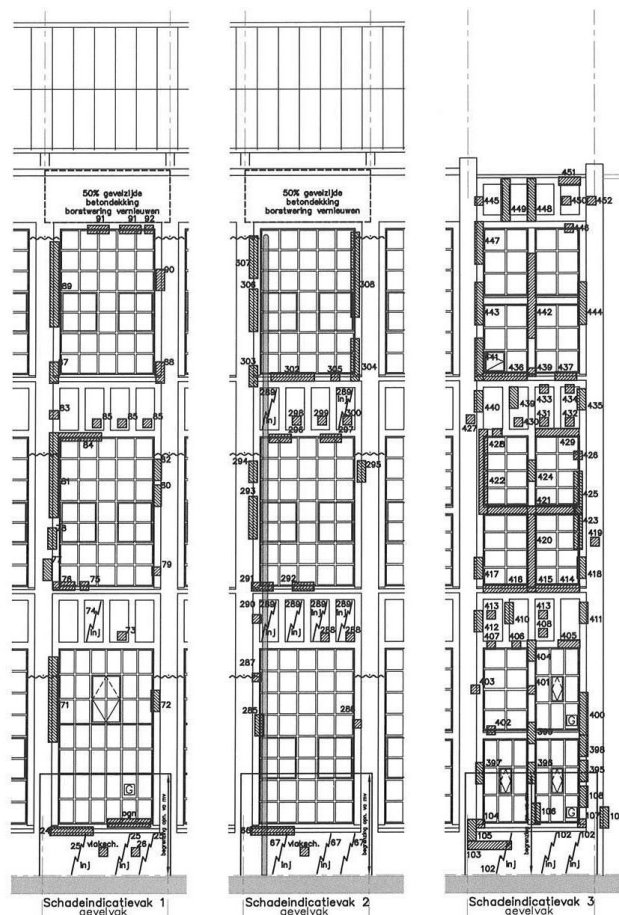
The architects Rothuizen, specialized in the restoration of young and historic monuments, carried the intervention project of 2010. For the assessment of the concrete and the advice on the repairs. The specialized company SGS-Intron was hired to complete the damage assessment of the exterior facades. In elevation drawings and pictures, the damage types were annotated (Figure 60).

Figure 60. Partial elevation drawing with damage mapping from the company Rothuizen Architecten. Source: Rothuizen.

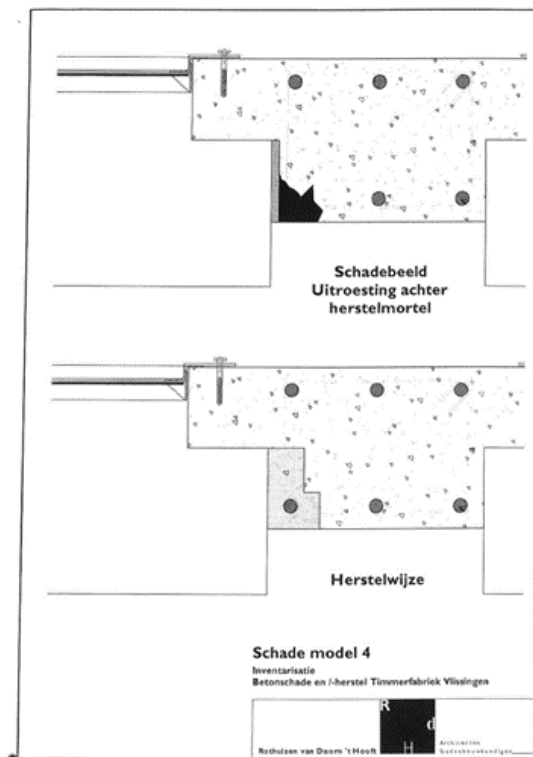
Figure 61. Sample of the specific detail for a patch repair in the corner of a column. Source: Rothuizen.

The architects also provided a catalogue with the different types of repairs depending on type and characteristics of the damage (Figure 61). With this catalogue, the subcontractor performing the repairs could apply the specific repair detail according to the damage.

The overall process of the patch repairs was: (1) removal of loose concrete and carbonated concrete around the reinforcement, (2) surface preparation, (3) application of bonding agent, (4) repair mortar application, (5) pull-out testing, (6) water repellent, and (7) final coating.

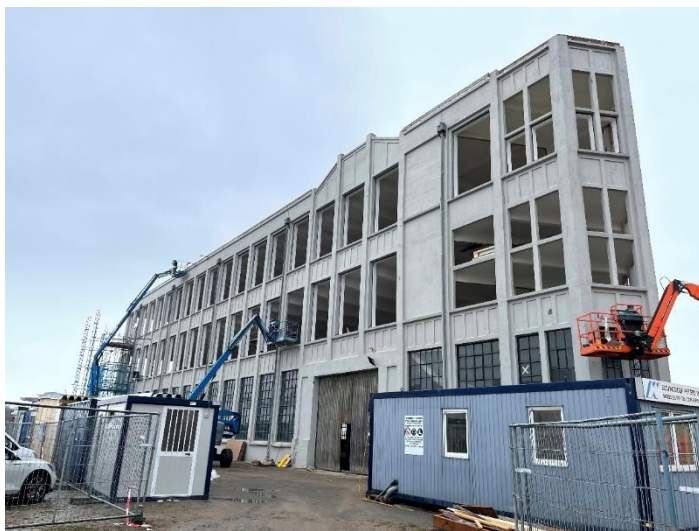
The concrete façade did not show signs of generalized damage (Figure 63). Scattered damage was found in a few locations. The damage consisted in small spalling and was located in the areas of the wall below the windows (Figure 64). The damage did not seem to correspond with previous patch repairs.

Figure 63. East facade condition in 2021.

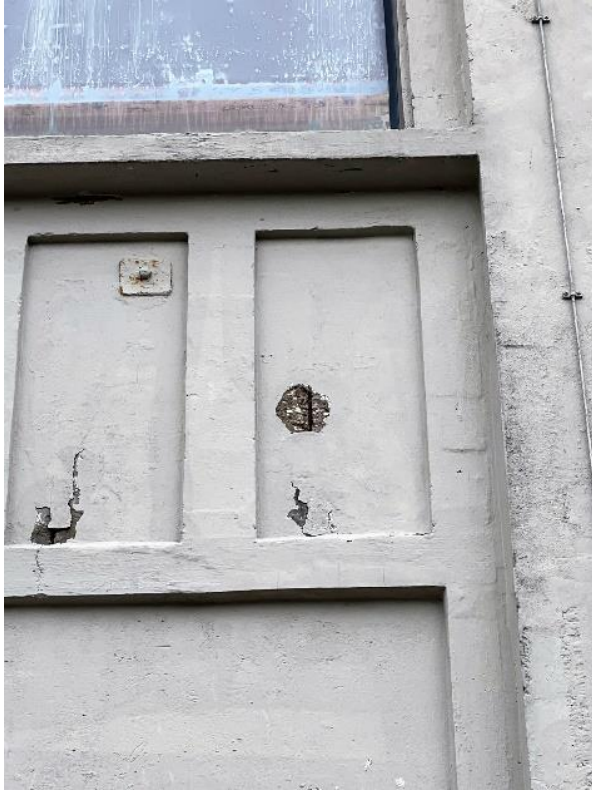
Figure 64. Spalling and incipient spalling recorded in the thinner parts of the wall in 2021.

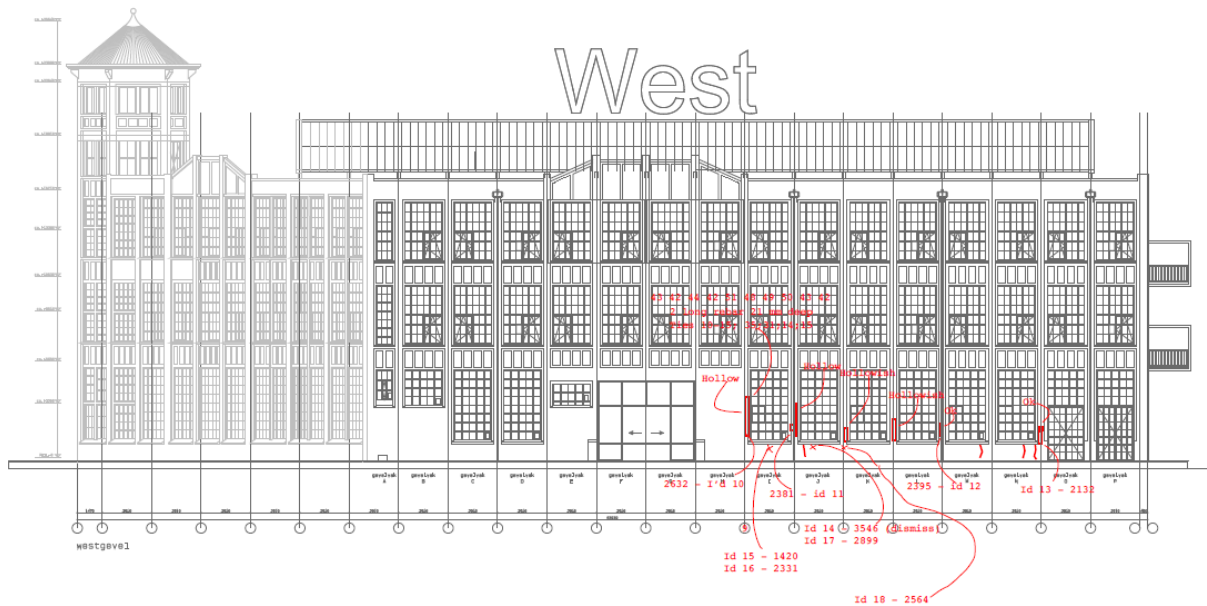
Figure 65. Annotations of the inspection and tests in the west facade.

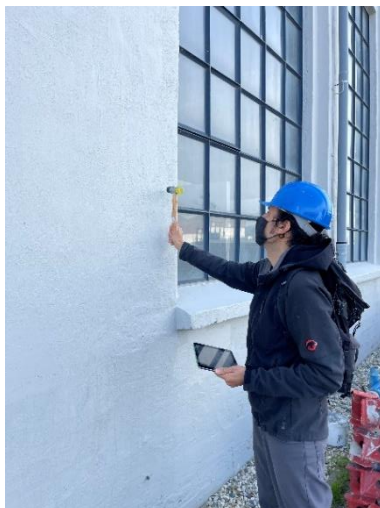
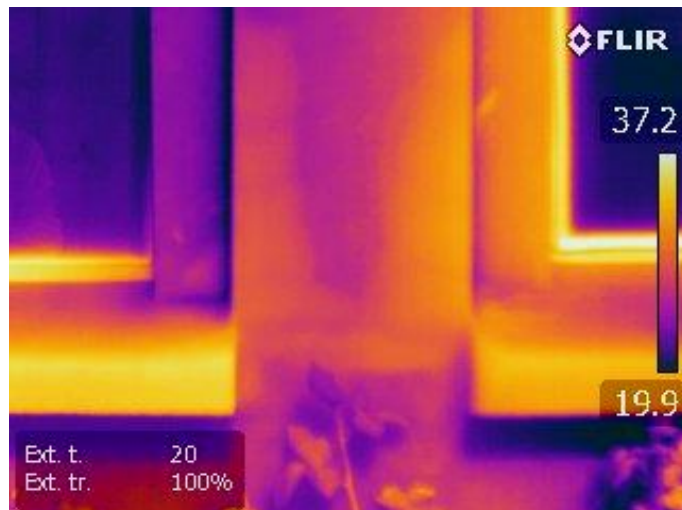
Once the patch repairs were located, they were tested with the three techniques: first, with the rubber hammer to assess if debonding was noticed by a hollow sound (Figure 66_left); secondly with the thermal camera to corroborate if the unbound and bound conditions were noticeable (Figure 66_right); thirdly with UPV.

Figure 66. Hammer sounding (left) and thermal picture in a columns with patch repairs (right).
