Merged Report on In-Depth Case Studies

TU Delft – Chair of Heritage and Technology

Editors: Gabriel Pardo Redondo and Silvia Naldini (TU Delft)

Date: November 19, 2021

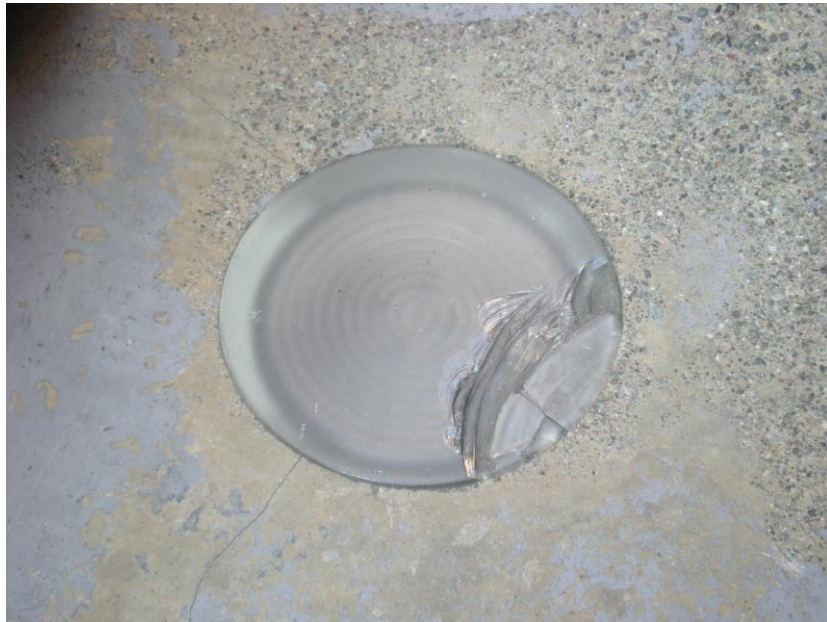
In spite of these precautionary measures, water infiltration occurred repeatedly in the intervening years, with visible results especially in the tholos where the Zacharias Cross is displayed.

Temporary reparations (photo G. Franco)

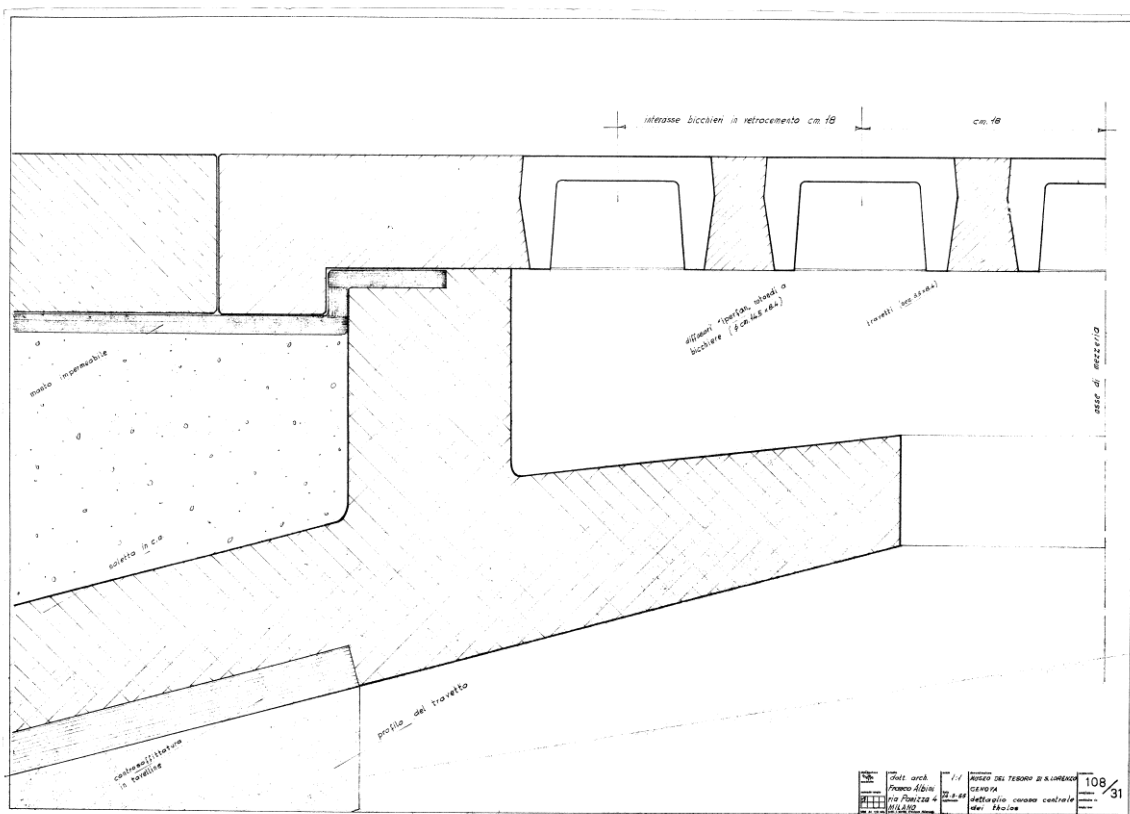
Detailed drawings of the skylight, Franco Albini. Courtesy Piero Boccardo, Direzione Musei di Strada Nuova

The most significant intervention was the repair of the block-glass skylight and their light diffusers (many of which were broken and some blocked up altogether). To prevent the leaking that became apparent during the study phase from becoming worse, the three existing discs in block glass were replaced with similar but newly manufactured discs.

Since the "useful life cycle" of the glass-cement panels was inevitably considered to be over, they had to be replaced in their entirety, and the problem of the unavailability of the original glass diffusers had to be addressed. The company merged with the company Seves Glass Block, based in Florence, which continues to produce glass "cups" with a cylindrical base, but smaller than those used in the museum, with a production diameter of 11.7 cm. However, given the small number of pieces (less than 60), it was possible to find some pieces belonging to the same batch, stored in some of the warehouse funds of the firm that had taken over the stocks of the original supplier, which has now disappeared. They were of the same size and had the same surface finish (concentric stripes) as those in place but were irreparably damaged and unrecoverable. They could therefore be inserted into new

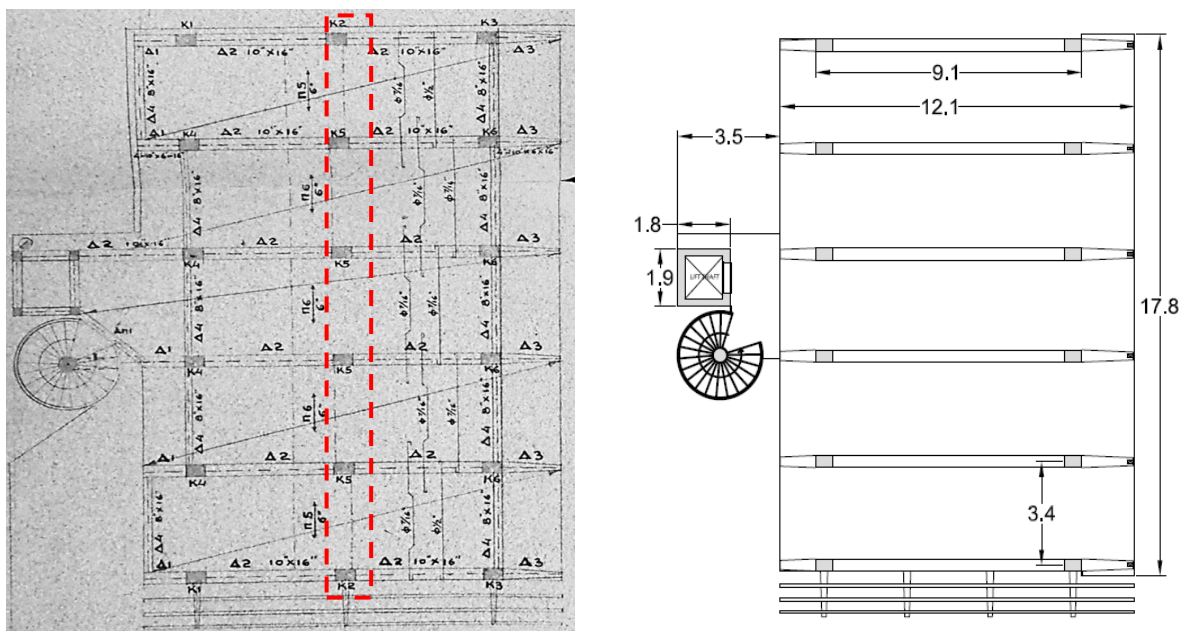
When comparing the original set of drawings to the recent survey drawings created for the restoration of the building in 2008, some important discrepancies of the structural system were found. The original drawings showed a series of columns located in the middle of the main frames from the ground level up to the roof level; this row of columns was not found during the recent surveys, as illustrated in Figure 76. The absence of these columns was confirmed during the site inspections that followed.

Figure 76. Typical floor plan as per: the original design (left) [7] and the survey plan (right)

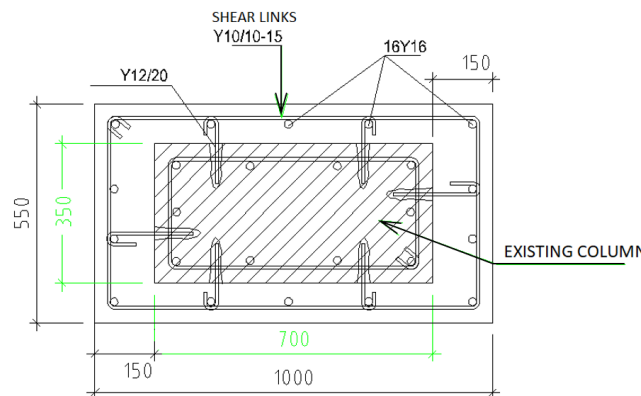
Figure 77. Reinforced Concrete jacketing detail [7]

The information on the structural aspects of retrofit works carried out were collected from the calculation set and structural report of the retrofit design, and through an interview with the Structural Engineer of the project. According to these sources, 26 columns at the two basement levels were strengthened with the RC jacketing technique, as per the detail shown in Figure 77, while the rest of the columns at the upper floor levels (121 in total) were retrofitted with 2 layers of carbon FRP. Prior to applying the FRP, all damages related to the corrosion of reinforcing steel were rectified. No strengthening works were carried out at the foundation level, or on the beams and slabs of the building [7].

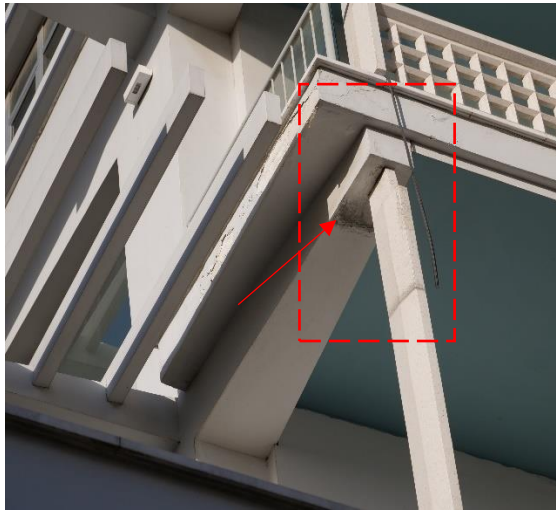
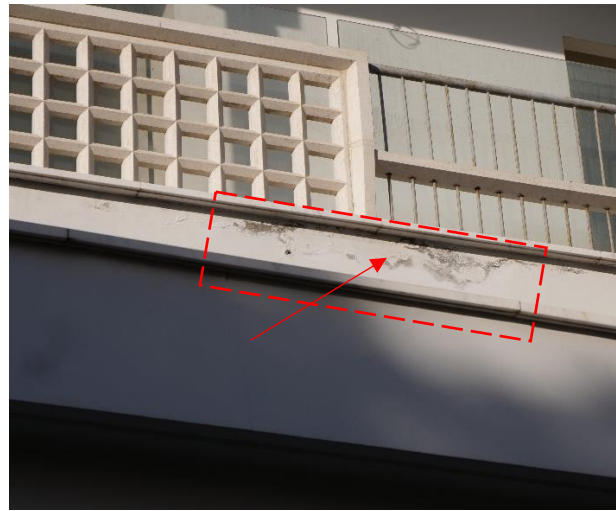
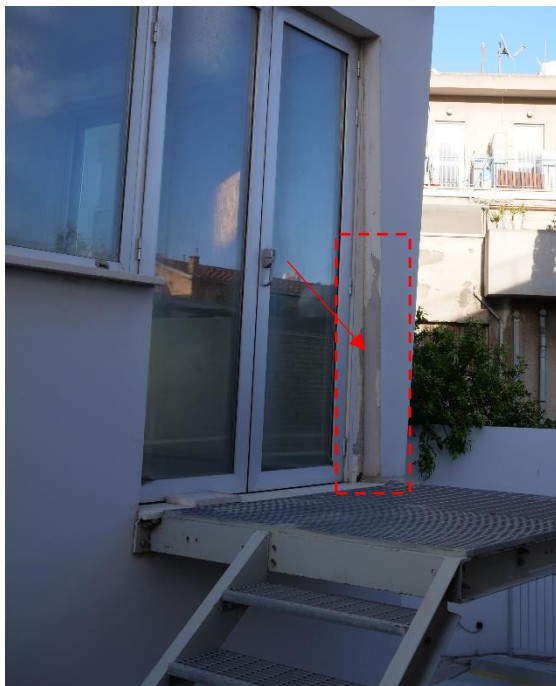
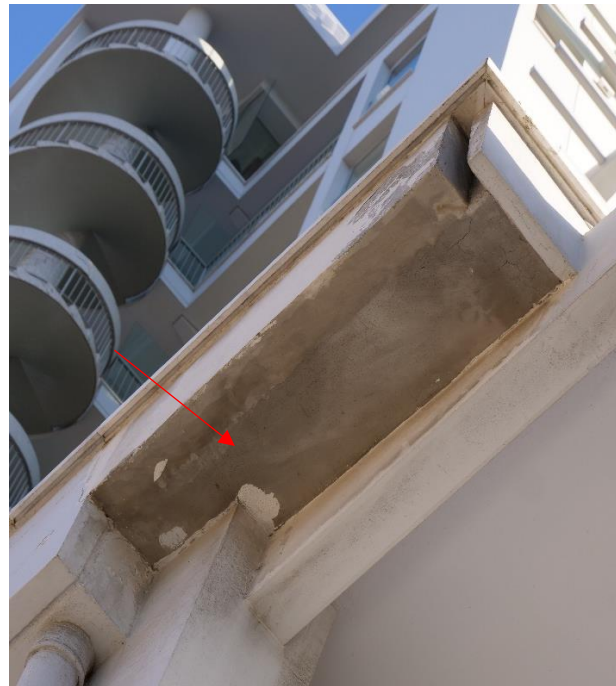
The damages identified during the visual inspection (post-retrofit inspection) were not severe and were mainly related to moisture ingress, causing peeling/flaking of external plasterwork and painting (Figure 79). The other type of damage found was microcracking at the junction points of beams-columns and horizontal cracking of the wall finishes (Figure 80). The most severe defect found was related to steel reinforcement corrosion and the corrosion of other embedded metal elements in concrete, that led to local concrete spalling (Figure 81). Inside the building, no significant defects were identified, although the majority of the concrete elements were not visible because of the addition of false ceilings and drywall partitions.

Figure 79. Minor defects related to moisture ingress causing plaster and paint flaking

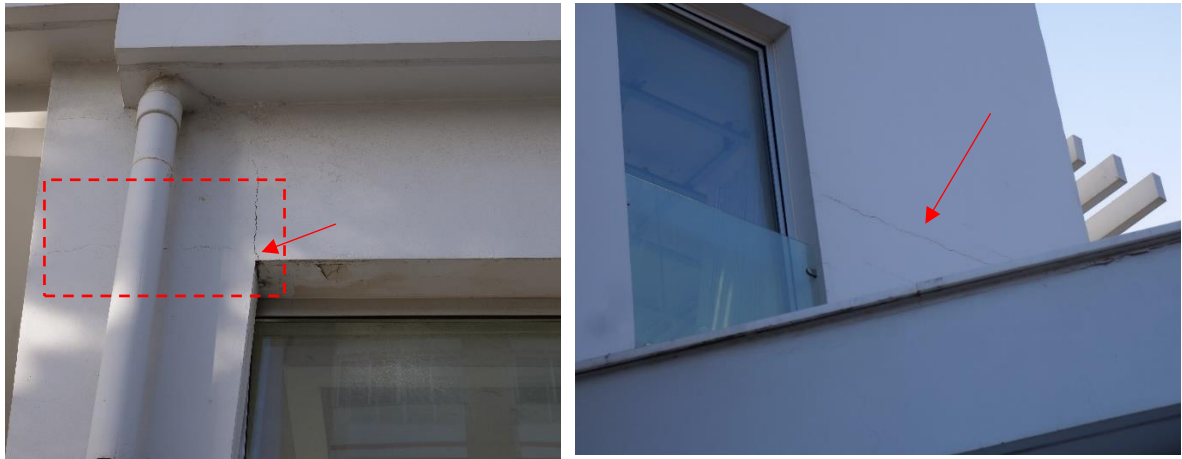
Figure 80. Micro-cracks on concrete elements and wall finishes

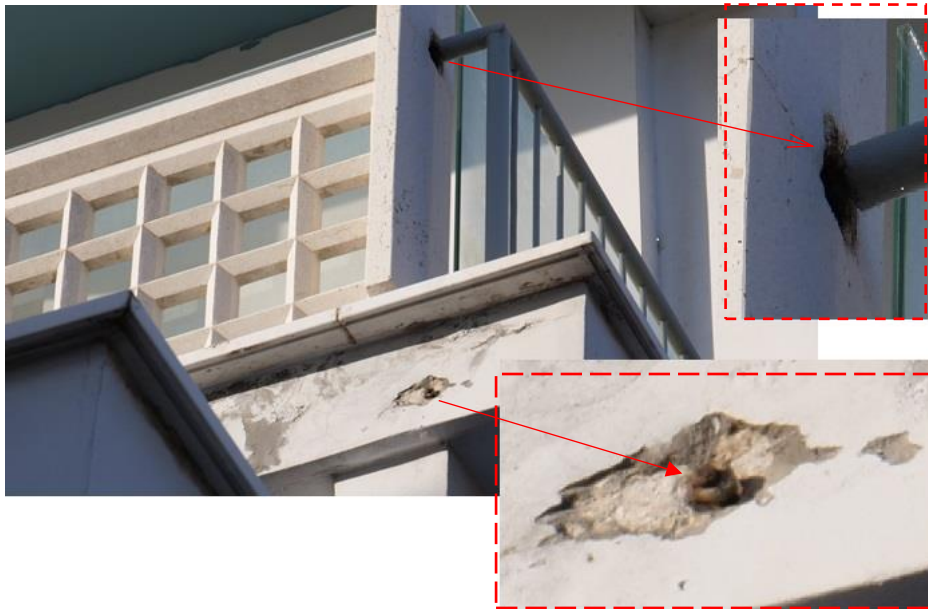
Figure 81. Reinforcement and other embedded metal corrosion causing local concrete spalling

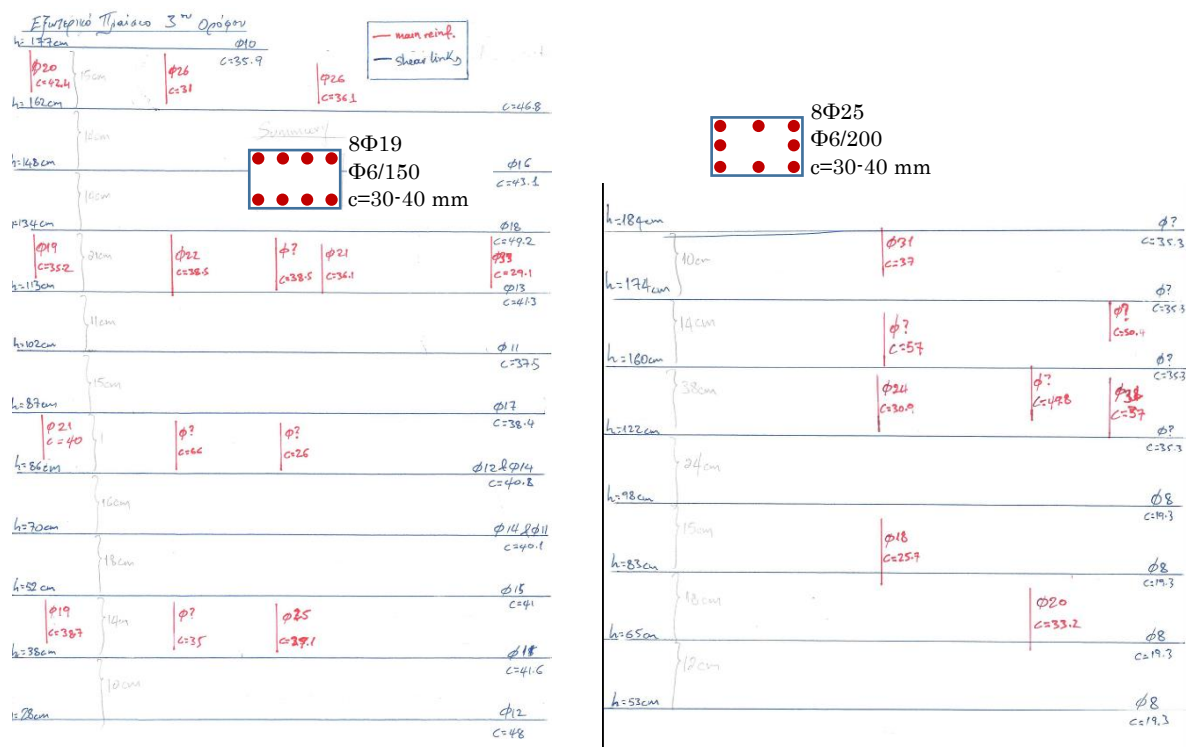
The reinforcement layout and diameter were measured with the rebar detector on two columns and one main frame beam at the 3rd floor level, which was the only floor accessible. The first problem encountered was the difference between the dimensions of the beams and columns between the original drawings and the as-built findings. As per the original drawings, the columns and beams should be of constant rectangular shape, while in reality they were built as tapered. Additionally, measuring the reinforcement was difficult, especially of the corner rebars, because of the use of metallic corners during the retrofit of the building. Yet, the rebar diameters were in close approximation to the ones mentioned in the original plans, as the columns during that time served only to transfer vertical loads to the foundation. The measured values are depicted in Figure . The main issue encountered during the measurements was the absence of reinforcement -both longitudinal and transverse- within the joint between the columns and the beams, which was also of a wider area than normal, due to the tapered geometry of the members.

Figure 84. Reinforcement measurements on 3rd floor columns; external frame (left) and internal frame (right)

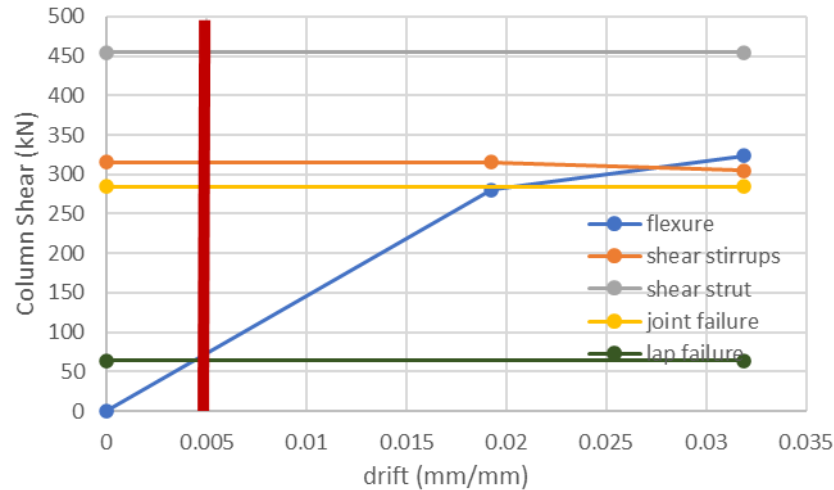
The above analysis shows that the prevailing mode of failure of the main frames of the structure will be brittle lap splice failure. Especially for the external frames, the failure load will be 64 kN per column, or 128 kN per frame.

Figure 88. Comparison of different failure mechanisms in the bottom of the column

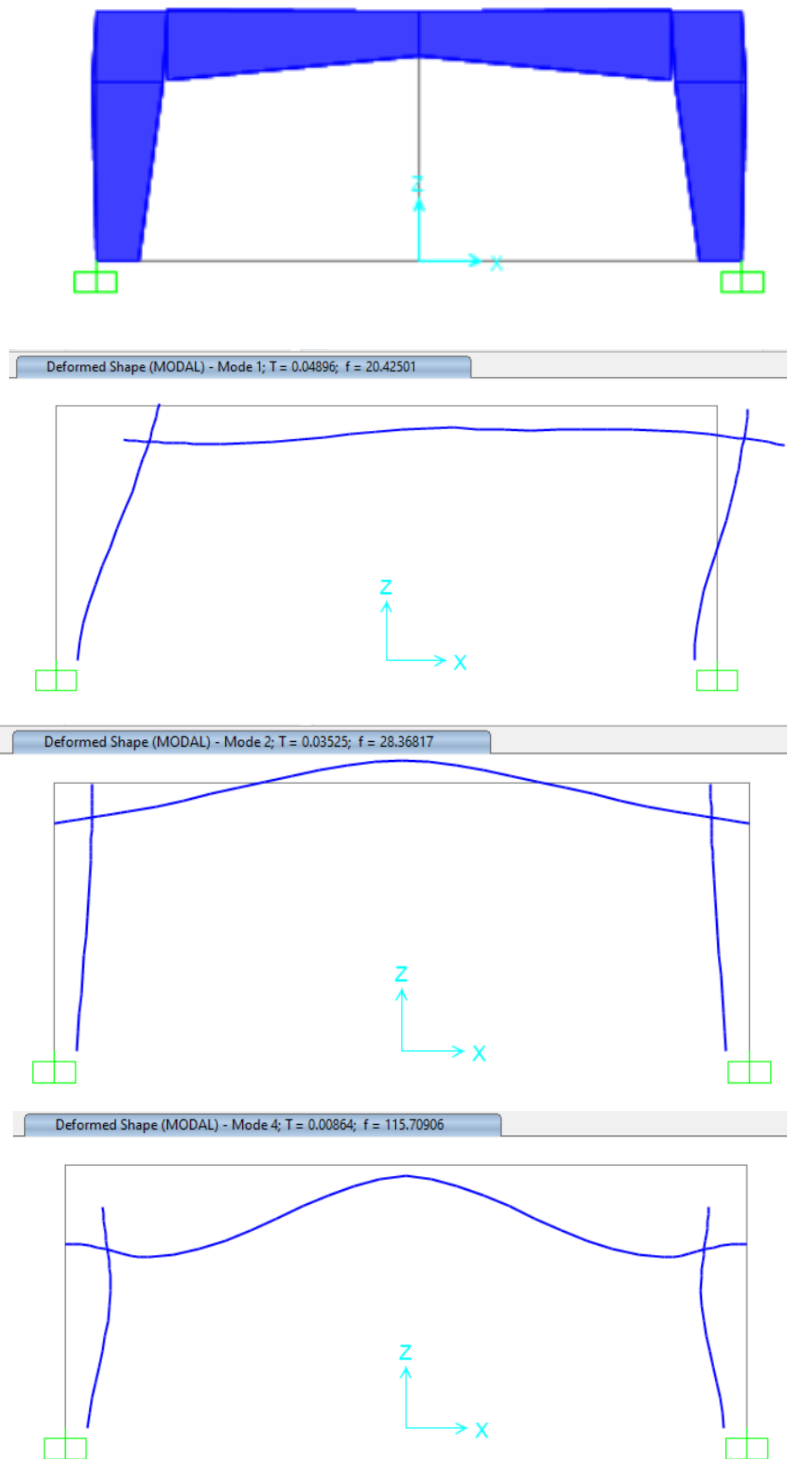
The modal analysis results are depicted in Figure 89, with the first mode to be translational in the X-direction, with a mass participation factor of 0.98.

Figure 89. Simulation of the frame with tapered members in SAP2000 and modal shapes
