Report on Conservation Proposals

Project: CONSECH 20

Working Package 4 – Task (iii)

Date: 30 June, 2022

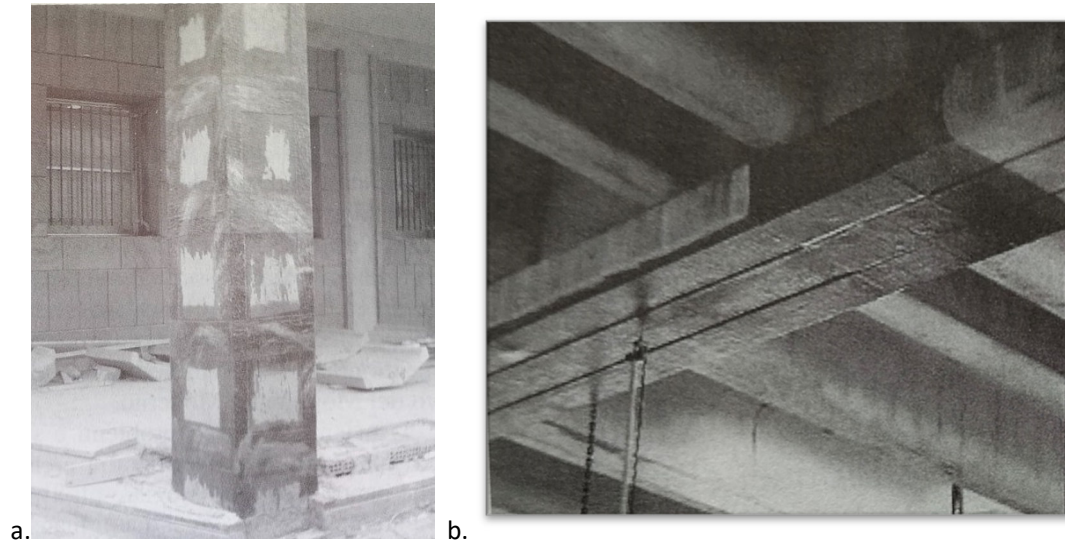
Figure A.2-1 a. Column shear strengthening with carbon FRP; b. Strengthening of beams with carbon FRP

- Processing of the edges of the member to be repaired to smooth them to avoid rupture of the fabric (provide minimum radius of curvature of 20-30 mm);
- Application, by roller or brush, of epoxy primer;
- Levelling of the intervention surface area;
- Application of two-component epoxy resin;
- Laying of fabric strips/net by hand or roller;
- Impregnation of fabric strips/net with two-component epoxy resin.

- Sandblasting of the intervention surface with quartz sand to make it rough and facilitate the clinging of the next layer of plaster;
- Substrate preparation;
- Realization of the FRP strips cover.

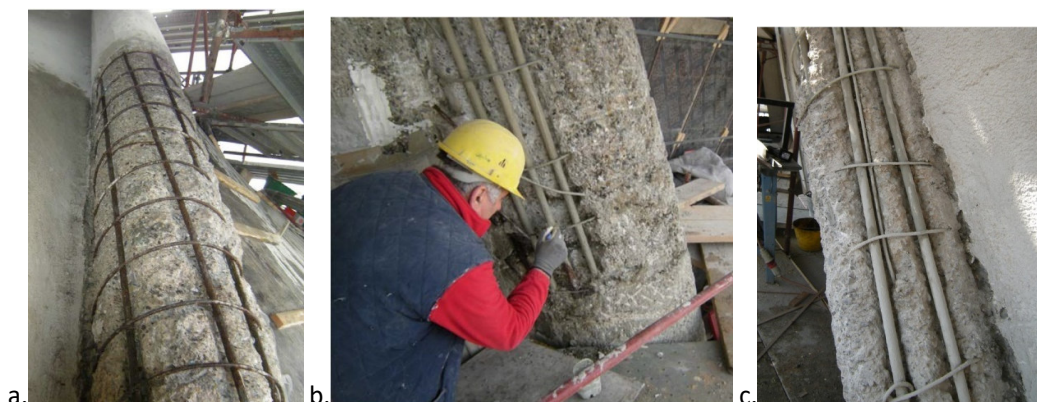
Figure A.2-2 a. Preparation of the intervention area through scarification and iron cleaning; b. brush application of the protection for the reinforcement; c. area ready for integration with mortar. Chiesa-Tenda, Longuelo, Bergamo

- Removal of degraded concrete by hand or electric hammer;
- Removal of the corroded layers of reinforcement and mechanical cleaning from dust, grease, and other contaminants through the use of metal brushes or by sandblasting or hydro-sandblasting;
- Replacement of any failed, damaged or strongly corroded steel reinforcement;
- Application by brush of a corrosion inhibitor on the exposed reinforcements;
- Restoration of the reinforcement cover with cement mortar of adequate thicknesses and compatibility with the existing member geometries.

- Cleaning and humidification (without saturation) of concrete;
- Application of thixotropic mortar, after making state-of-art wooden or plywood formwork, in successive layers of 20-30 mm, for interventions that require large thicknesses of the new material;
- Finishing of the reconstructed part with cement mortar with fine grain size.

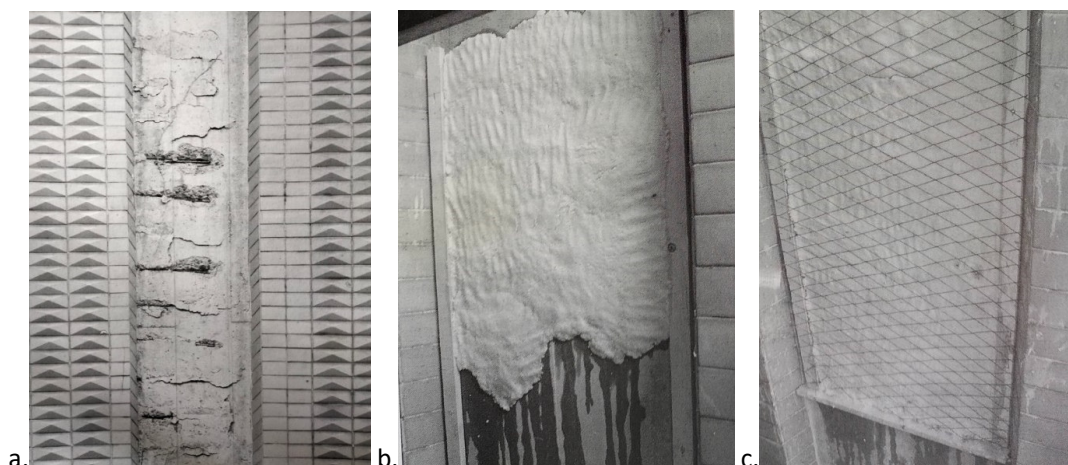
Figure A.2-1 State of facts before intervention (a); application of anode system: cellulose pulp layer (b), titanium net activated (c). Chiesa Ospedale San Carlo Borromeo, Milano.

- Removal of degraded concrete by hand or electric hammer;
- Removal of corrosion products present on the surface of reinforcements and mechanical cleaning from dust, grease and other contaminants through the use of metal brushes or by sandblasting or hydro-sandblasting;
- Replacement of any failed, damaged or strongly corroded steel reinforcement;
- Application by brush of a corrosion inhibitor on the exposed reinforcements;
- Preliminary covering of concrete and reinforcement with cement mortar, leaving a portion uncovered to be connected to the electrical system.

- Punctual investigation through the creation of a hole in the steel cover;
- Spray application of pH indicator.

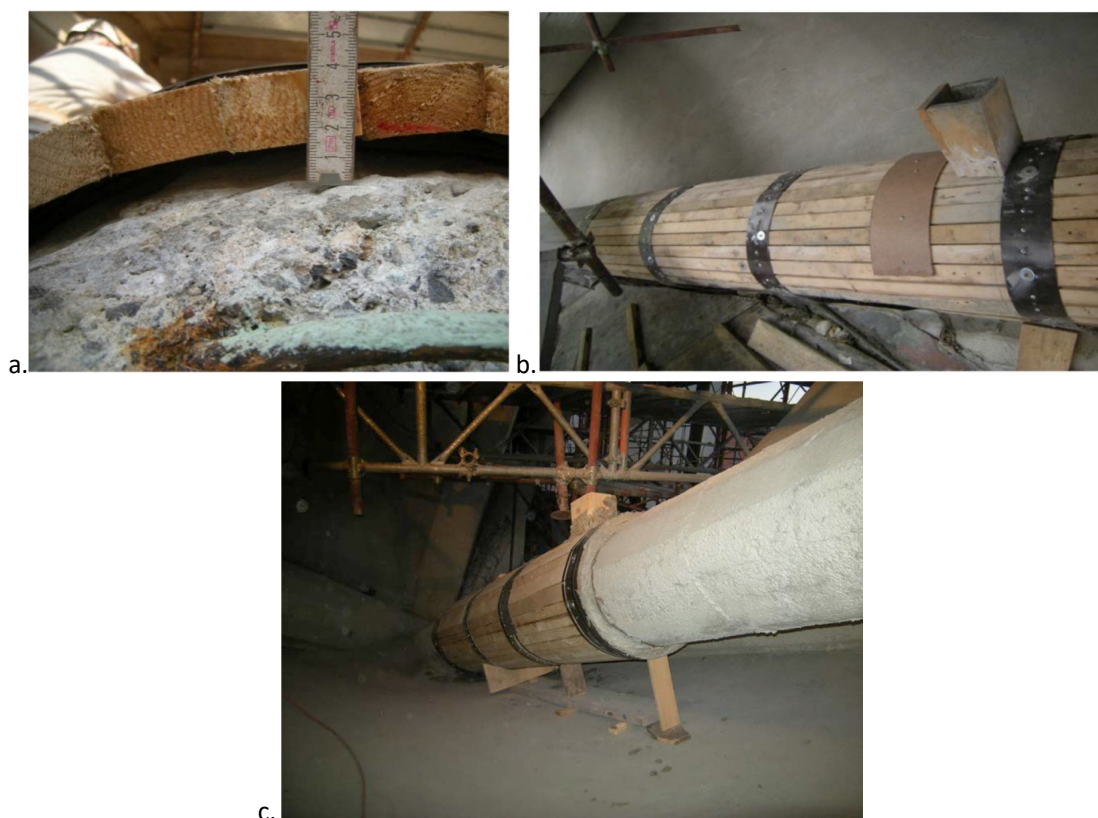
Figure A.3-1 Steps of realization of the wooden formwork: assembly at a minimum distance of 10 – 15 mm from the substrate (a); completion of the wooden formwork with strips of metal foil and funnel for casting (b); filling of the formwork with plaster mortar (c). Chiesa-Tenda, Longuelo, Bergamo

- Disassembly of wooden formwork no earlier than 4-5 days from casting.

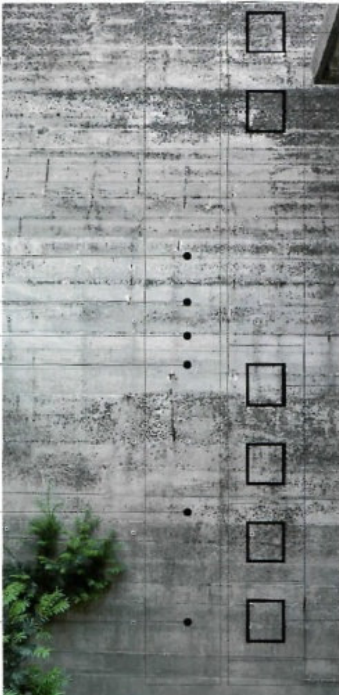
SAMPLE CODE	CLEANING PROCEDURE	MONITORING	EXTRINSIC FACTORS - previous interventions of plaster replacement since 2001-2 Exposure to the environment: external environment, north, summit surfaces runoff, humidity INTRINSIC FACTORS - "defects" of realization (cf diagnostic): absence of summit concrete protection from rain with consequent runoff and humidity absence of expansion joints and consequent cracks to verify and to differentiate from failure
	ENVIRONMENT CHARACTERISTICS		SAMPLE CLEANING E	PRODUCTS APPLICATION METHOD

depth of carbonation	EXTRINSIC FACTORS - previous interventions of plaster replacement since 2001-2 - Exposure to the environment: external environment, north, summit surfaces runoff, humidity

chemical tests	INTRINSIC FACTORS - "defects" of realization (cf diagnostic): absence of summit concrete protection from rain with consequent runoff and humidity

cracks monitoring	absence of expansion joints and consequent cracks to verify and to differentiate from failure

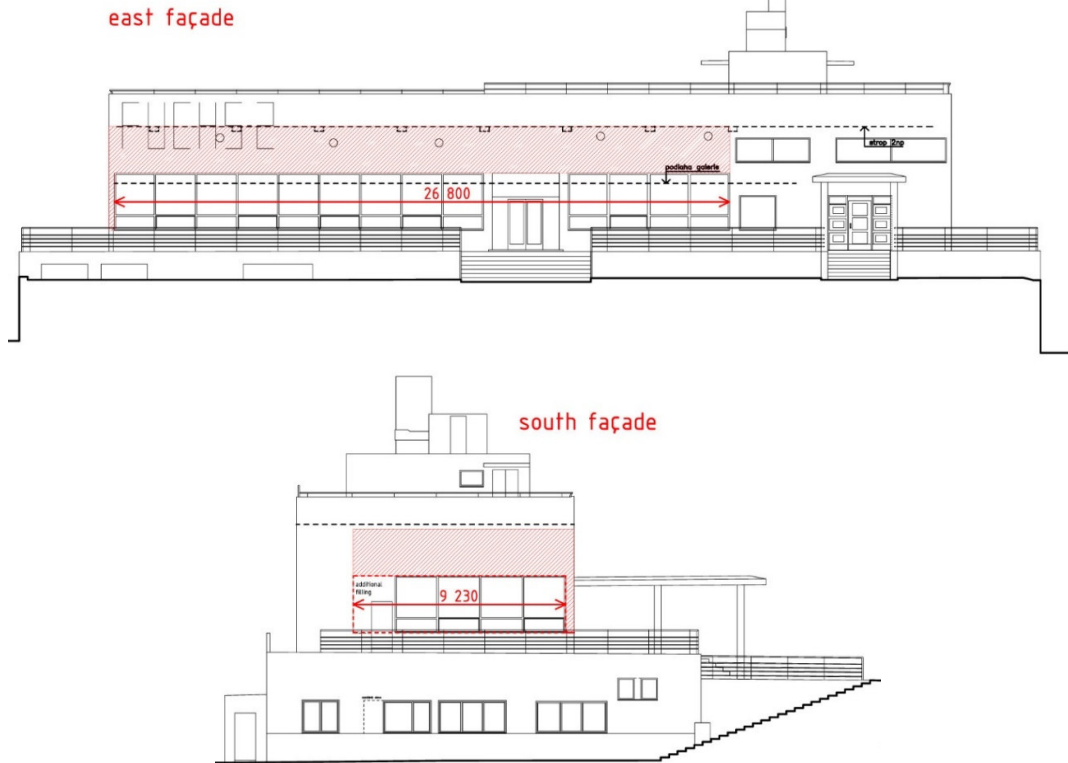
Originally, the stripe windows on the ground floor measured 26.80 m (east façade) and 9.23 m (south façade) in width, with an equal height of 3.16 m (Figure B.2-4); these two windows were divided by a corner column measuring 230 x 380 mm.

Figure B.2-4 East and south façade (current state) showing the original span of the lintel walls (marked in red).

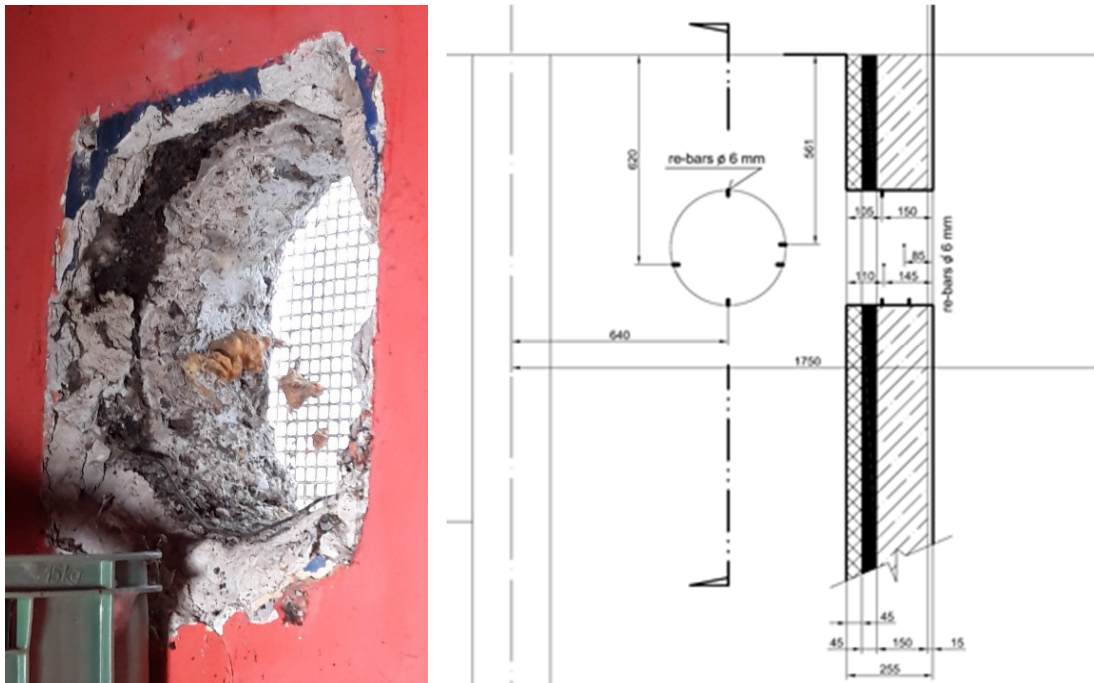
The visual inspection of the building brought new information on the structure of the lintel wall. Its composition is revealed in six perforations (perimeter circa 400 mm) made into the east façade during the last intervention to install the ventilation system (Figure B2-10). The wall consists of exterior plaster, 120-150 mm of reinforced concrete, 45 mm of insulation, and 45 mm of additional concrete

layer and plaster on the interior side. Both the horizontal and vertical reinforcement bars are visible in the section through the main concrete layer.

Figure B.2-10. Detail of the ventilation hole on the lintel wall and cross-section drawing of its layout.

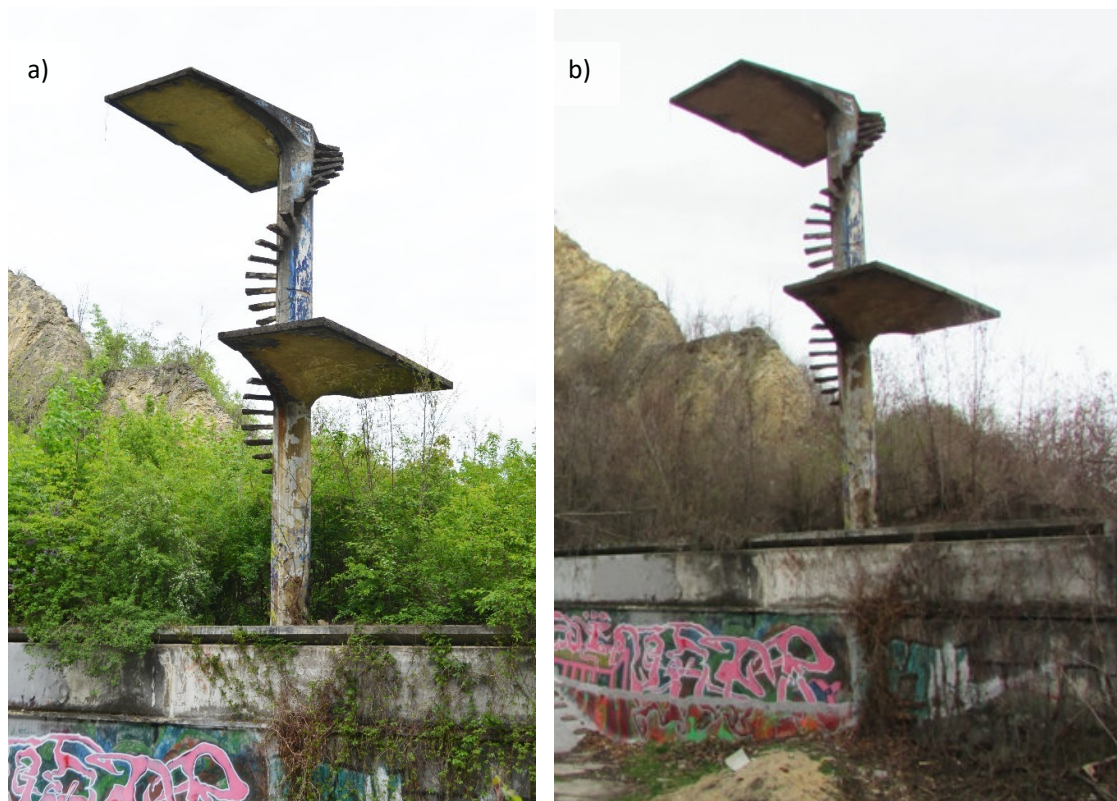
The visual inspection of the structure was performed on 21.7.2020, when vegetation was flourishing (Figure B.2-15a) and on 27.2.2020 when the surrounding vegetation was naked (Figure B.2-15b). The description of the damage types was done according to the MDCS atlas [29]. Figure B.2-16 shows the south elevation drawing of the tower with the indication of the main damages observed.

Figure B.2-15 General view of the diving tower: a) Photo taken on 28.4.2020, b) Photo taken on 27.2.2020.

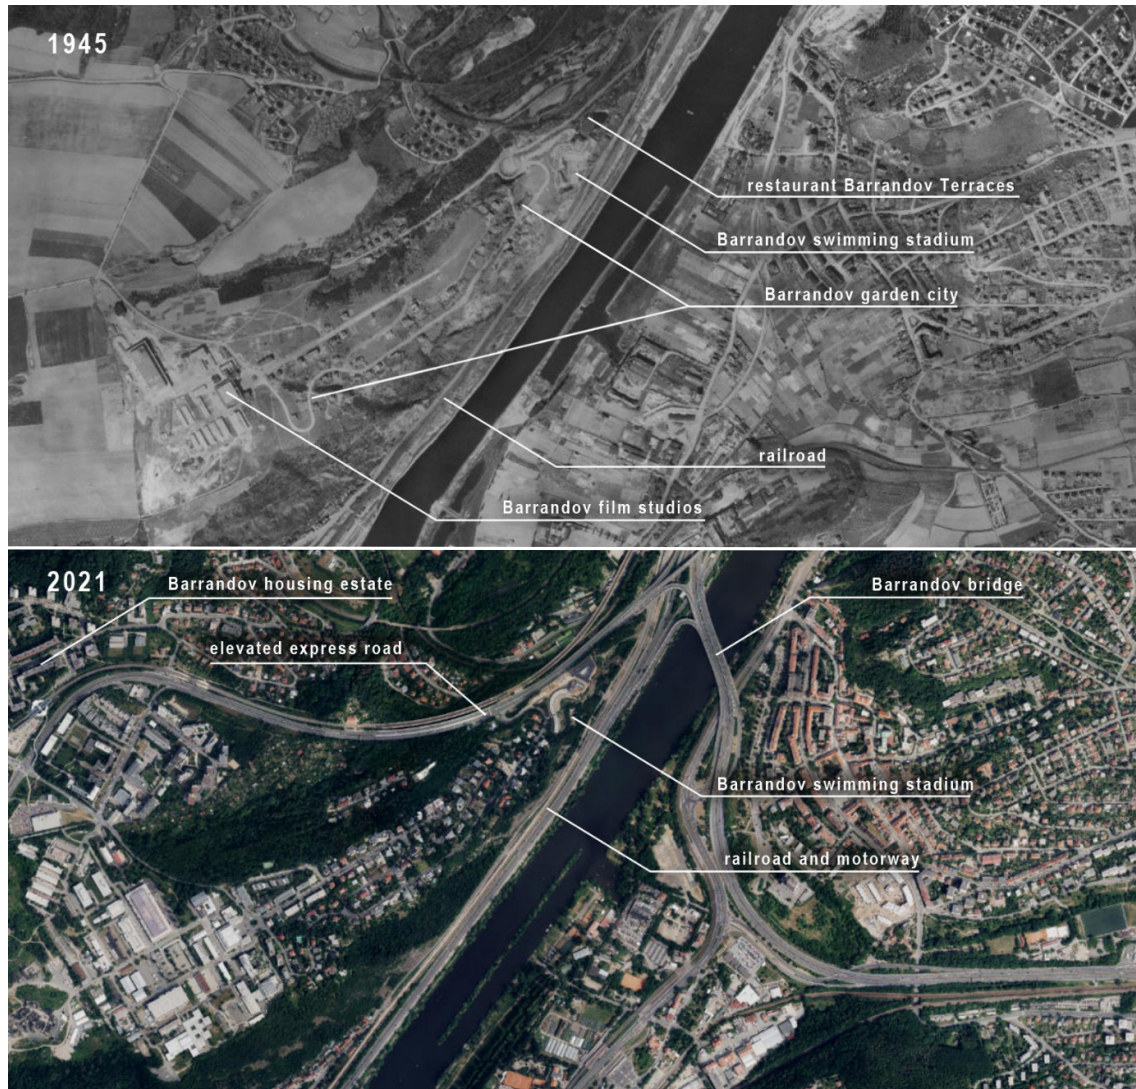
district. The original context has changed throughout time, mainly via urbanistic reconfigurations of the area (Figure B.2-21).

Figure B.2-21. Aerial photos comparing the urban context between 1945 and 2021 (source: IPR Praha).

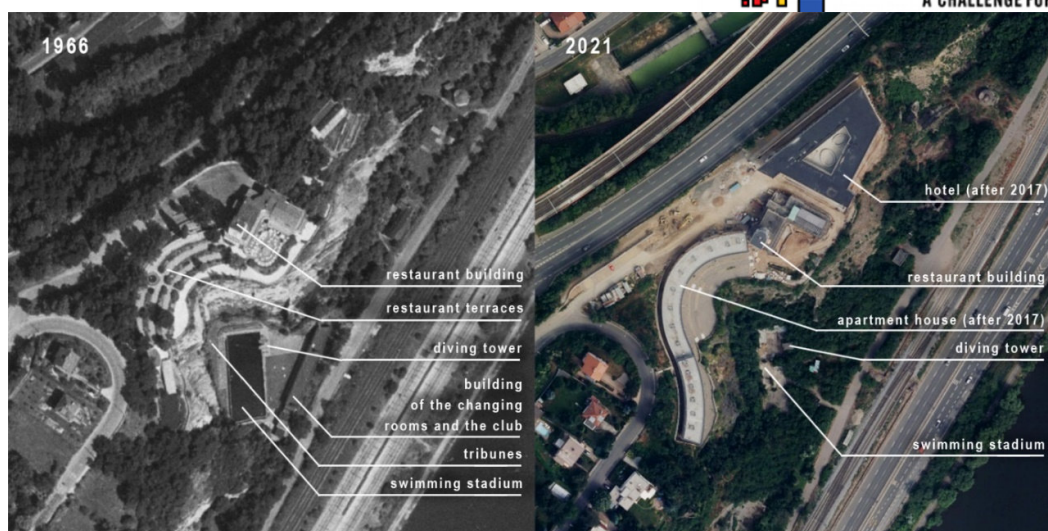
The site's surroundings have lost most of their idyllic natural atmosphere with the construction of the Barrandov bridge (built between 1978 and 1988) and of a highway between the riverbank and the site. Another elevated road serving the 1980s housing estate (*Sídlíště Barrandov*) has been erected in the proximity of the *Barrandovské terasy* restaurant.

Recently, the original building of the *Barrandovské terasy* restaurant was restored after decades of neglect. The restaurant's site has been transformed; the open terraces of the restaurant, serving initially as a viewpoint towards the city, are now occupied with new buildings, i.e., an apartment house on one side and a hotel on the other (Figure B.2-22). Surrounded by new voluminous structures, the original restaurant building with a lighthouse-like tower has lost its original landmark meaning. The new buildings are also visible from the former swimming stadium site.

Figure B.2-22. Aerial photos comparing the site and its surroundings between 1966 and 2021 (source: IPR Praha).

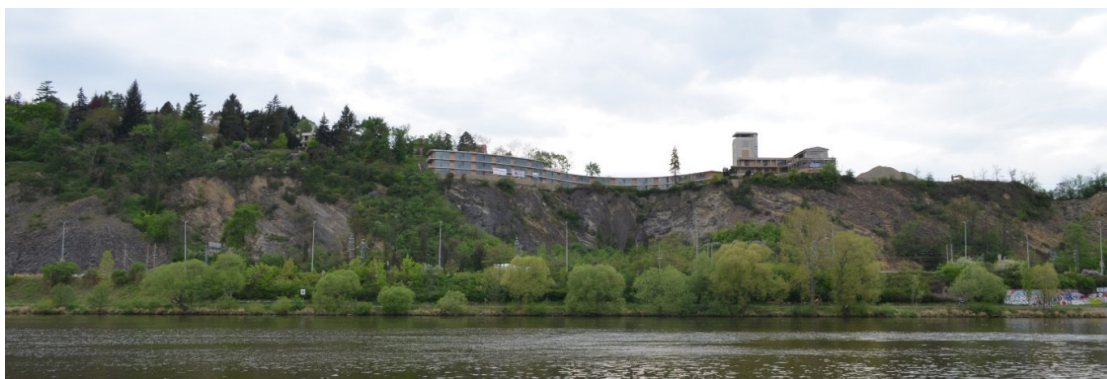
Despite the changes mentioned above, the principal components of the original interwar urban development are still legible: the garden city with the constructivist villas on the ridge of the Barrandov hill, the viewpoint restaurant on the edge of the cliff, and the site of the swimming pool below. From a closer view, the unique relationship between the restaurant building and the swimming pool site is still present. Moreover, the limestone cliff, the most important natural component of the scene, protected as part of the National Natural Heritage *Barrandovské skály*, remains unchanged (Figure B.2-23).

Figure B.2-23. View of the Barrandov hill from the other side of the river Vltava with the new buildings under construction.

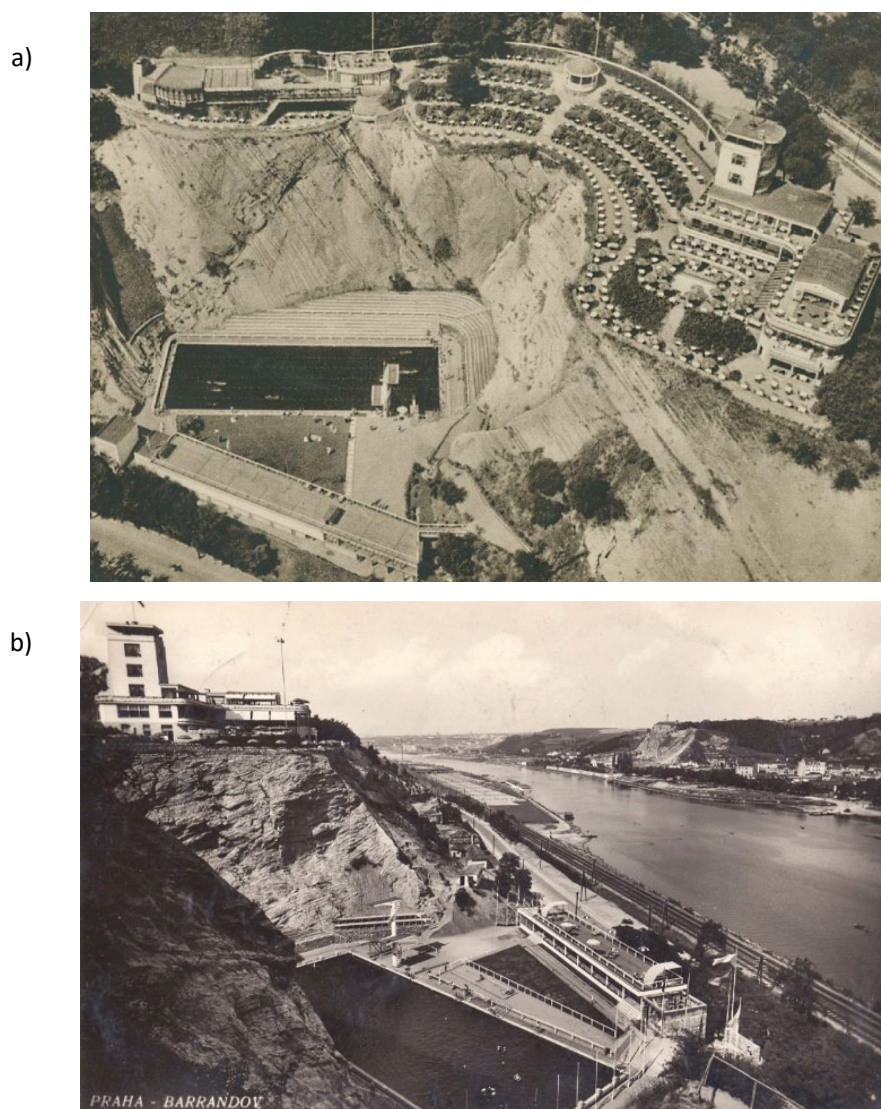
Figure B.2-25. Historical 1930s photos showing the layout of the stadium: a) View of the structure of the changing rooms that was extended after the fire can be seen; b) Photo before the fire that damaged the changing rooms (winter 1934) [30]

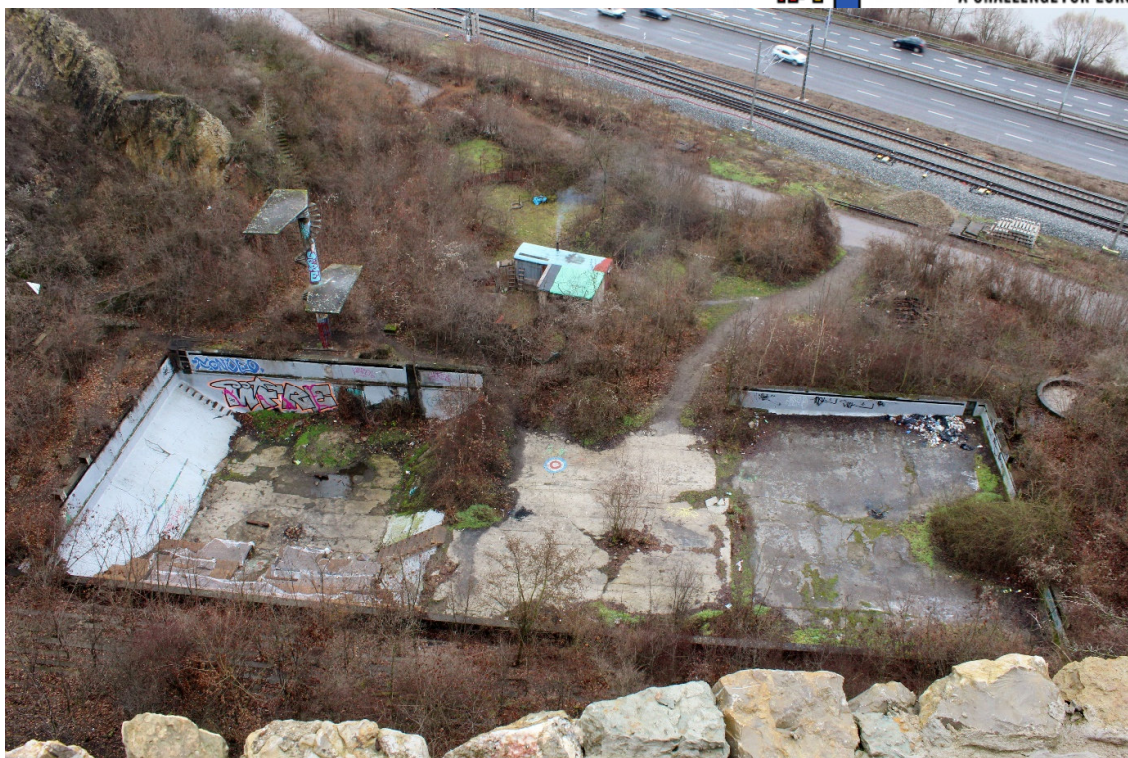
Figure B.2-26. General view of the current state of the swimming stadium. The building of the changing rooms no longer exists, and the site's topography has been altered (photo taken on 3.2.2020, source: Klub za starou Prahu).

On the east side wall of the swimming pool, an opening has been made in its central part (Figure B.2-26). Some of the original elements of the swimming pool are still present, such as the pool ladders and "start swimming blocks" (Figure B.2-27). Near the southeast corner of the swimming pool, a small round basin is still preserved (Figure B.2-26).

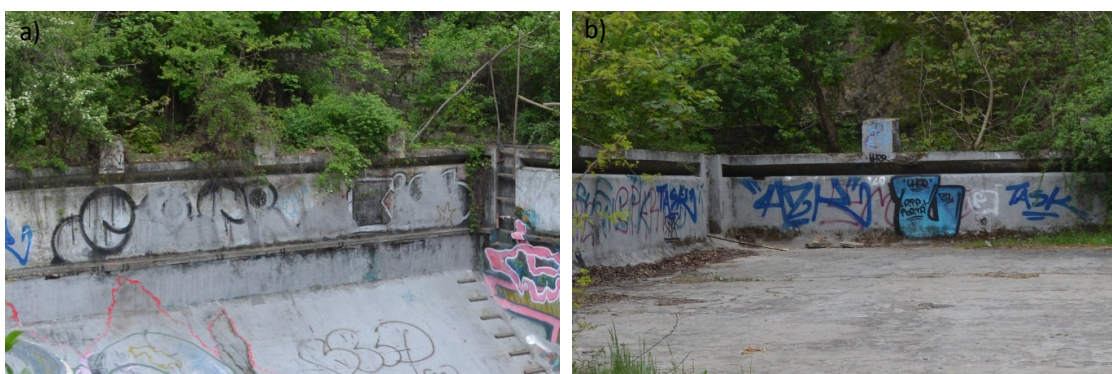
Figure B.2-27. Details of the swimming pool: a) Ladder at the right corner of the diving area; b) "Start blocks" on the southeast side of the pool. Photos taken on 29.4.2020.

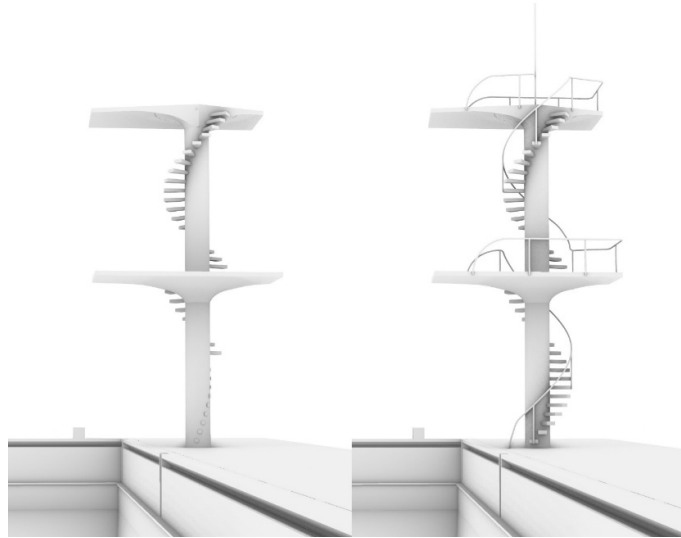
After decades of abandonment, the structure of the diving tower has lost elements that are significant for its architectural expression: the handrail, the flagpole, and the first 10 stair steps (Figure B.2-31). The restoration of the original state of the diving tower (*restitutive restoration* according to [34]), or at least of its original form, may be considered (Figure B.2-32). The swimming stadium complex is in a state of ruins; in particular, the pool area has minimal chance of being renovated to recover its original state. If the whole complex does not undergo a radical transformation, the intervention to return the original state of the diving tower brings controversy. Such intervention, including applying new coatings on the concrete structure and reinstallation of steel elements (handrail and flag pole), can hardly be accepted if the rest of the complex is preserved in a state of ruins.

Figure B.2-31. Model of the current state (left) and reconstruction of the original state (right).

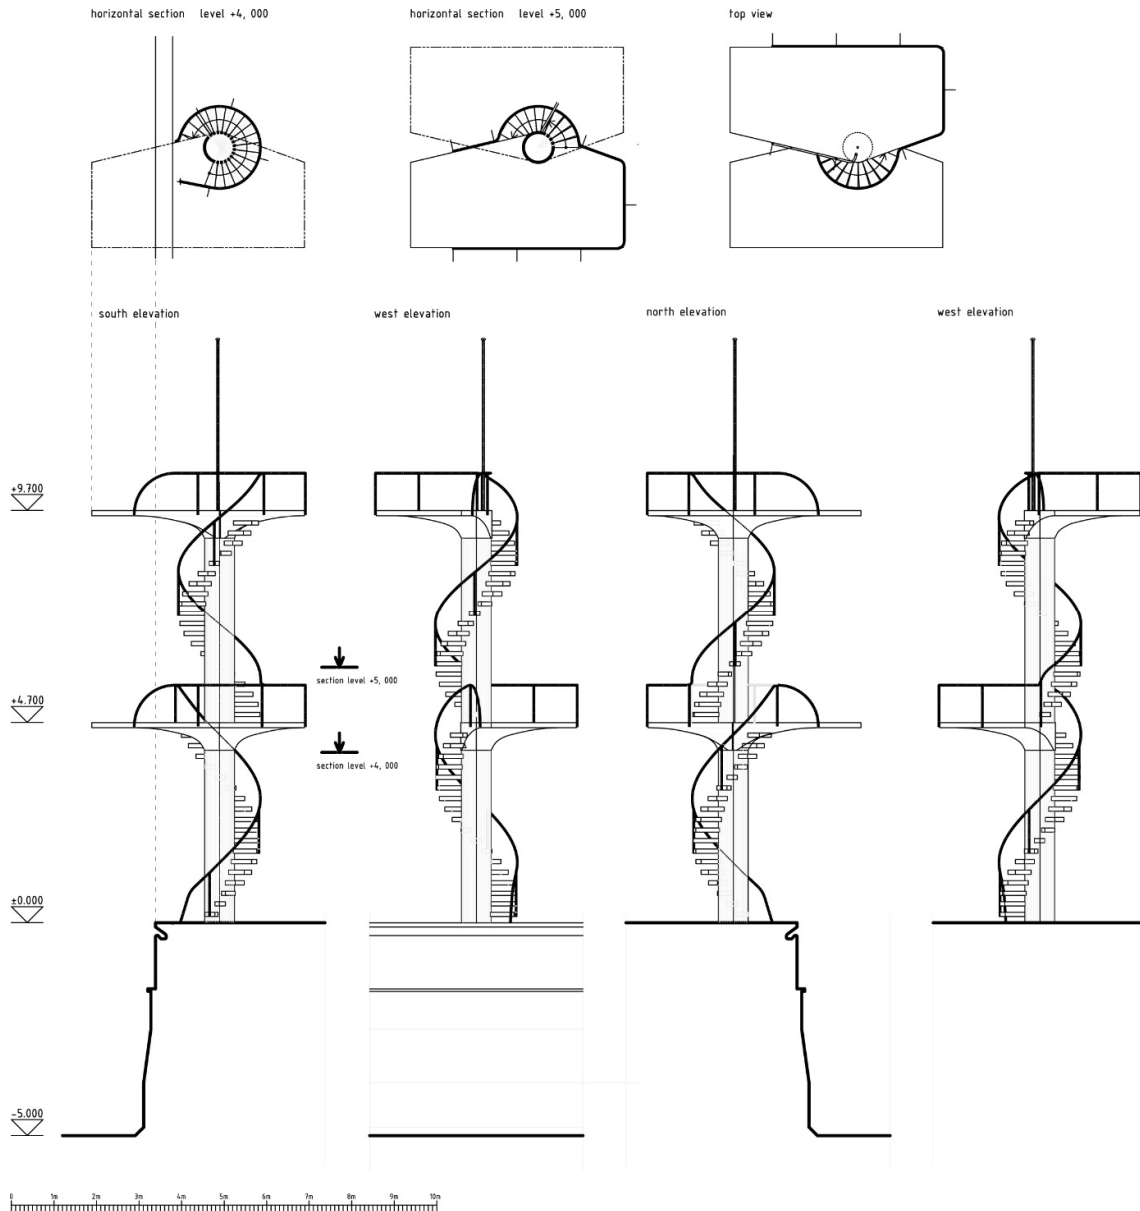
The shape of the handrail and the flagpole can be partly visualized from the original drawings (the anchoring points of the handrail columns); the rest of the geometry can be derived from historical photos (Figure B.2-33). The handrail has been removed, but the same material may still be present in the anchoring points of the platforms. The material specification (e.g., steel pipe D42 mm for the handrails) can be found in the proposed budget plan. Other metallic elements were produced with this material, as can be observed in the remnants of the pool ladders.

Figure B.2-33. Drawing of the reconstruction of the original state of the diving tower.

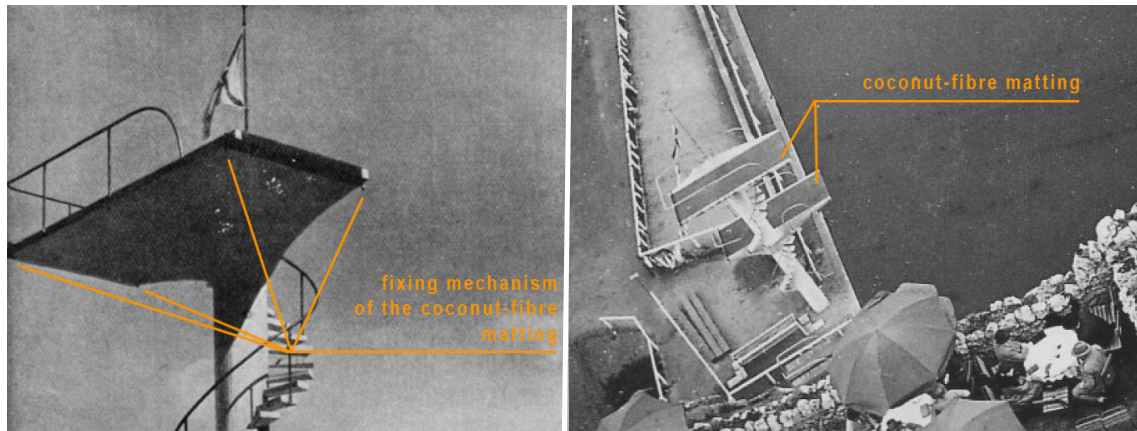
Other steel elements have disappeared: the tightening mechanisms of the coconut matting on the platforms. These elements were not a direct part of the structure, as they were clamped to the slabs

of the platforms. The restitution of these elements goes hand in hand with the restitution of the original floor cover of the platforms: the coconut-fibre matting (Figure B.2-34).

Figure B.2-34. Fixing elements of the coconut-fibre matting cover to the platforms.

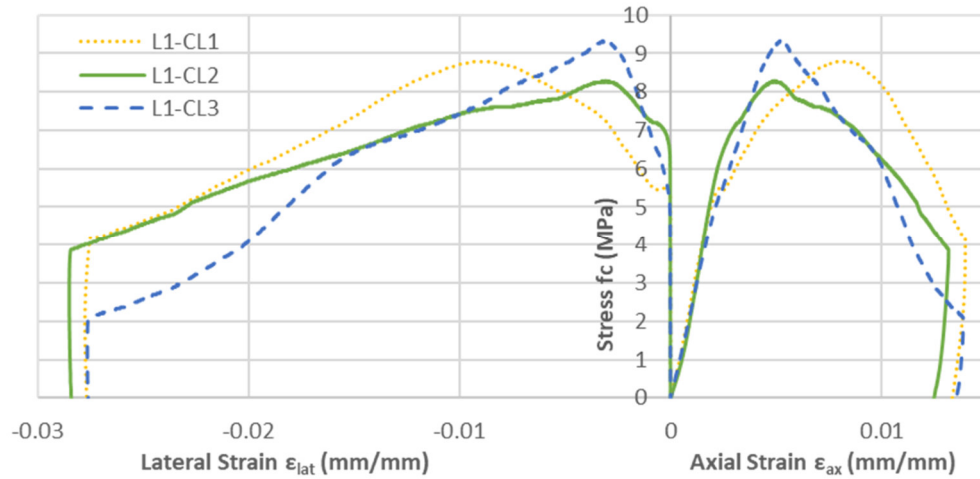
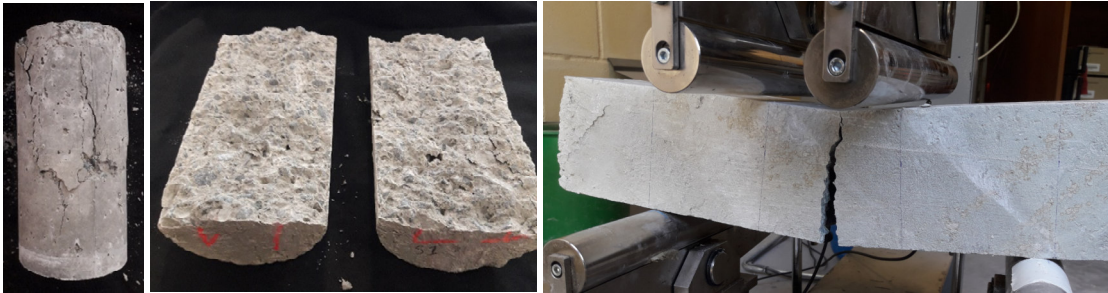
Figure B.3-3. Top: Compressive stress-axial strain-lateral strain of LSC specimens. Bottom: Failure patterns under uniaxial compression (left), split cylinder (middle) and four-point bending (right) tests.

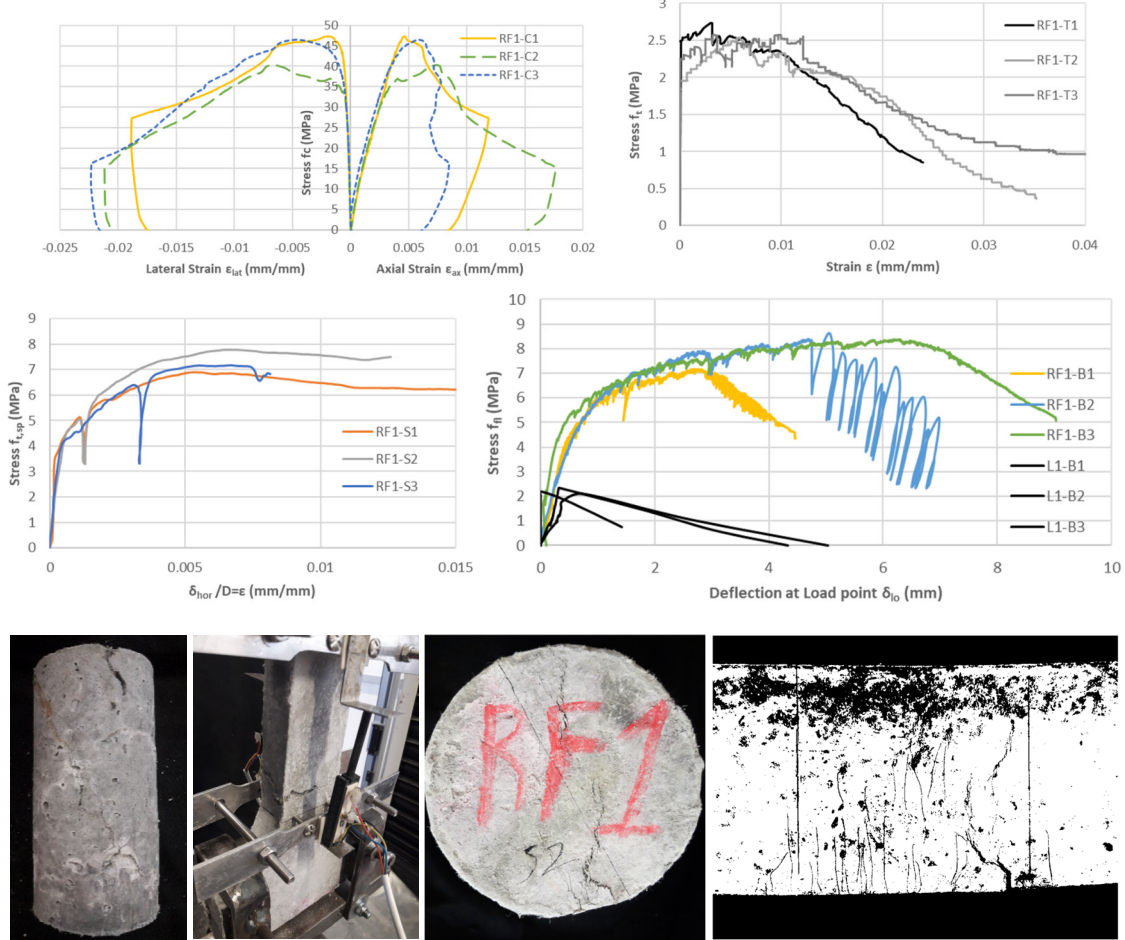
For the characterization of the behavior of the ECC jacket material, uniaxial compression, tension, split cylinder and four-point bending tests were performed, resulting in the stress-strain curves of Fig. B.3-4. The ECC material exhibited strain hardening behavior, with an ultimate tensile strain prior to crack localization in the order of 1%. The uniaxial tensile stress obtained was ca. 2.5 MPa. The strain hardening behavior was extrapolated to the indirect tensile tests of split cylinder and four-point bending that also exhibited multiple cracking, large deformation capacity, increase of strength after first cracking and high energy dissipation. Additionally, in the uniaxial compression tests, failure was delayed with a shift of strain at peak load, and low lateral deformations, due to the confinement action of the fibers bridging vertical cracks; this is typical of strain hardening fiber reinforced cementitious composites [50].

Figure B.3-4. Top row: Compressive stress-axial strain-lateral strain (left) and uniaxial tension stress-strain curve (right) of ECC specimens. Middle row: Split cylinder stress-horizontal strain (left) and four-point bending stress-load point deflection (right) of ECC specimens. Bottom row: Failure patterns of ECC specimens.

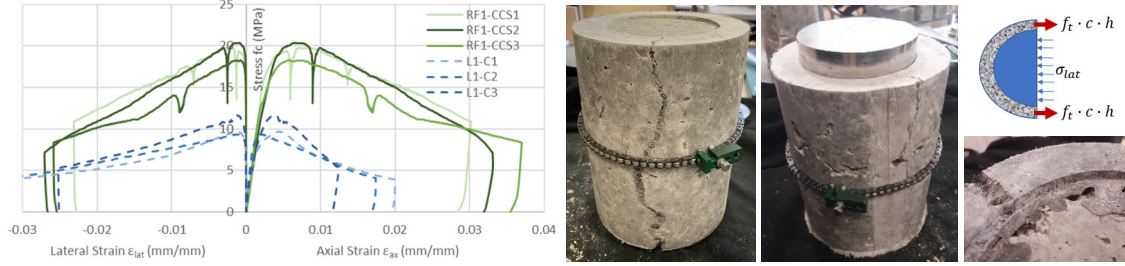
Figure B.3-5. Compressive stress-axial strain-lateral strain of LSC confined with ECC (left) and failure patterns (right).

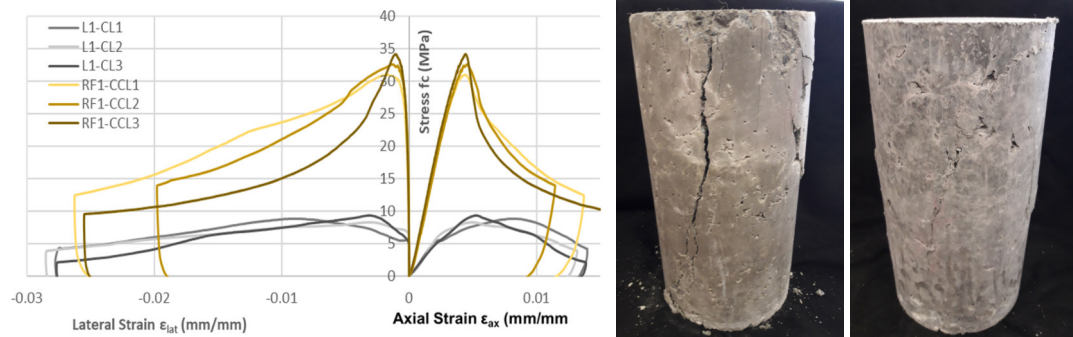
As seen in Eqs. 4 and 5, the compressive strength of the jacketed column is related to (a) the split tensile strength at the initiation of cracking, $f_{t,sp,y}$, and the compressive strength, $f_{c,ecc}$, of the ECC repair material, and (b) the ratio between the internal diameter and the jacketed column total diameter, D_o/D_{col} .

Figure B.3-6. Compressive stress-axial strain-lateral strain of jacketed LSC member with 25 mm ECC (left) and failure patterns of LSC (middle) and jacketed (right) members.

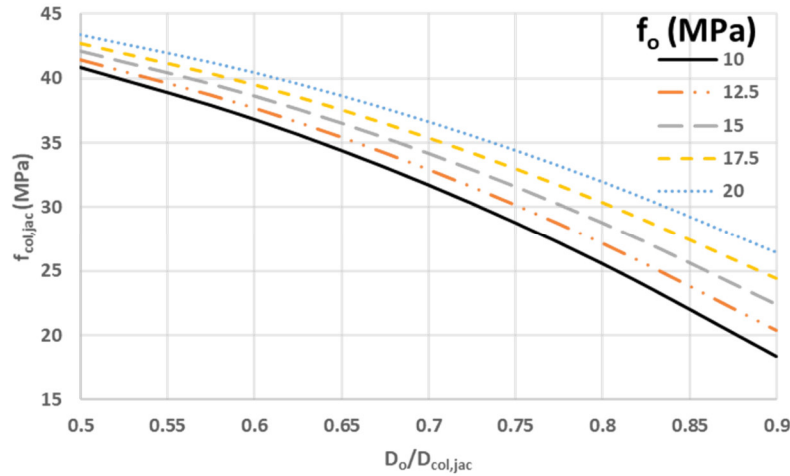
jacketed column's final diameter and the resulting/required compressive strength of the repaired member. These three parameters may be plotted in diagrams for different LSC compressive strengths, as shown in Fig. B.3-7 for the specific repair ECC material. The equation relating these properties is extrapolated by Eq. 6:

Figure B.3-7. Simple diagrams for the calculation of the necessary $D_o/D_{col,jac}$ ratio in relation to the required compressive strength of the repaired concrete ($f_{col,jac}$) and the compressive strength of the original concrete (f_o).

The design of the repair of LSC members using ECC jacketing may benefit from the use of diagrams that relate the original member's compressive strength, the ratio of the jacket thickness to the

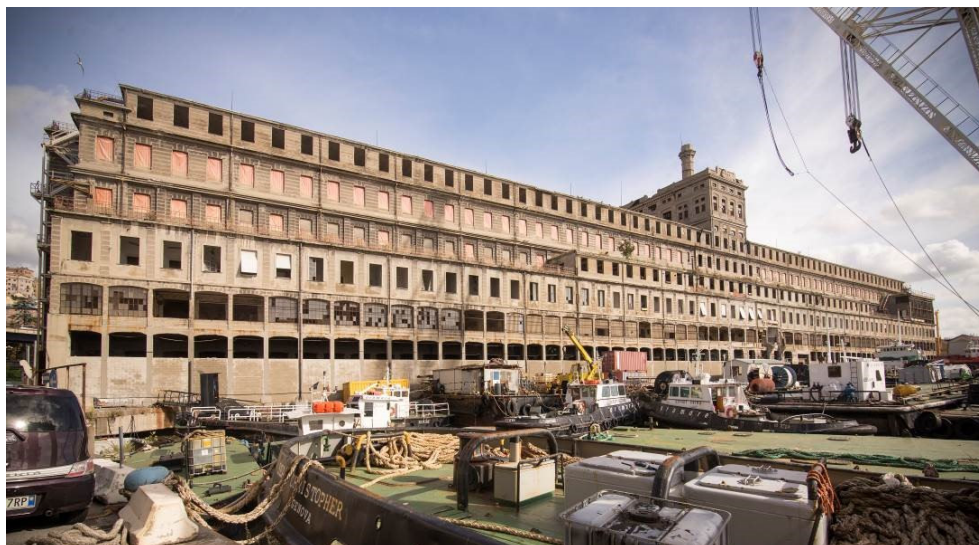
The complex has been abandoned since the 1980s and is currently in a state of total abandonment (Fig. B.4-3). The neglect and lack of the most basic maintenance and protection works have favored the progress of degradation processes, which are now in many parts irrecoverable, and compromise the stability of some structural elements, such as floors, pillars, beams, especially in some portions of the building which are often exposed to stormwater leaching and other aggressive environmental and atmospheric agents [53].

Figure B.4-3 The southern facade of the complex
